FINAL PHASE
IMPLEMENTATION REPORT
FOR SMALL-ARMS RANGE D-30 REMEDIATION PROJECT
AT MARINE CORPS BASE (MCB) CAMP LEJEUNE, NORTH CAROLINA

July 25, 1997

Battelle
505 King Avenue
Columbus, Ohio 43201-2693

HEPACO, Inc.
2711 Burch Drive
Charlotte, North Carolina 28269

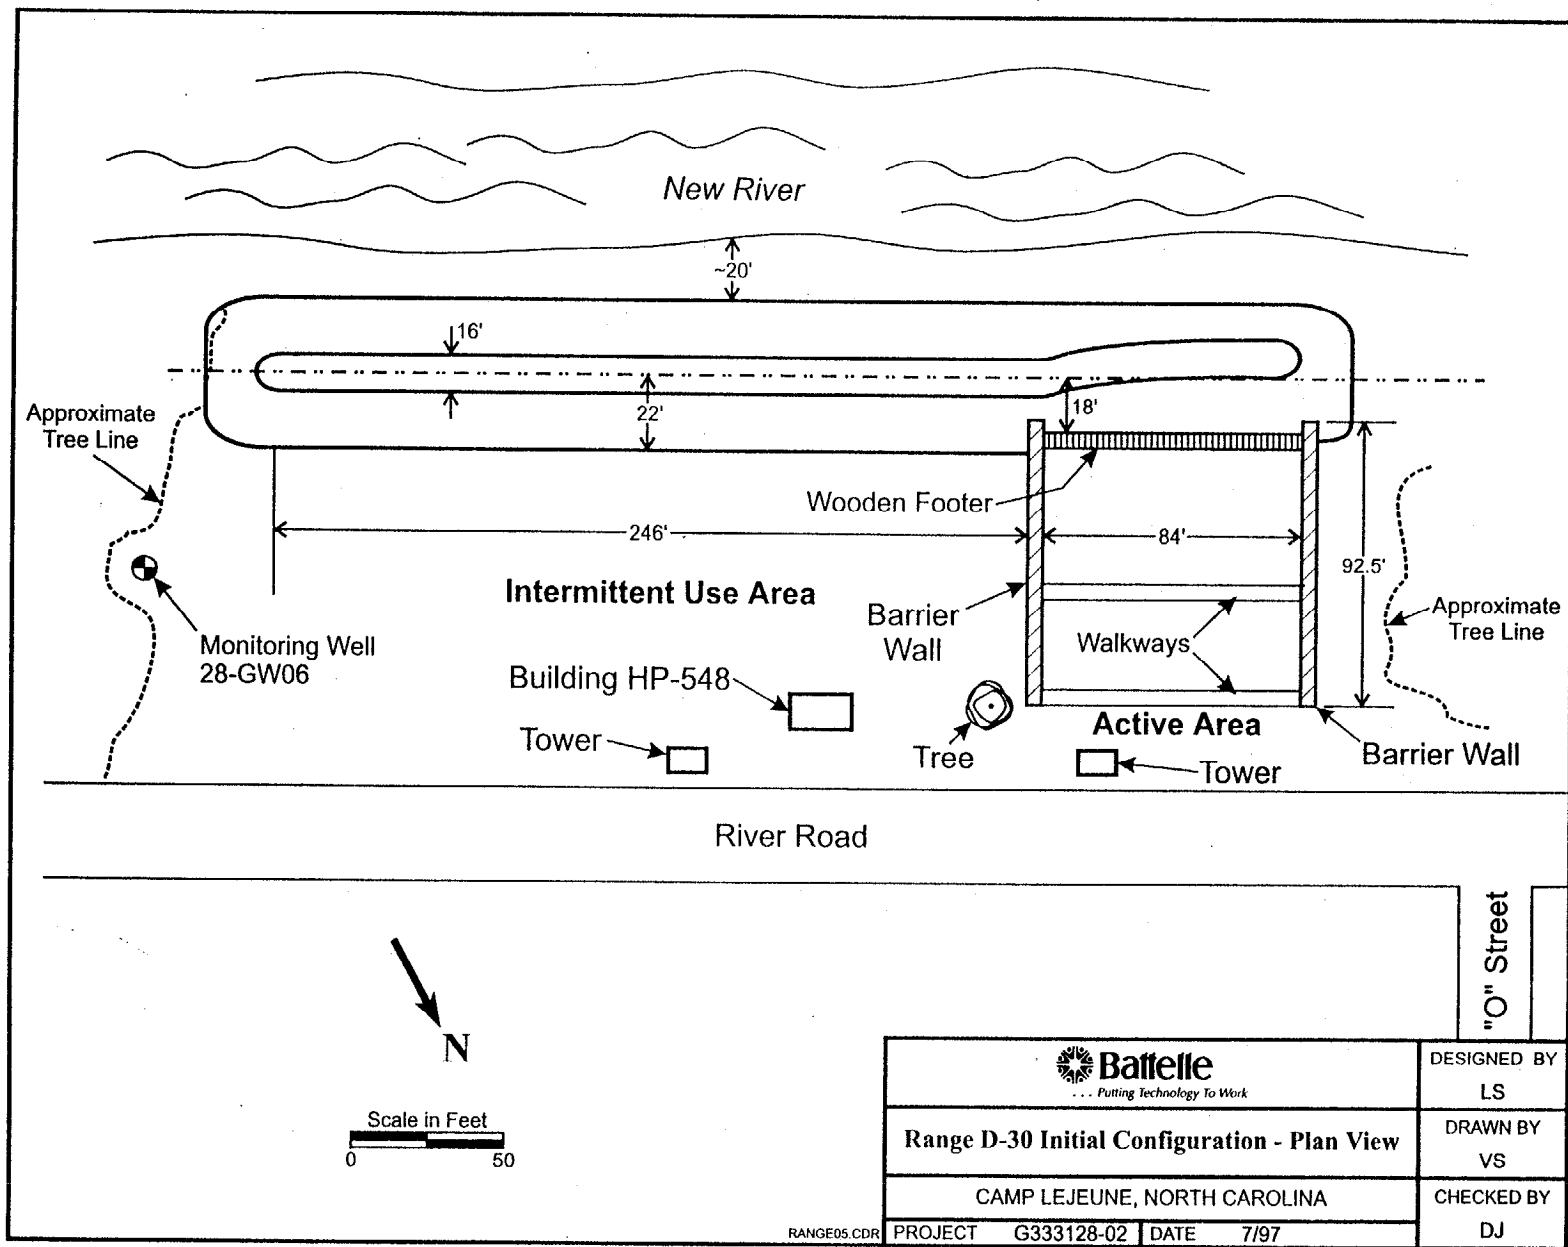
Figure 1-2. Range D-30 Initial Configuration — Plan View

The portion of the range located to the right when facing the river is about 84 ft long and is actively used for pistol training and qualification. A longer portion of the range, located to the left when facing the river, is used intermittently. There is an earth-filled wooden barricade on the right end of the actively used portion and a second earth-filled wooden barricade between the active and intermittent use portions of the range.

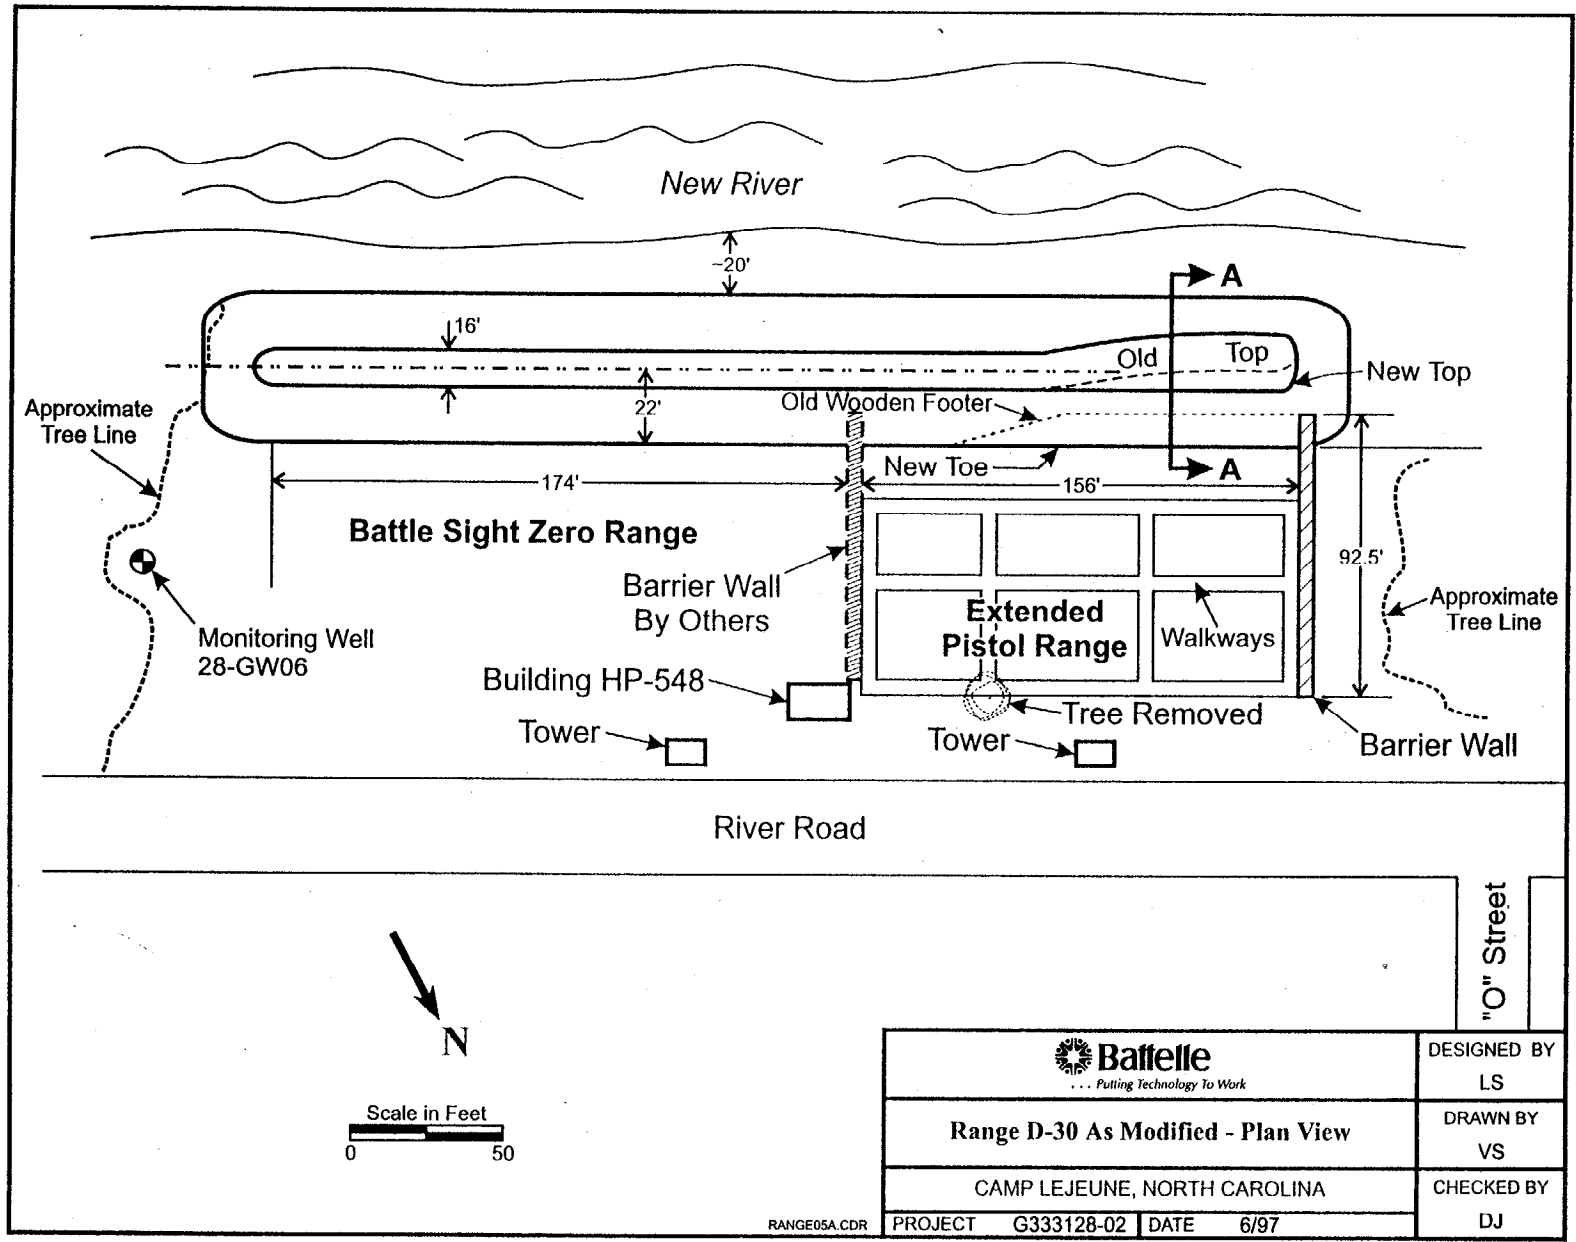
Figure 1-3. Range D-30 as Modified — Plan View

The front of the active area berm was several feet further from the firing line than the front of the intermittent use berm. The front of active area berm needed to be aligned with the front of the intermittent use berm to allow the planned extension of the active use area. The alignment required the addition of about 160 yd³ of soil to advance the front of the active area berm into alignment with the intermittent use area berm, as well as construction of a new drainage path at the toe of the berm, removal of the existing concrete walkways that marked firing line locations, and placement of 843 ft of gravel walkways to mark new firing line locations. MCB Camp Lejeune supplied two trucks and operators to move the soil from the borrow pit to Range D-30. Base personnel removed a tree that interfered with the range extension.

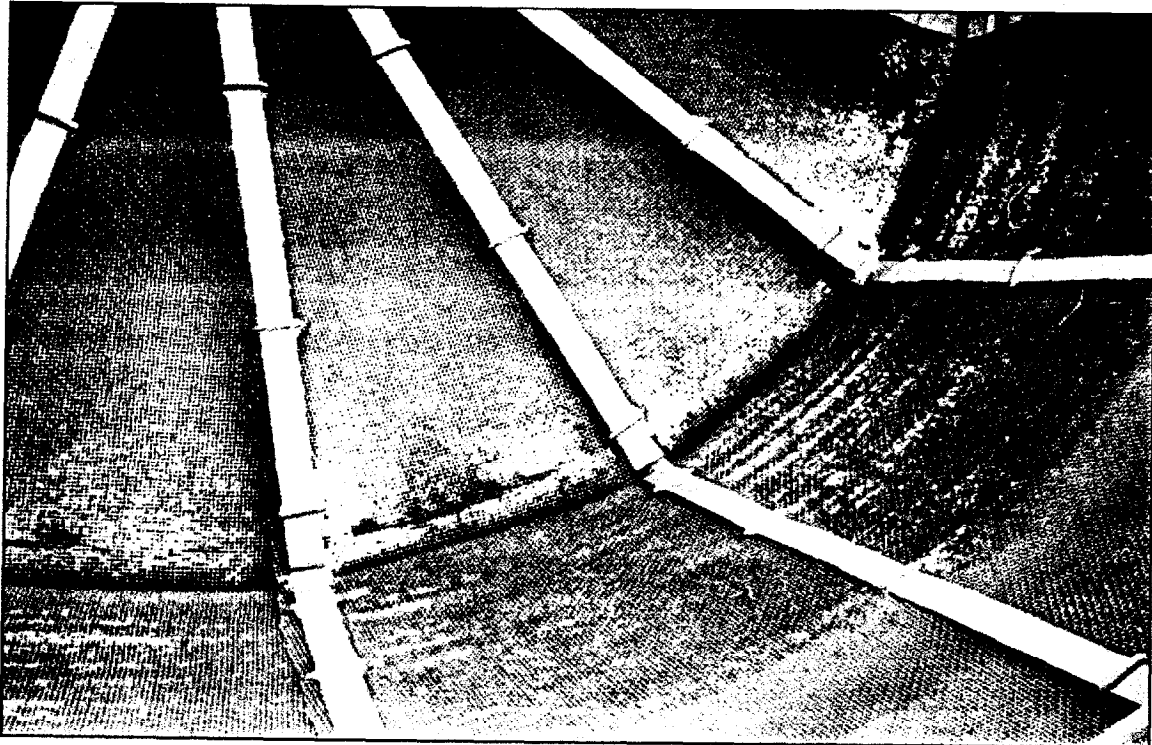
The soil proved to be more cohesive than expected, causing the #5 mesh screen to plug frequently. The active area soil, which contained the highest proportion of bullets and bullet fragments, was screened using the #5 mesh. The intermittent use area soil was screened through a more open mesh (3/8-in. mesh screen) which did not plug with the moist, cohesive soil. The larger screen opening retained lead fragments because of the inclined orientation of the screen and the tendency for the soil to partially fill the openings.

Photo 4. Screen Showing Soil Accumulation in Openings

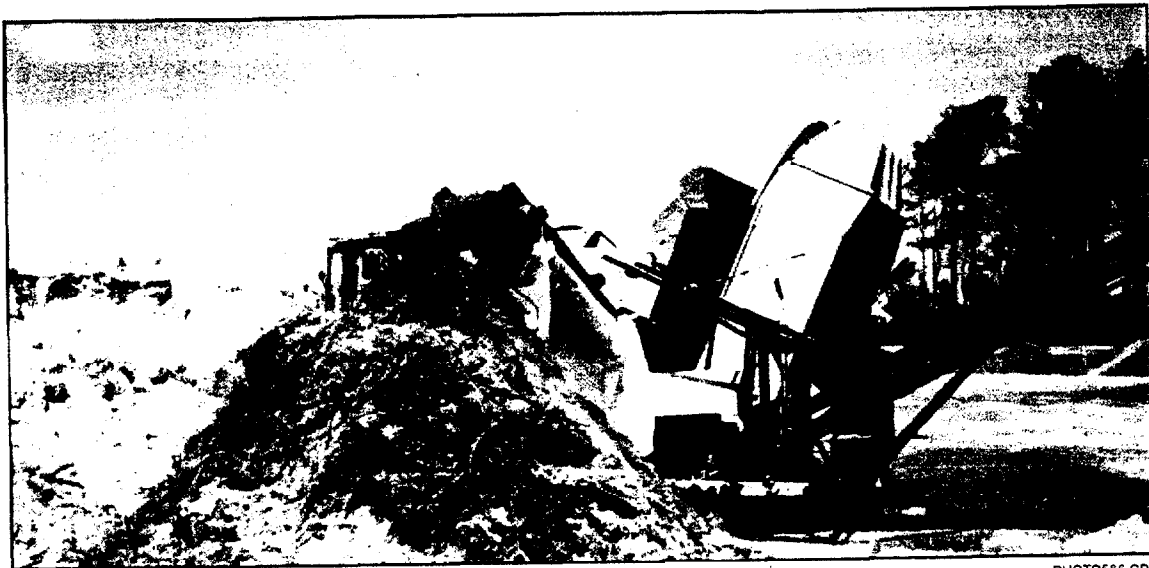
The interior of the berm contained an unexpectedly large proportion of fibrous roots. A high organic content is detrimental to smelter operation, so the roots had to be removed by rescreening the oversize material through a 3/4-in. mesh screen. This larger screen allowed metal to pass through but retained the organic debris. Even with several passes through the 3/4-in. screen, the material sent to the smelter contained excessive organic material, resulting in a small additional processing charge.

Photo 5. Organic Debris Removed from Lead-Bearing Material Prior to Recycling

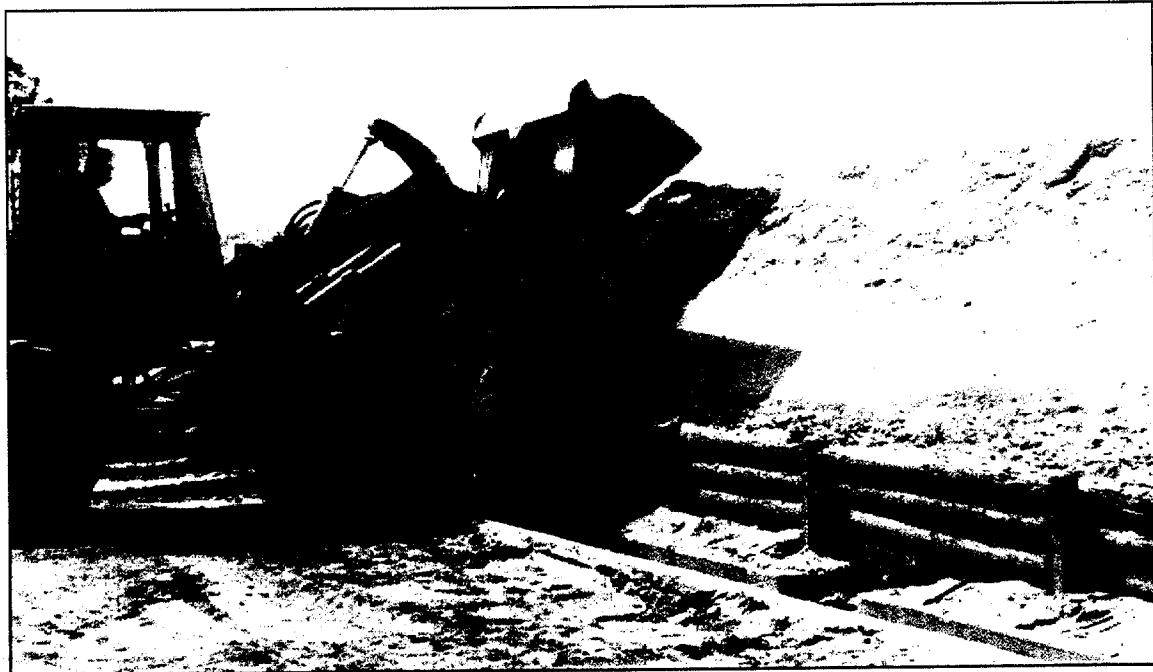
Photo 8. Rebuilding Berm Face

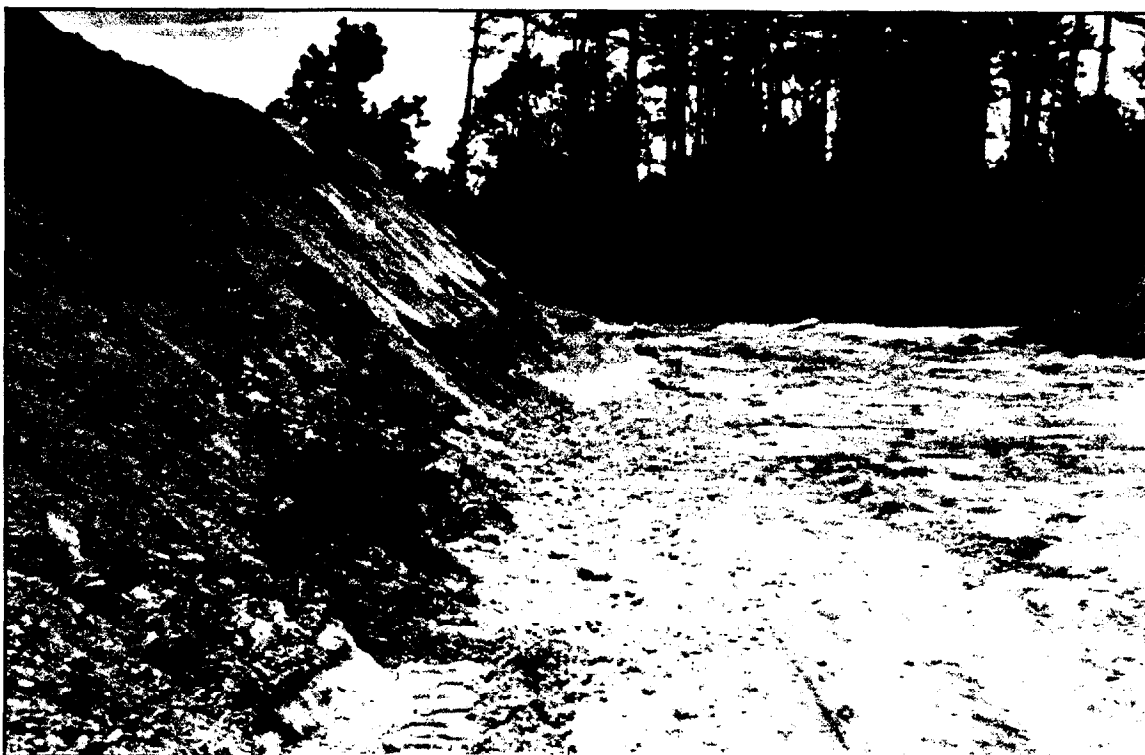
Photo 9. Gravel-Lined Drainage Channel at the Base of the Completed Berm
