Re: Progress Report: JP-5 Recovery, MCAS, New River

RE: Jet Fuel Clean-Up

JOB: <u>JP-5, CAMP LEJEUNE, MCAS</u>

MONTHLY ASSESSMENT MONITORING REPORT

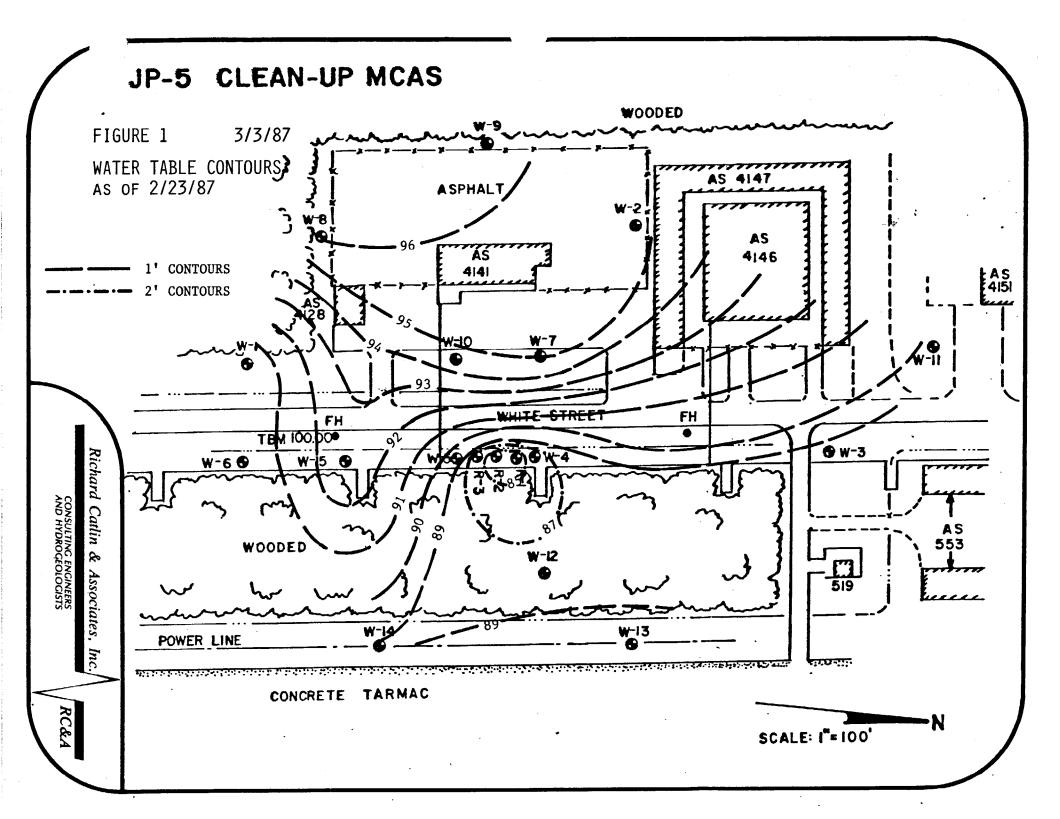
Figure 1 shows a diagram of the interpolated water table contours. The estimated extent of free floating JP-5 contamination at the site is illustrated on Figure 2. Figure 3 shows the cumulative recovery of JP-5 over time, as it is collected from the separator by J. Gonzalez, of Specialized Marine, Inc., and the United States Marine Corps fire training personnel.

A) OBSERVATIONS: Our latest data shows a water table configuration relatively the same as that observed on our previous visits. The change in the shape of the cone of depression is due to the transfer of an ejector pump, as discussed under 3) below.

- A) CHANGES SINCE LAST REPORT: The more symmetrical cone of depression, as opposed to the one interpreted in the 2/23/87 report, is due to an ejector pump being transferred from well #W-5 to well #R-3.
- B) DISCUSSION: Although the recovery system has apparently continued to function successfully in free product recovery, no additional recovered JP-5 has been removed from the separator since our last report. To date, approximately 2,957 gallons of recovered JP-5 have been removed from the separator by J. Gonzales, of Specialized Marine, Inc., and the U.S.M.C.

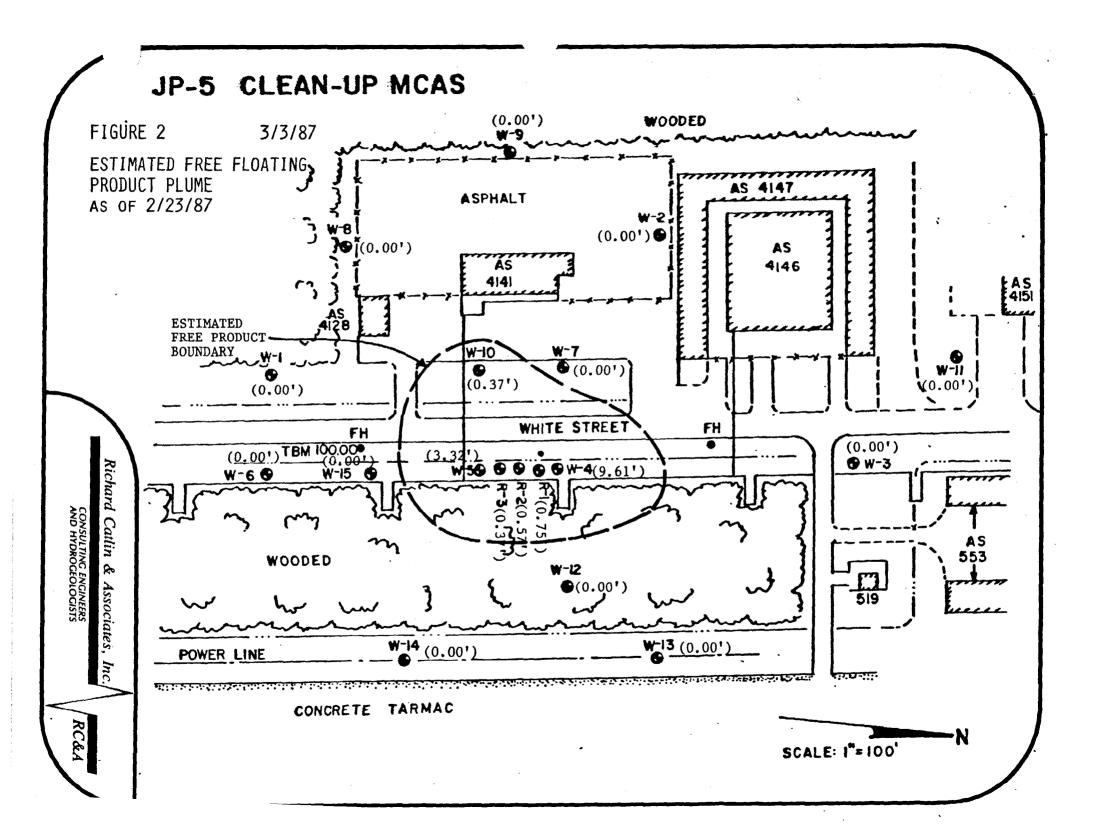
A) CHANGES SINCE LAST REPORT: Since our last report (2/23/87), measurable amounts of product accumulation have decreased in monitoring wells #W-4, #W-10, and recovery wells #R-1, #R-2 and #R-3. The only increase in free product accumulation was found in monitoring well #W-5.
