**AST CLEANING AND FUEL DISPOSAL
MICHAEL ROAD FUEL FARM B-20 TANK**

**MARINE CORPS BASE
CAMP LEJEUNE, NORTH CAROLINA**

August 11, 2009

**Navy Contract No. N62470-05-D-6200
Delivery Order No. 0070
CATLIN Project No. 209-038**

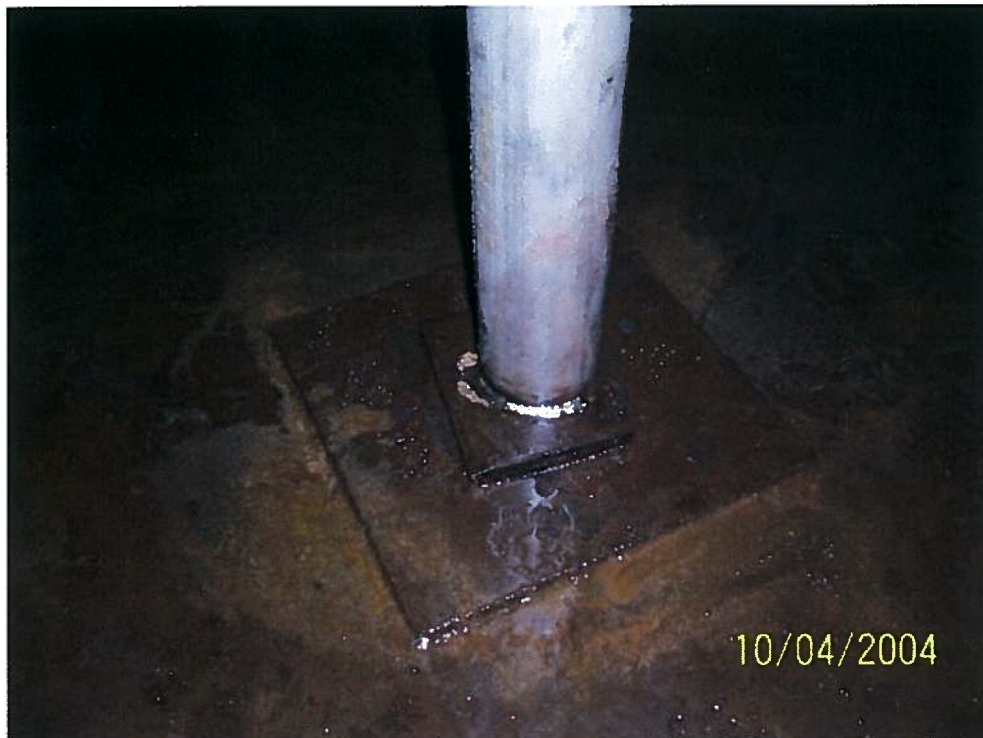
4.9 Fixed Roof: The fixed roof is a supported cone roof. The roof is supported by a 3" pipe column also used as a gauge well. The column is intermittently welded to a reinforcement pad which is lap welded to the floor. The coating system is in satisfactory condition. The nominal thickness of the fixed roof is 0.1875 inches. The fixed roof was evaluated for remaining metal thickness using ultrasonic technology. The fixed roof thickness ranges from a minimum of 0.169 inches to a maximum of 0.173 inches. Thickness measurements are listed in the Fixed Roof Plate Thickness Measurements table in Appendix C. The fixed roof is in satisfactory condition.

Fixed Roof Support/Gauge Well

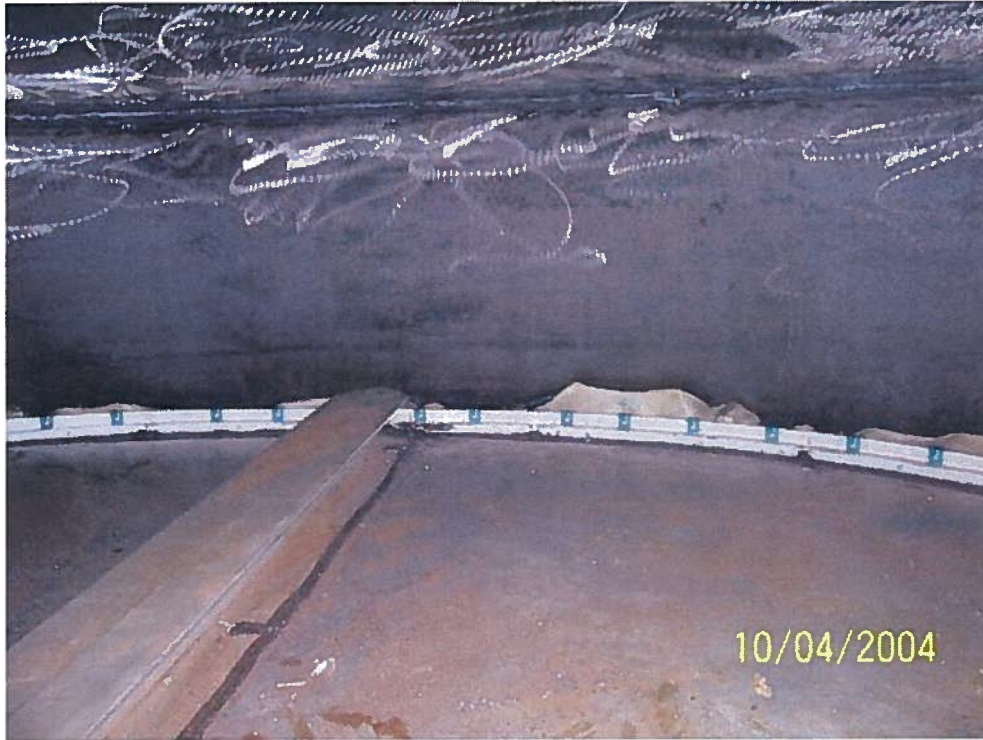
4.8 Floating Roof: The floating roof is an internal sandwich-panel floating roof with a primary foam log seal. The primary seal shows some wear on the outer skin. The maximum seal-to-shell gap measured 4 inches. The annular space between the floating roof and the shell measured between 3 and 4 inches. The floating roof is in satisfactory condition.

Topside of Foam Log Seal

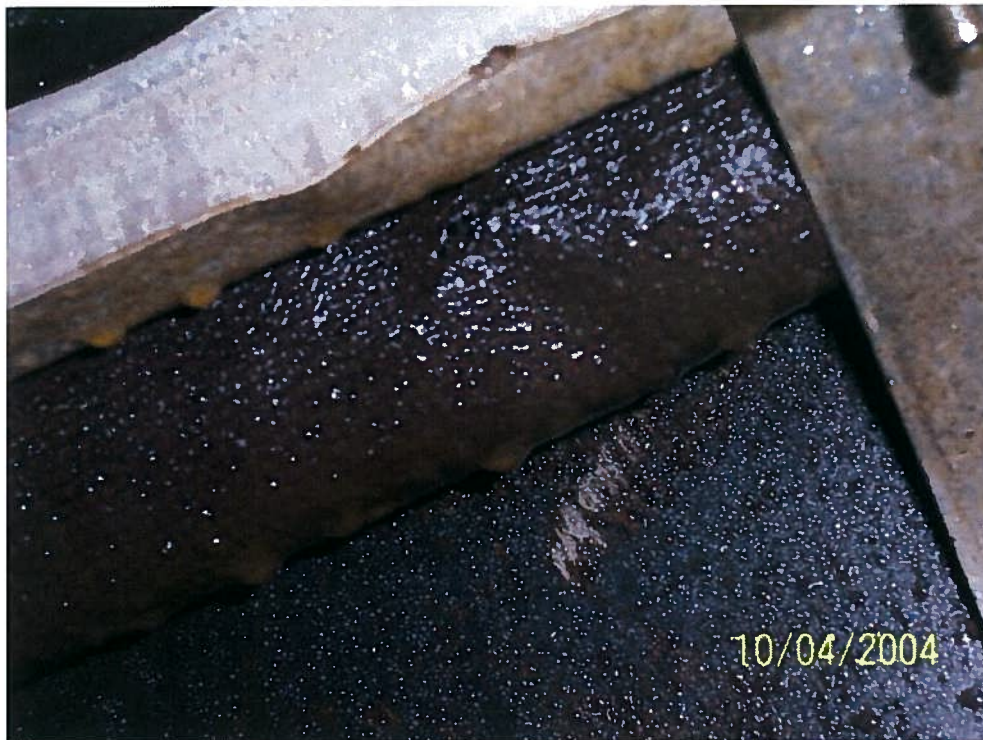
Liquid side of Foam Log Seal

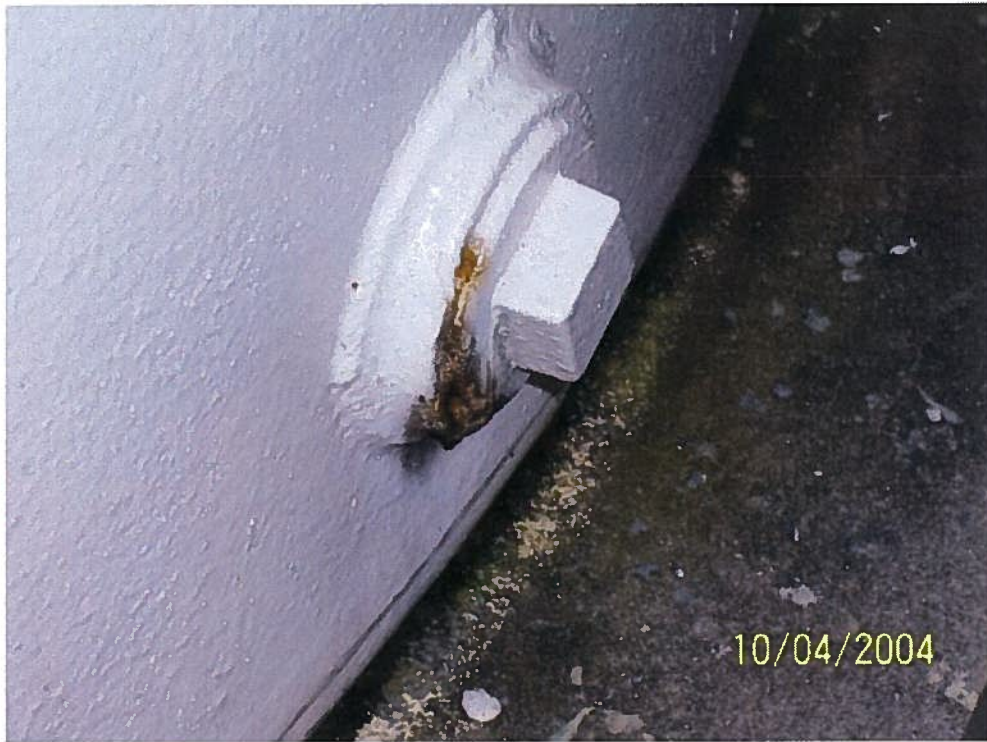
Nozzle "A" Plug

5.6 Shell Appurtenances: Remove the male plug from nozzle "A", clean and retape all threads before reinstalling plug to prevent any further seepage. Repair/replace the valve for nozzle "E" to prevent any further product seepage through valve handle.

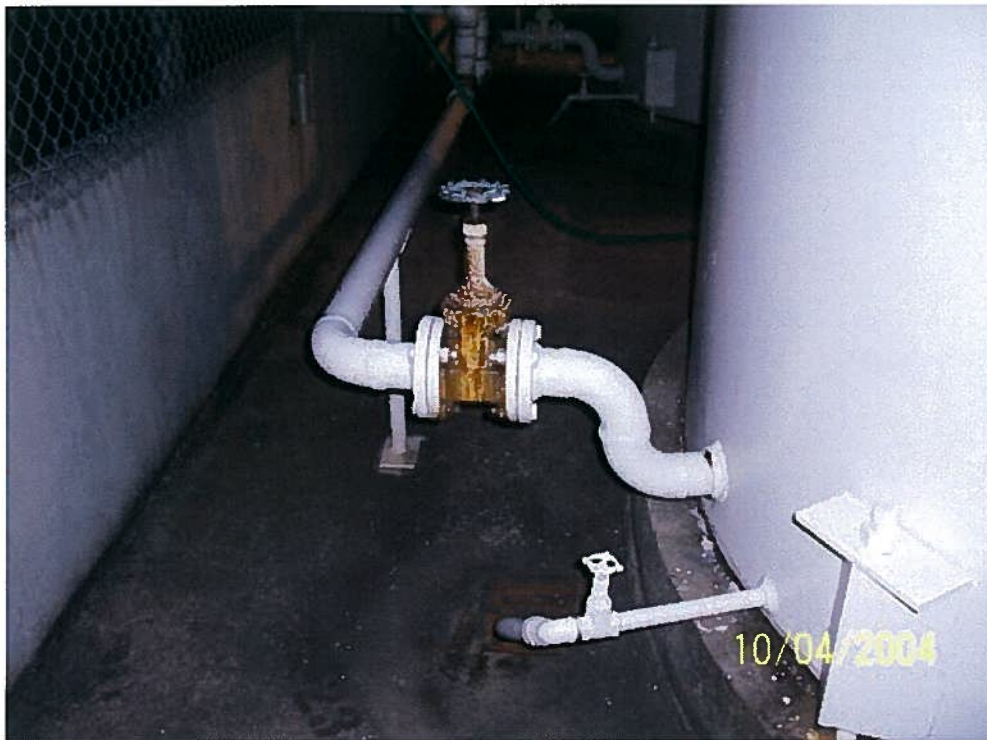
Nozzle "E" Product

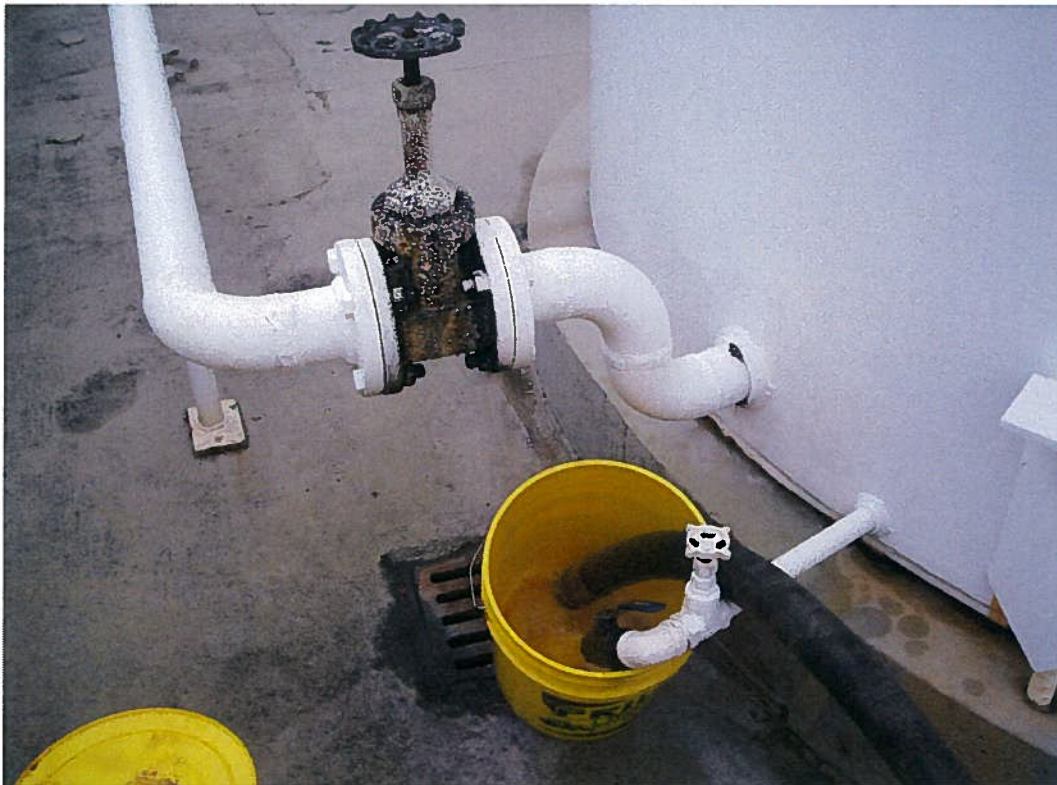
Photo 2; Decanting nuisance water from bottom of tank for disposal at EMD.

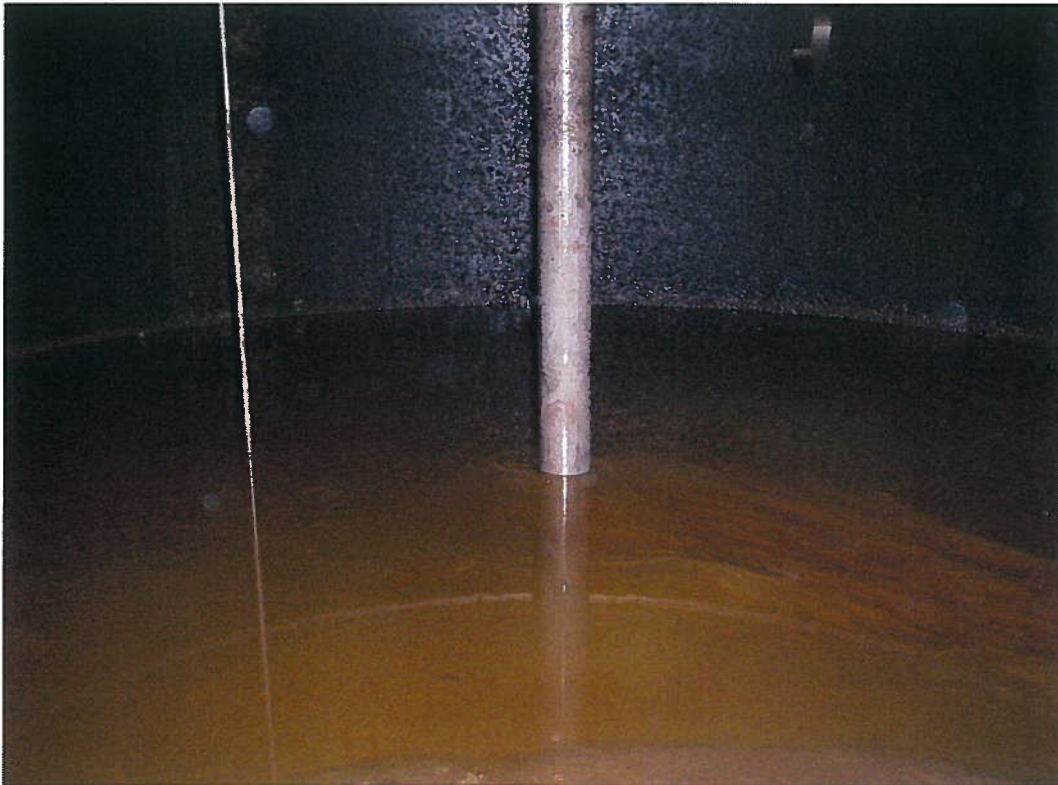
Photo 4; Sludge remaining after fuel removed from the AST.

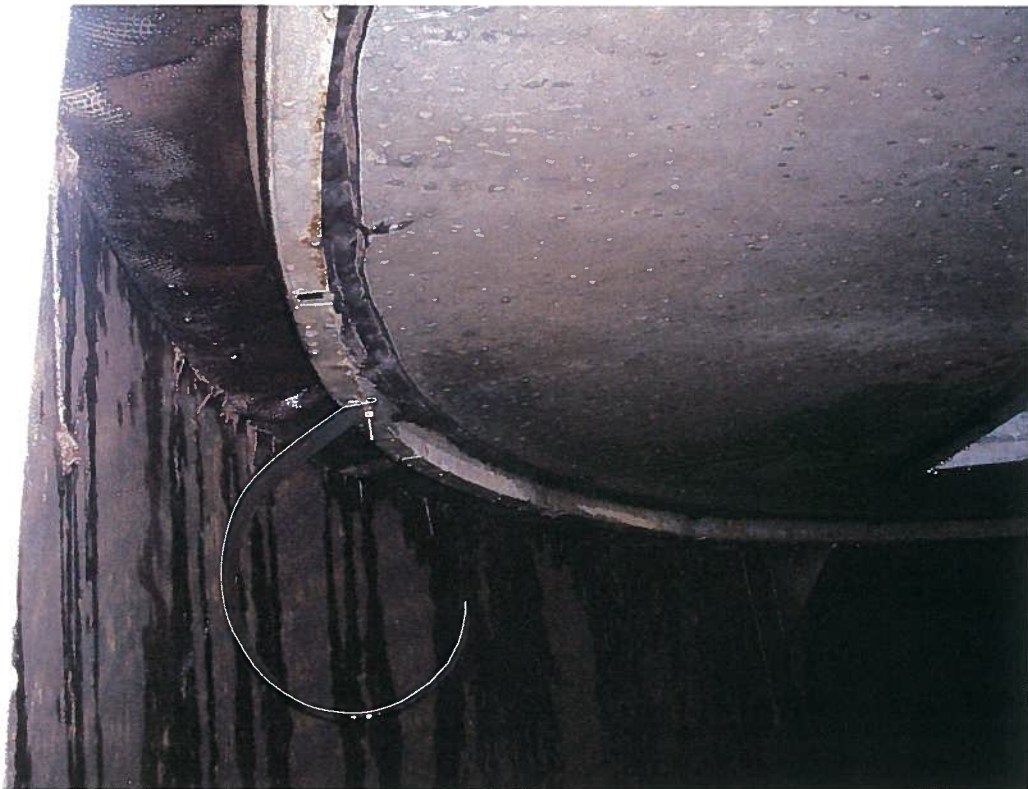
maintenance work at the fuel farm. The foam log portion of the floating roof was observed to be worn and may warrant replacement as part of the next scheduled maintenance associated with the fuel farms. CATLIN also recommends that the fuel lines associated with the dispenser of the AST be thoroughly cleaned and purged prior to putting the AST back into service.

Photo 5: Built up sludge on foam log of floating roof prior to cleaning.

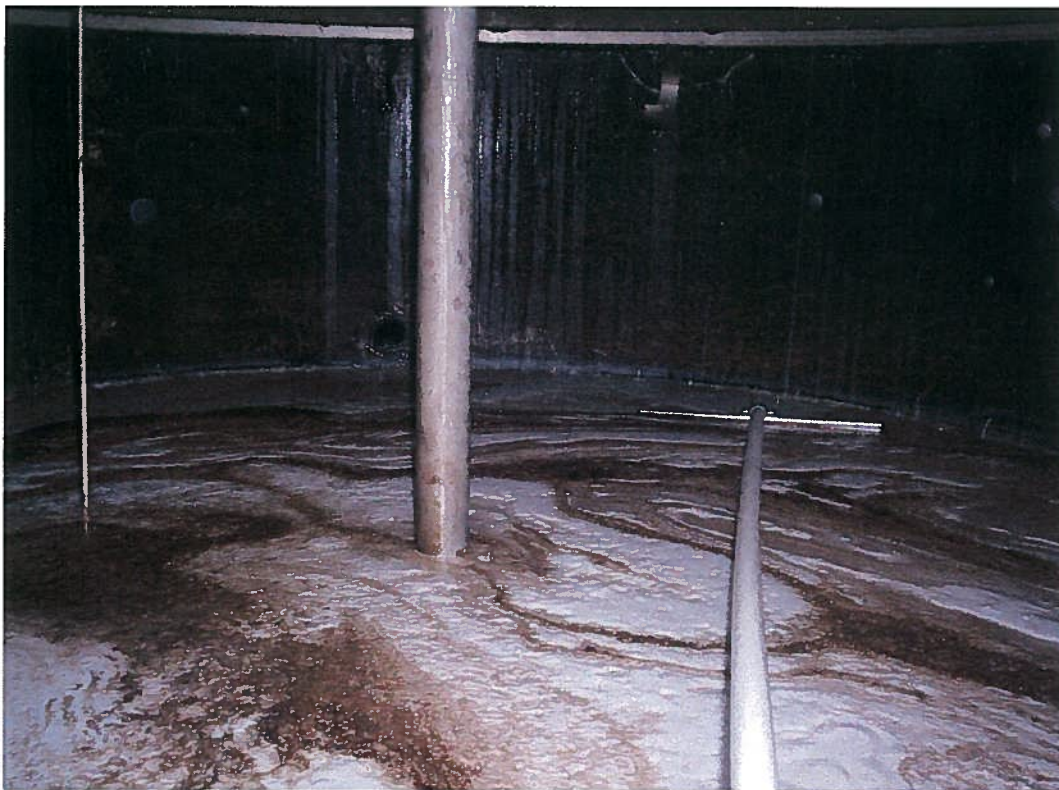
Photo 12; Emulsification of residual bio-diesel and cleaning solution.

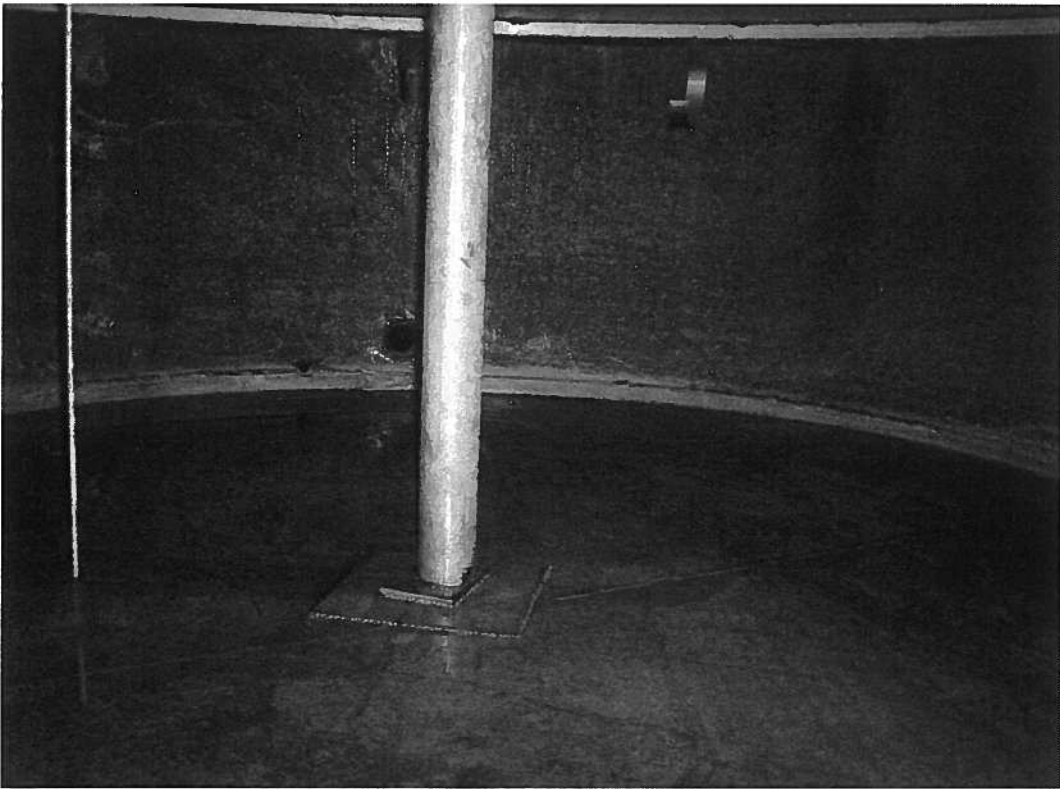
Photo 14: Lower portion of AST after cleaning completed.

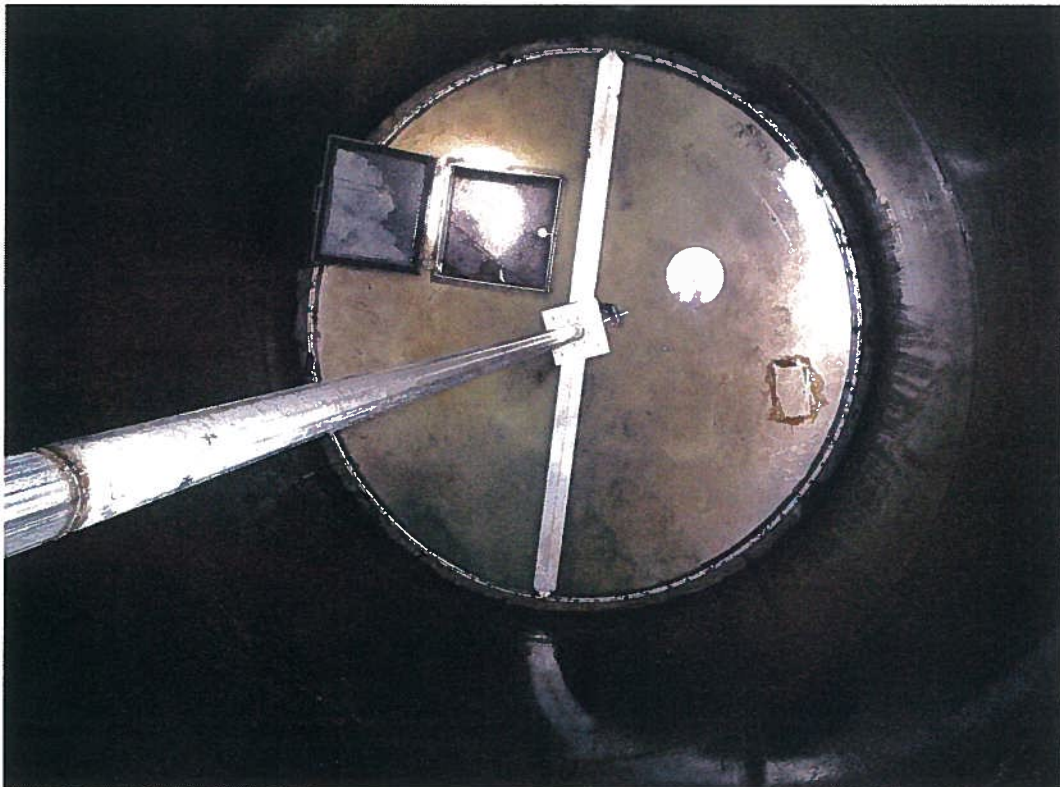
Photo 15; Portion of AST above floating roof after cleaning completed. (looking down from above)

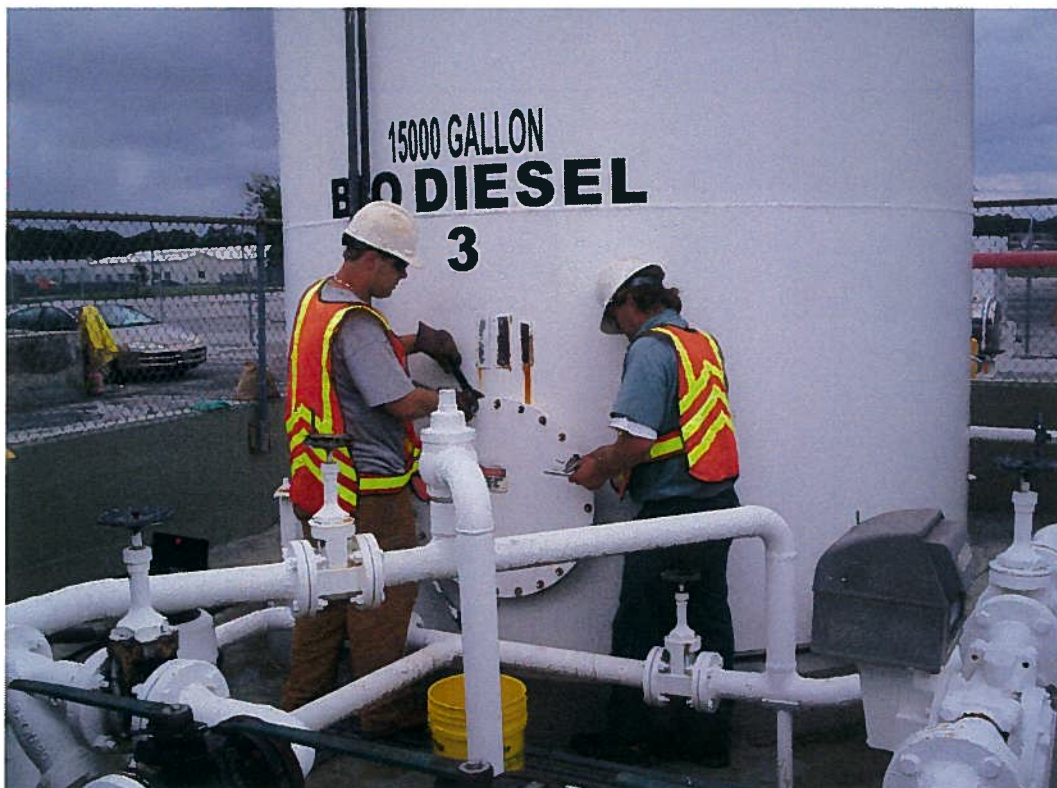
Photo 16; Completion of cleaning with installation of man ways using new gaskets and new nuts and bolts
