RE: PROGRESS REPORT: JF-5
RECOVERY, MCAS, NEW RIVER

RE: JP-5 Clean-up, MCAS
RC&A Project # 8636

MONTHLY MONITORING REPORT

SITE: JP-5 FUEL OIL RECOVERY, CAMP LEJEUNE, NC

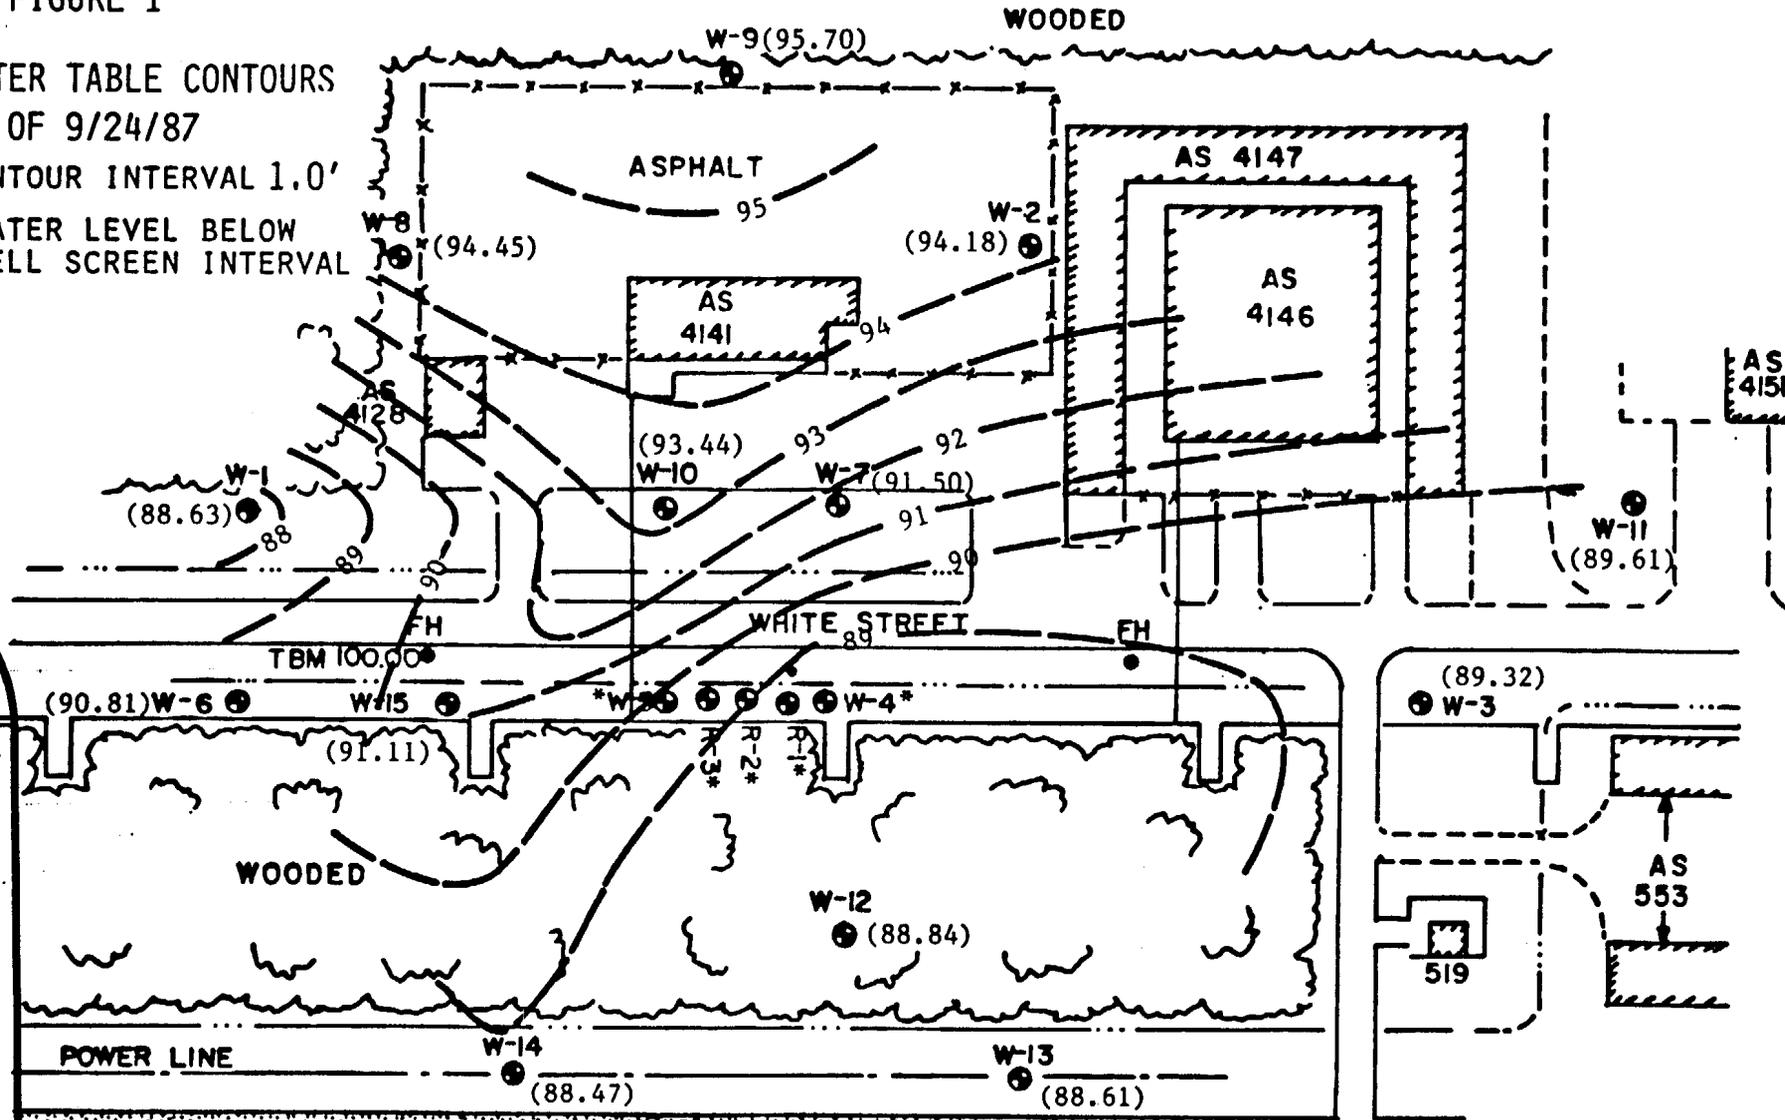
FIGURE 1

OBSERVATIONS: The interpolated well data indicate that the water table surface levels in the monitoring wells have risen an average of about 0.3' since the August site visit. Due to an air compressor malfunction, the multiple cones of depression usually observed at the site had been lost at the time of our visit.

WATER TABLE CONTOURS
AS OF 9/24/87
CONTOUR INTERVAL 1.0'

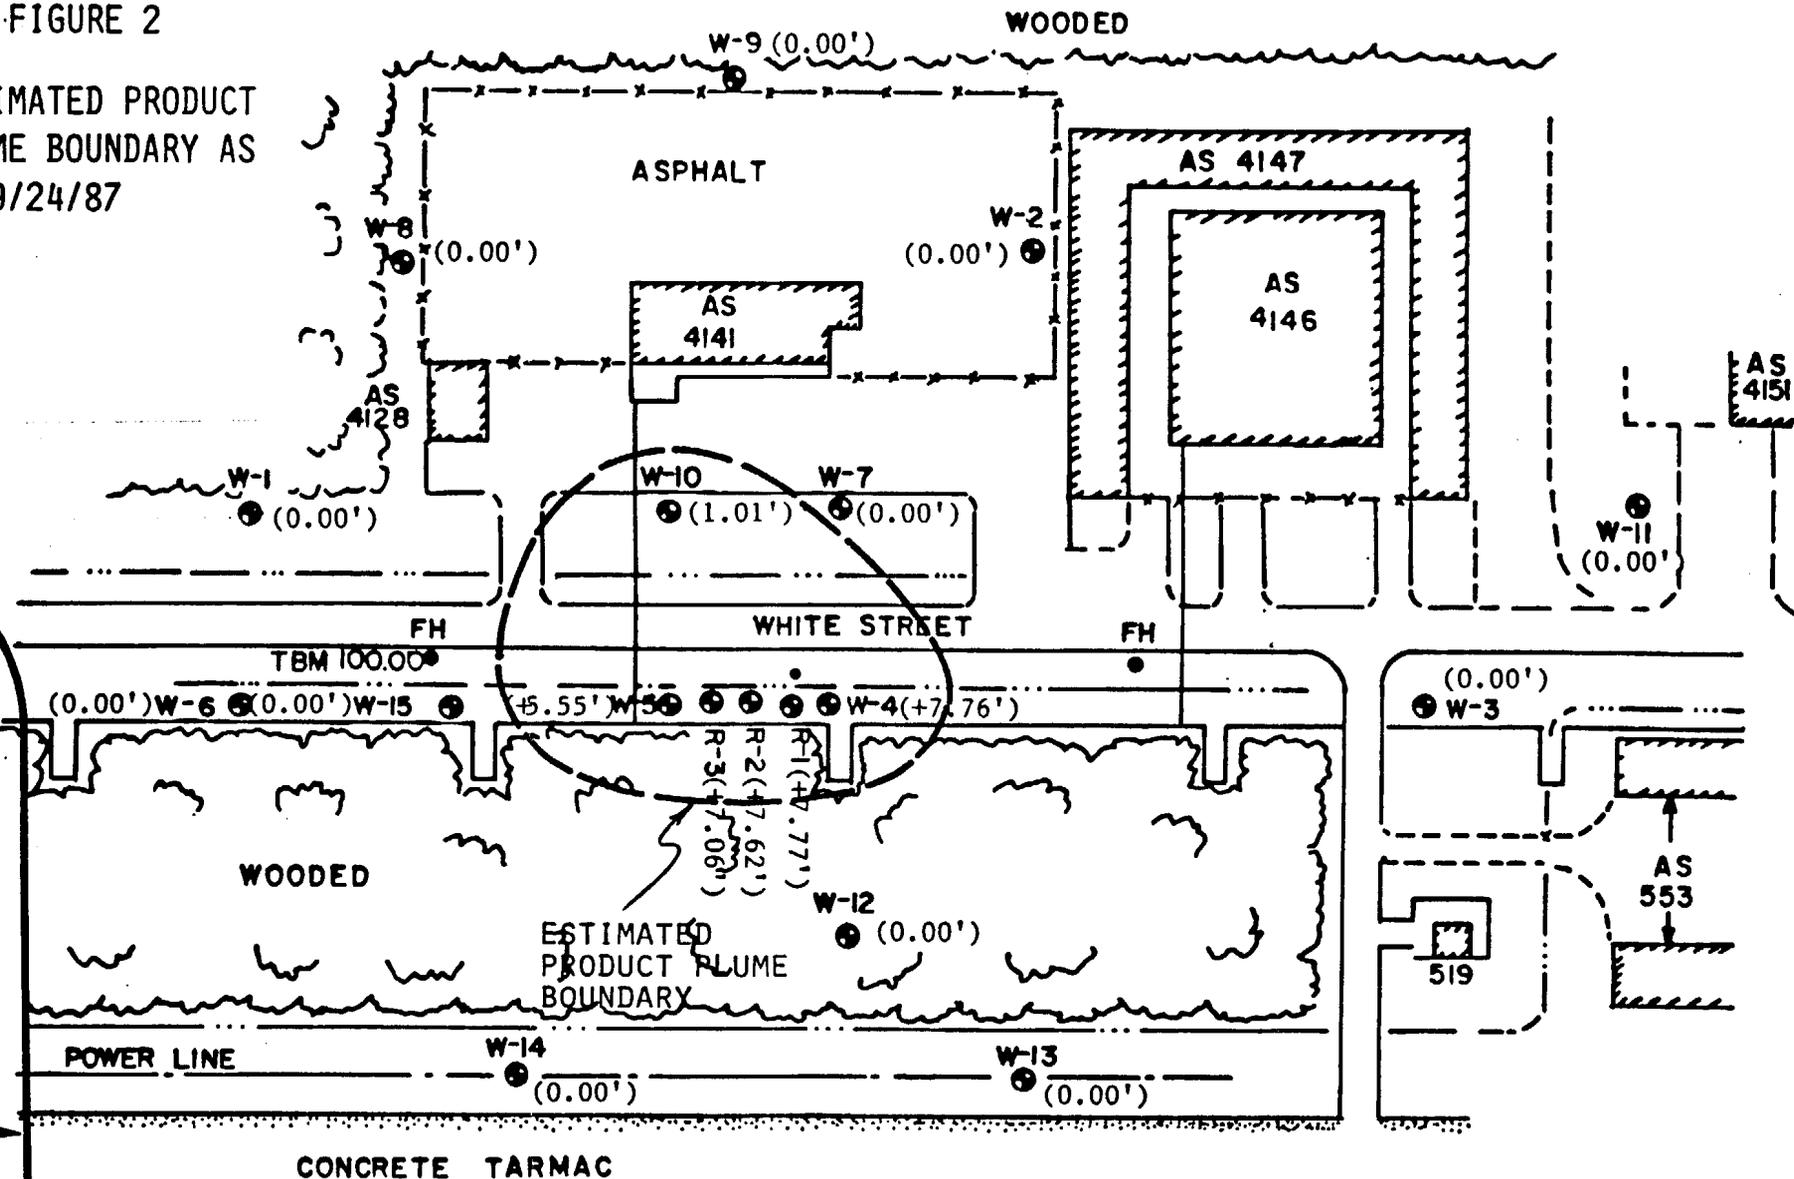
FIGURE 2

A) OBSERVATIONS: On 9/24/87, measureable accumulations of free product were found in wells R-1, R-2, R-3, W-4, W-5 and W-10.

B) DISCUSSION: The free product thickness found in W-10 has increased slightly since our previous visit. The significant increases of free product noted in monitor/recovery wells R-1, R-2, R-3, W-4 and W-5 are the result of the recovery pumps being inoperative due to the compressor malfunction noted above.

ESTIMATED PRODUCT
PLUME BOUNDARY AS
OF 9/24/87

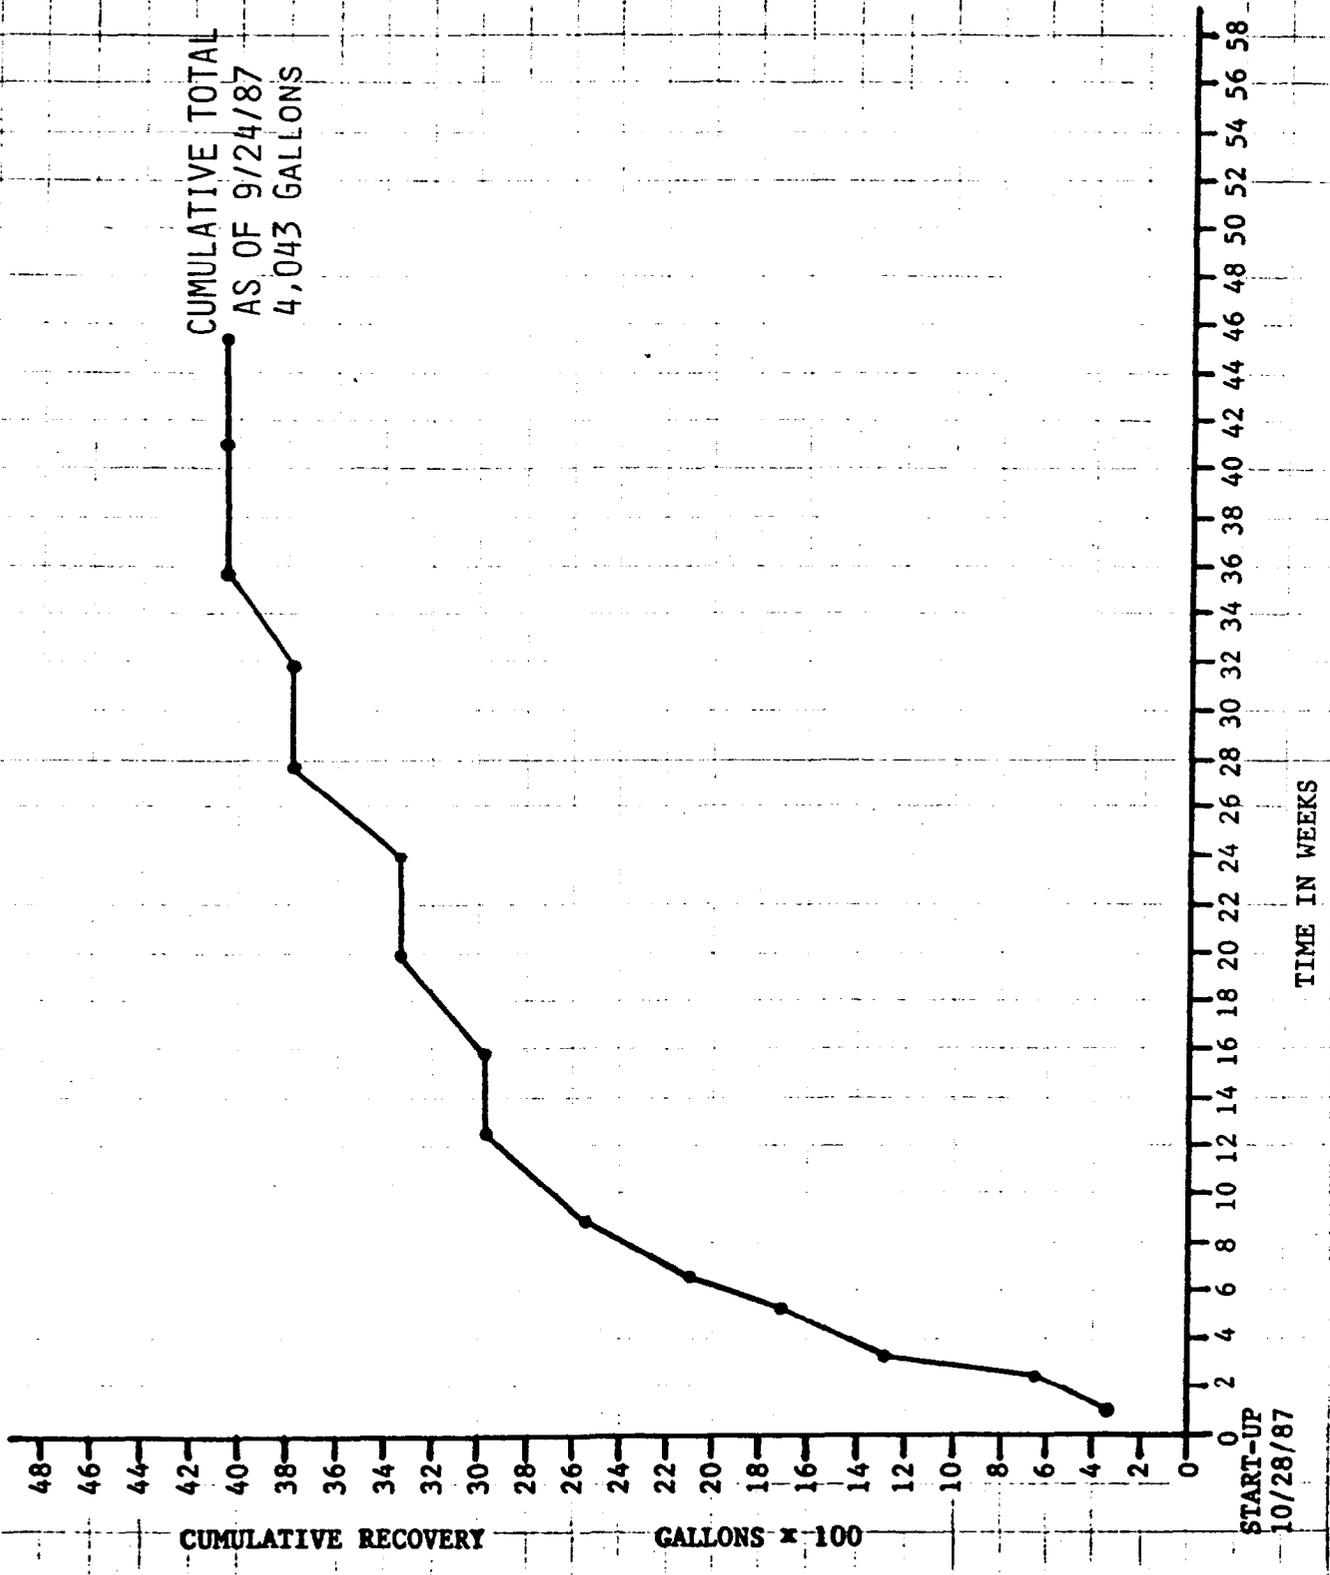
FIGURE 3

OBSERVATIONS: Due to a slipped fan belt on the air compressor, which was replaced, the recovery system was inoperative at the time of this month's site visit. Ejector pumps were installed in monitor/recovery wells R-1, W-4 and W-5 during the site visit on 9/24/87. To date, a total of 4,043 gallons (see Figure 3) of recovered JP-5 has been removed from the on-site separator by J. Gonzalez of Specialized Marine, Inc., and the U.S. Marine Corps training personnel.
