Contractor's Closeout Report
Time Critical Removal Action Plan
Soil Remediation
Operable Unit 11, Site 80
MCB Camp Lejeune
Jacksonville, North Carolina

OHM Project No. 18319

Contractor's Closeout Report

Time Critical Removal Action Plan Soil Remediation Operable Unit 11, Site 80 MCB Camp Lejeune Jacksonville, North Carolina

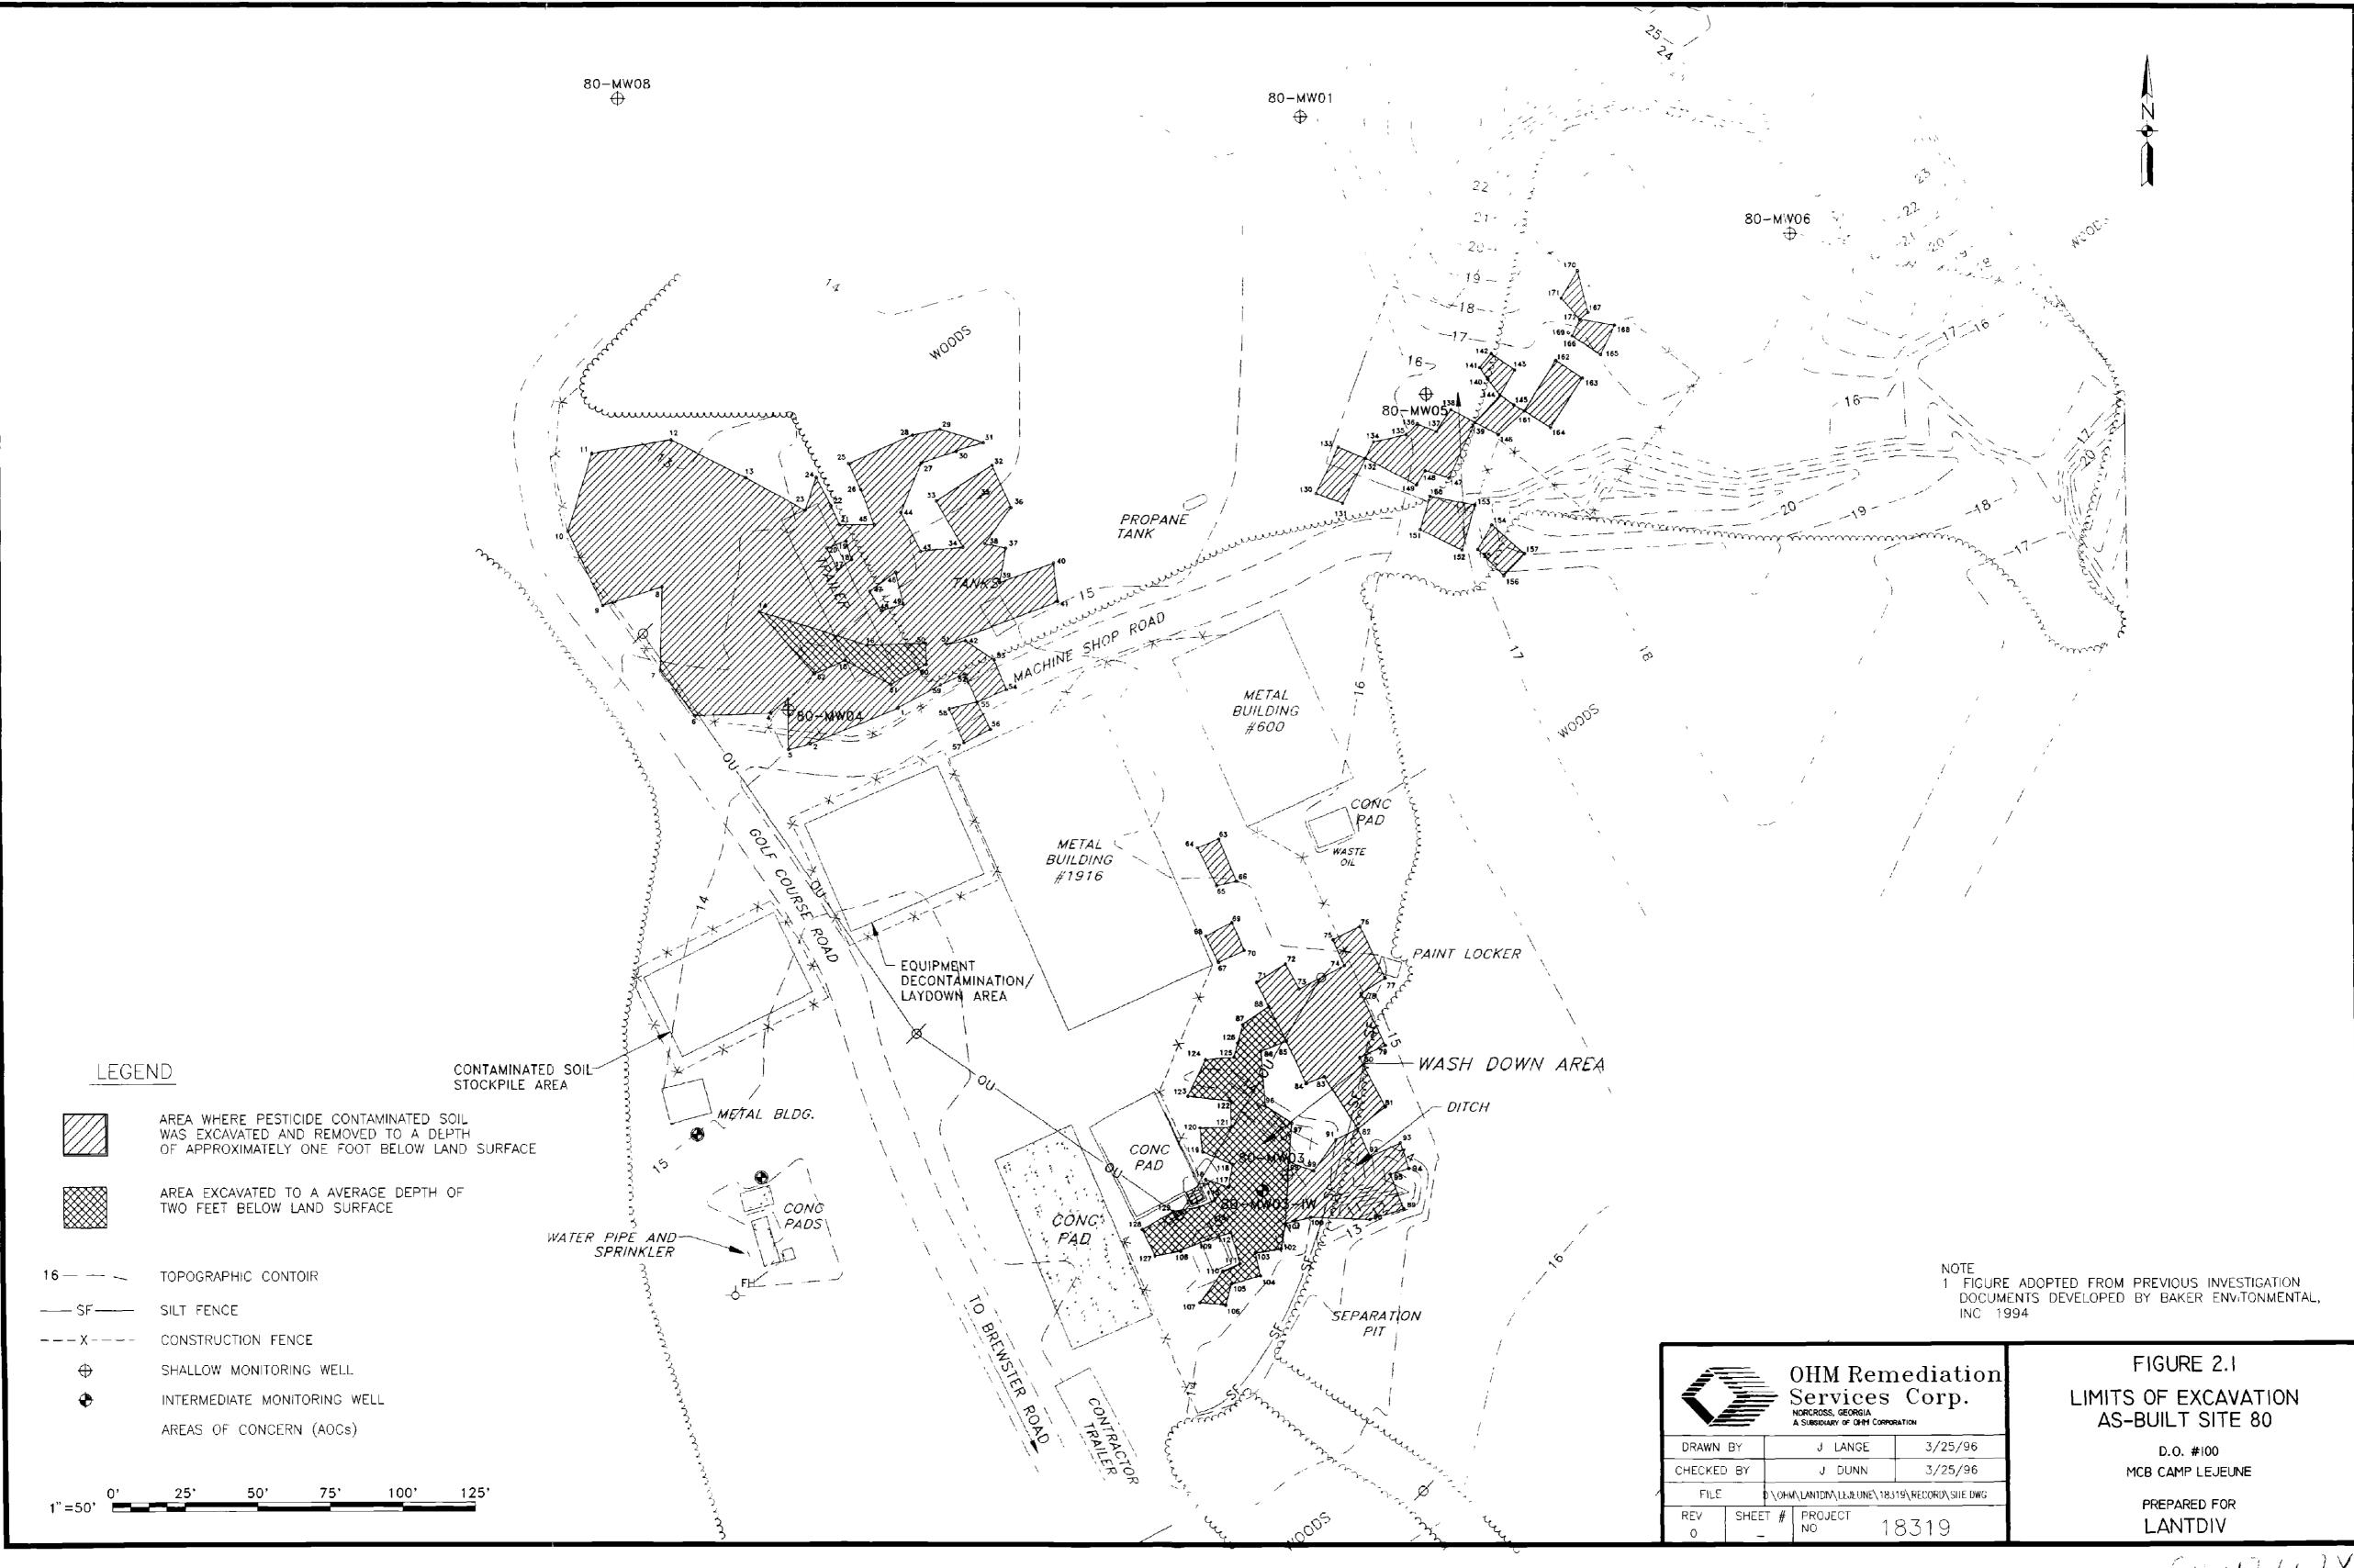
FIGURE 2.2 LIMITS OF EXCAVATION SURVEY POINTS SITE 80

DT "		S FOR EXCAVATION		CUT FI
PT #	NORTHING	EASTING	TOP EL	CUT EI
1	356,173 56	2.485.072 91	18 20	17 30
2	356,161 34	2,485,042 61	17.80	16 60
3	356,176.36	2,485,034.86	17.50	15 60
5	356,171 81 356,171 81	2,485,029.02	17 40	15 80
	356,159 44	2,485,034 98 2,485,002 86	17 60	16 20
7	356,170 88		17 10	15 90 15 4 0
8	356.186 27	2,484,991.02	16 90 16 70	14 90
9	356,214 64 356,208 25	2,484,991 76 2,484,971.47	16 50	14 40
10	356,233 43	2,484,959 58	16 30	13 60
11	356,259 70	2,484,967 95	15 60	14 90
12	356,264 35	2,484,994 95	16 70	15 30
13	356,251 5 0	2,485,020 62		14 40
14			16 70	
15	356,206 13 356 189 67	2,485,025 16	19.00	15 60
16	356,189 67 356,194 93	2,485,054 64	18.00	16.80
17	356,220 32	2,485,062 31	17 10 17 20	16 50
18		2,485,052.17	17.00	-
19	356,223 82	2,485,056 93 2,485,055.12	16 90	16.20
20	356,230 10 356,227 77		17 10	16 30
21	356,235 62	2,485,048 55	16.60	15.60
22	356,242 13	2,485,052.95 2,485,049.93	17.00	15.80

COORDINATE	S FOR EXCAVATION	LIMITS	,
PT #	NORTHING	EASTING	TOP EL	CUT EL
151	356,234 03	2,485,253 05	21 63	18 43
152	356,226 97	2,485,267 67	20 43	18 93
153	356,242.25	2,485,272 05	19 93	19 23
154	356,235 5 3	2,485,277 84	20 23	19 5 3
155	356,227 29	2,485,273 10	20 43	19 63
156	356 218 30	2,485,282 04	21 93	20 23
157	356 225 75	2,485,289 21	22 63	20 03
158	356 208 32	2,485,298 15	21 83	20 93
159	356 198.77	2,485,292 91	21 93	20 53
160	356.203 51	2,485,283 17	21 93	20.53
161	356 274 03	2,485,289 19	20 63	19 63
162	356.291.16	2,485,300 14	20 63	19 83
163	356,285 17	2,485,185 39	17 99	15 99
164	356,268 48	2,485,298 29	20 5 3	19 23
165	356,293.13	2,485,315 64	20 63	19 63
166	356,299.36	2,485,305 76	20 93	19 83
167	356,307 36	2,485,311 29	20 93	19.53
168	356,303 05	2,485,320 52	20 83	20 03
169	356,300.49	2,485,304 50	20 83	19.83
170	356,321.58	2,485,307 71	20 93	19.93
171	356,312.20	2,485,302.15	20 73	20.03
172	356,304.96	2,485,308.52	20 73	19.73

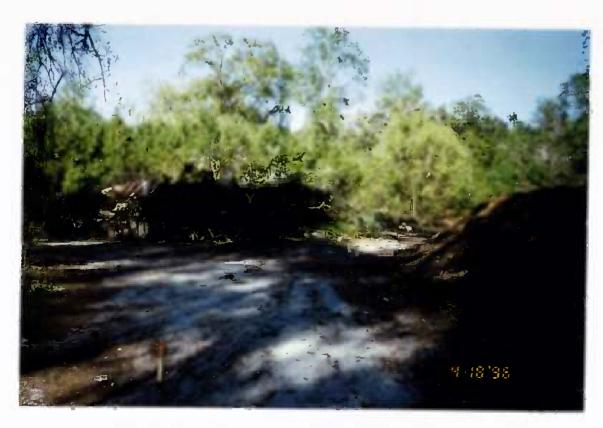
Delivery Order: 100 Location: AOC 13-16

Description: Preliminiary photo

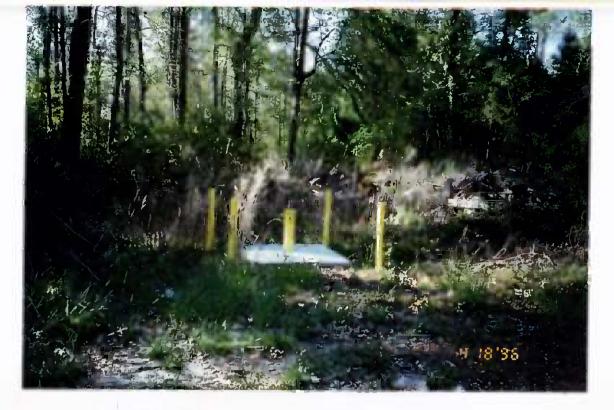
Delivery Order: 100 Location: AOC 17-20

Description: Preliminary photo

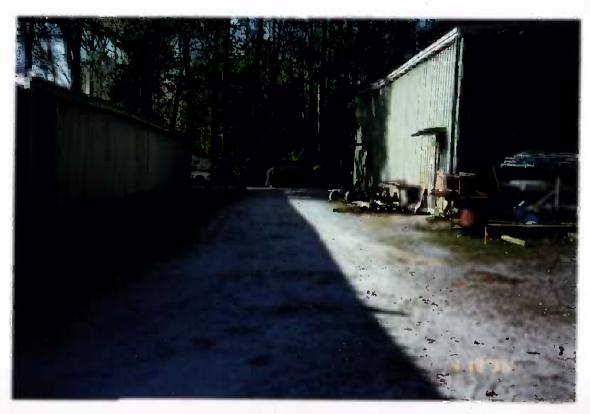
Location: AOC 21-24 and 25-28 Description: Preliminary photo

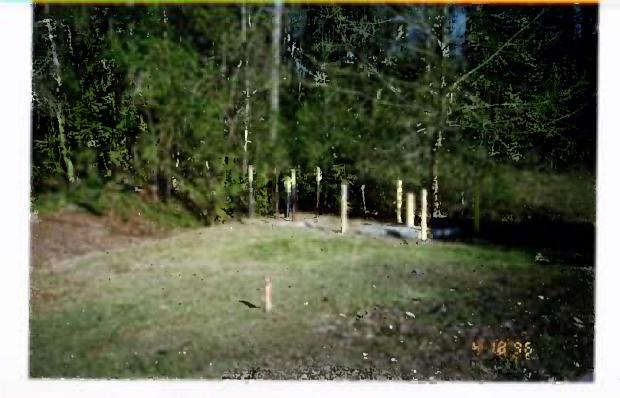
Delivery Order: 100 Location: AOC 33-38

Description: Preliminary photo

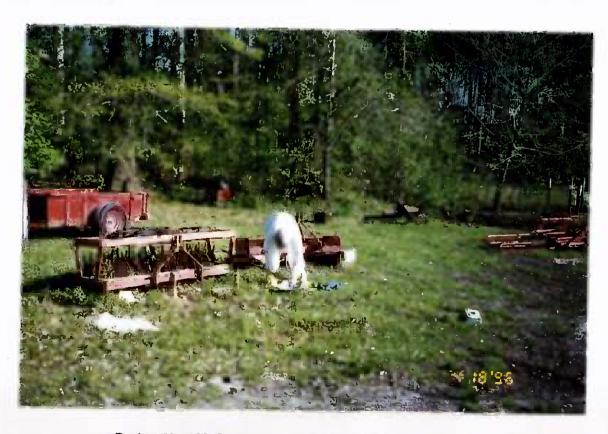
Location: AOC 29-32 Description: Field screen sampling

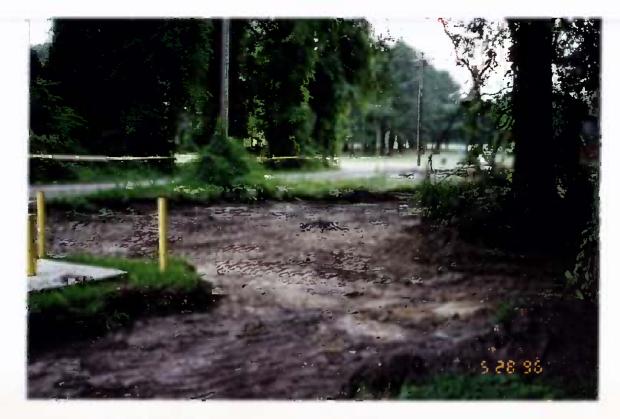
Delivery Order: 100 Location: AOC 1-12

Description: Initial excavation of soil to a depth of 1 foot

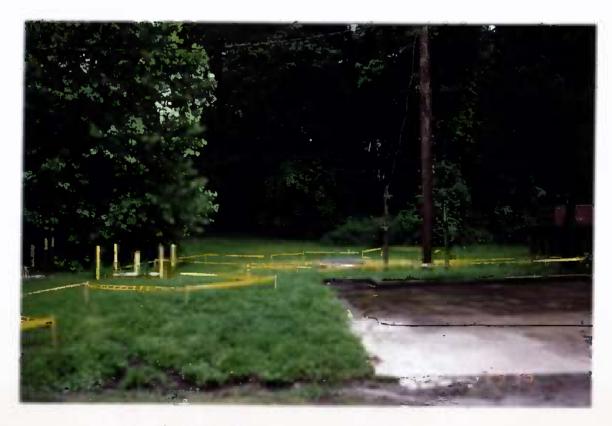
Location: AOC 33-38 and 39-42 Description: Delineation of AOCs

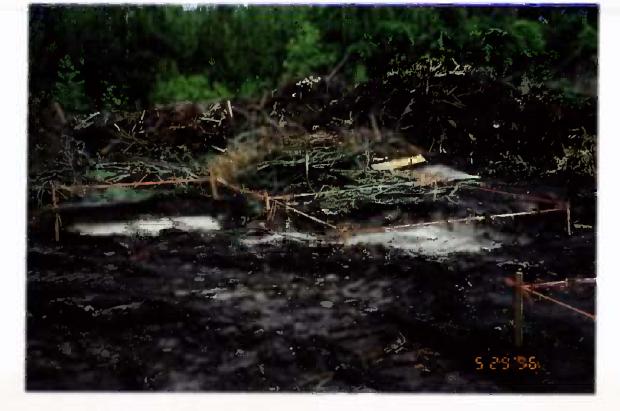
Delivery Order: 100 Location: AOC 13-16

Description: Initial excavation of soil to a depth of 1 foot

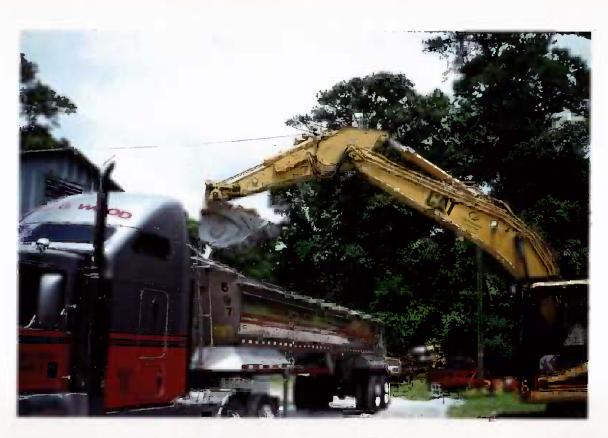
Delivery Order: 100
Location: AOC 33-38
Description: Soil loadout

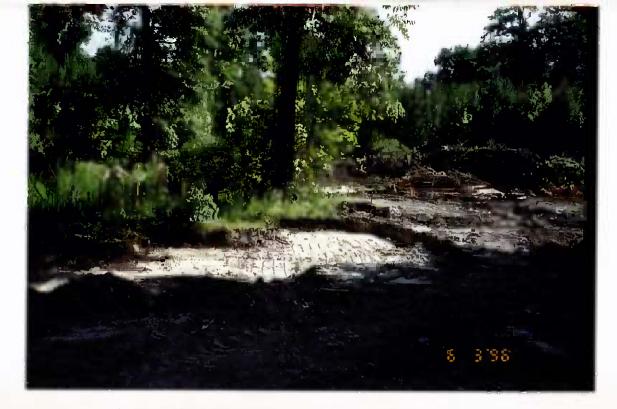
Location: AOC 13-16 and 17-20 Description: Excavation area

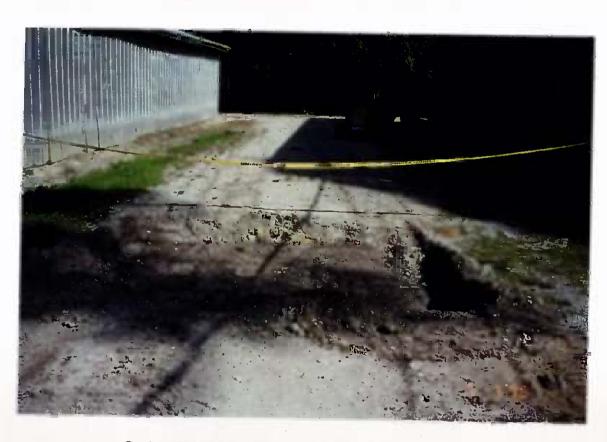
Delivery Order: 100 Location: AOC 25-28

Description: Excavation area

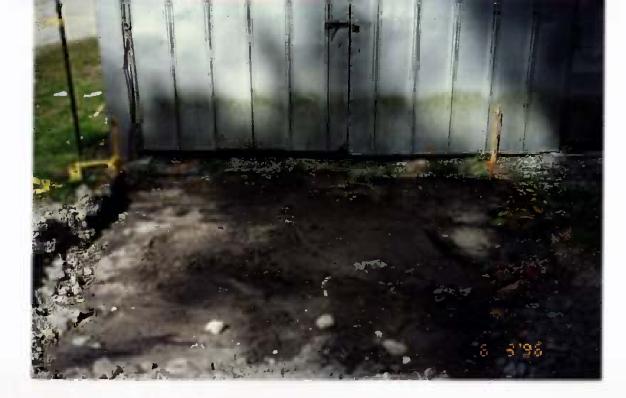
Delivery Order: 100 Location: AOC 29-32

Description: Excavation area

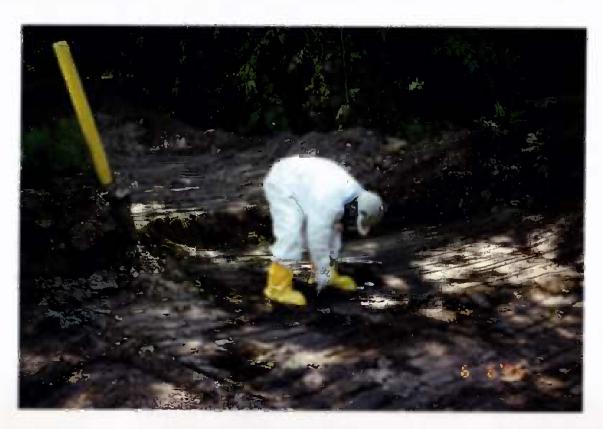
Delivery Order: 100 Location: AOC 33-38

Description: Confirmation sampling

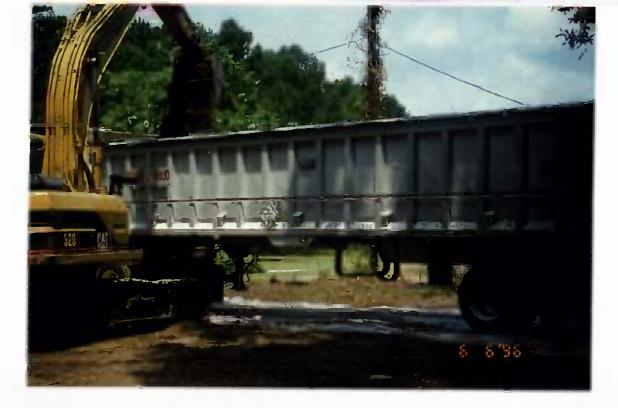
Delivery Order: 100 Location: AOC 1-12

Description: Loading of contaminated soils

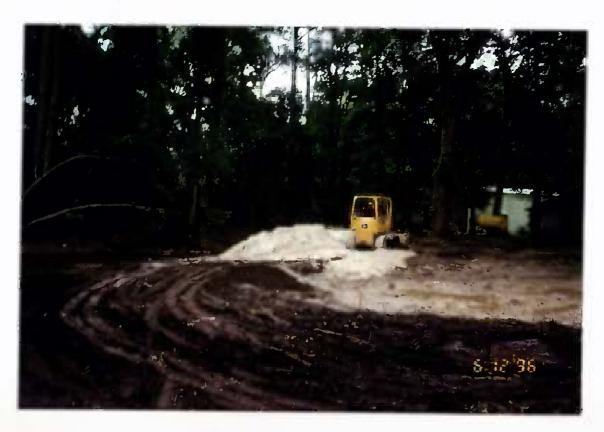
Location: AOC 1-12
Description: Backfill operations

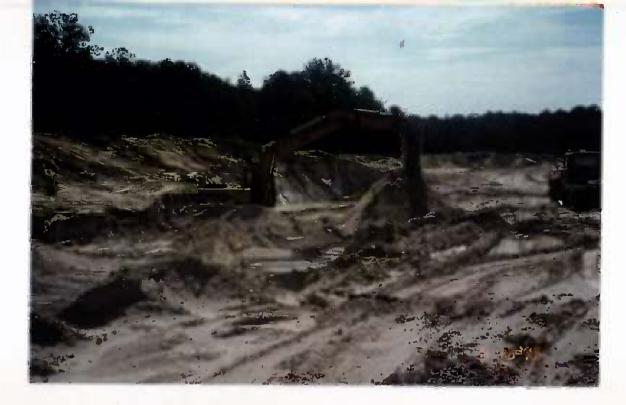
Delivery Order: 100 Location: Borrow Pit

Description: Staging backfill material

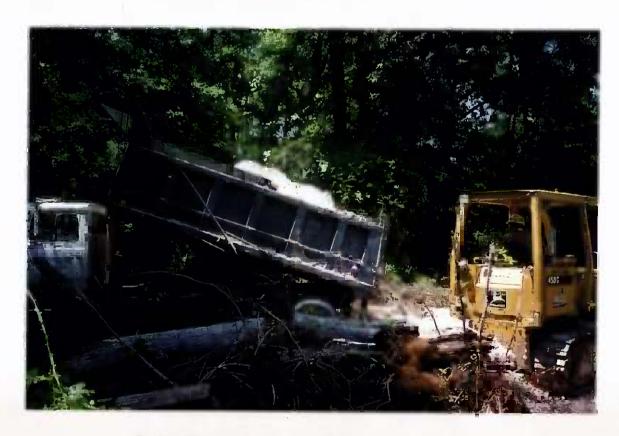
Delivery Order: 100 Location: AOC 17-20

Description: Backfill operations

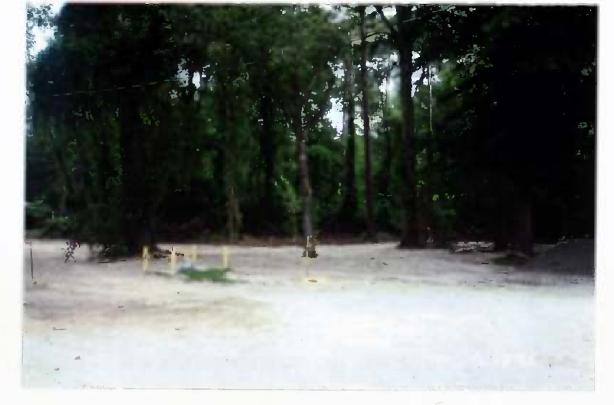
Delivery Order: 100 Location: AOC 1-12 Description: Final grade

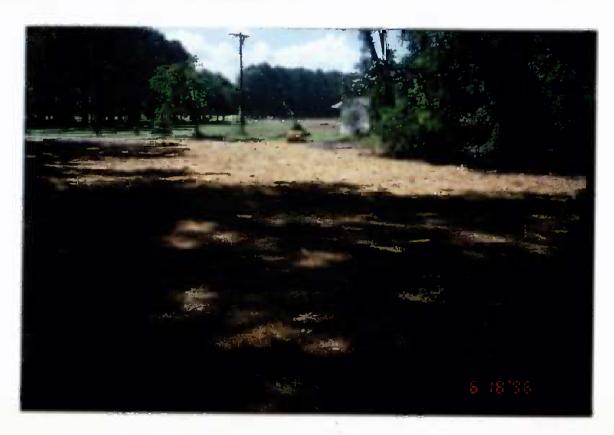
Delivery Order: 100 Location: AOC 1-12

Description: Area seeded and mulched

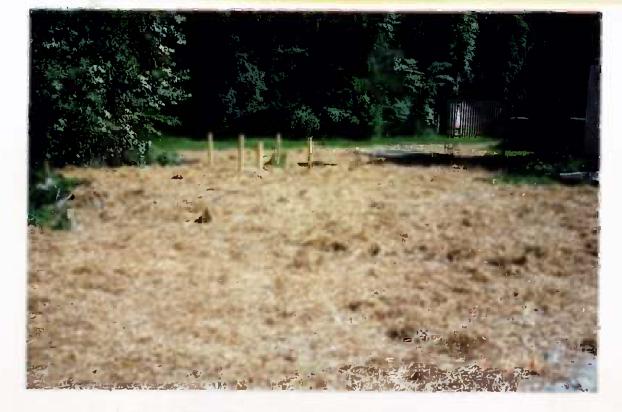
Location: AOC 33-38 and 39-42 Description: Area seeded and mulched
