Re: **FINAL** Soil Assessment Report
PP-3326
Marine Corps Base
Camp Lejeune, North Carolina

SOIL ASSESSMENT REPORT

PP-3326
MARINE CORPS BASE
CAMP LEJEUNE, NORTH CAROLINA

NCDENR UST INCIDENT NO. 24009
RICK CLASSIFICATION: LOW RISK
LAND USE CLASSIFICATION: RESIDENTIAL

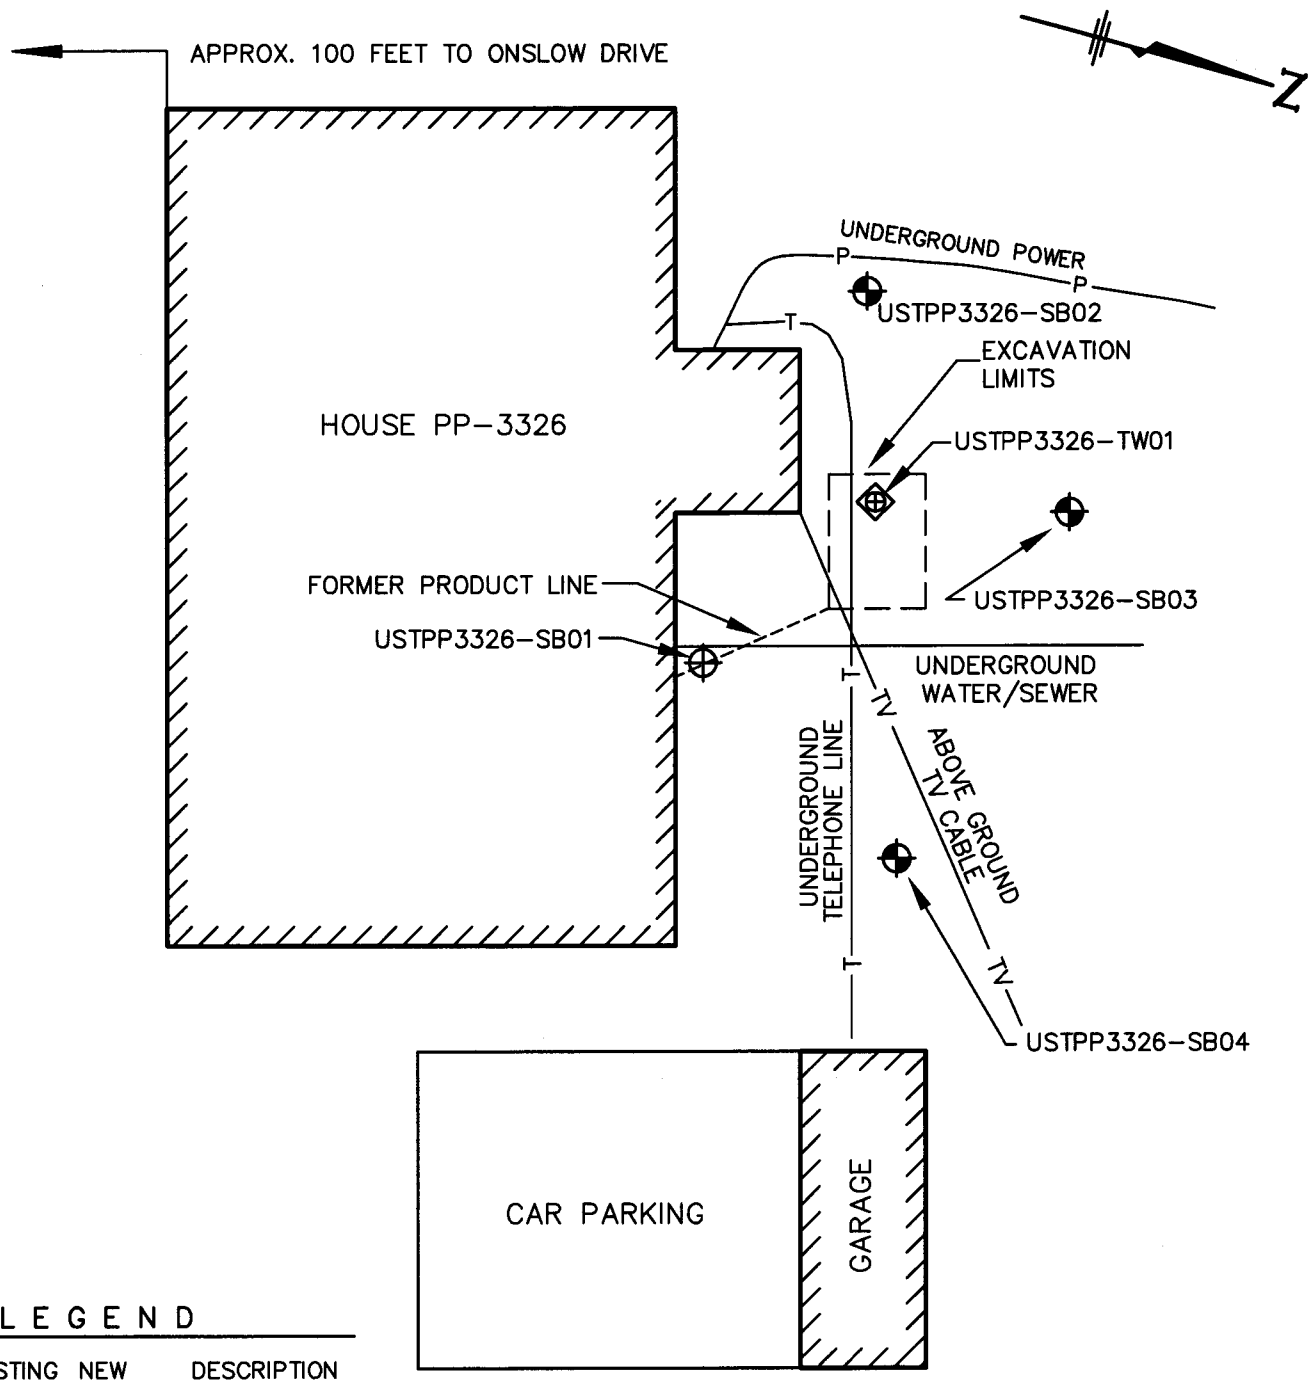
Municipal sanitary sewer and water lines enter the residence on the north side of the residence, immediately east of the source area. Underground power, water, sewer and telephone lines transect the northern side of the property. It is uncertain exactly where these utilities enter the residence. Due to the shallow depth of these utilities and the depth and limited nature of known contamination, it is not deemed likely that these utilities would serve as preferential pathways for contaminant migration. Known utilities are illustrated on Figure 3.

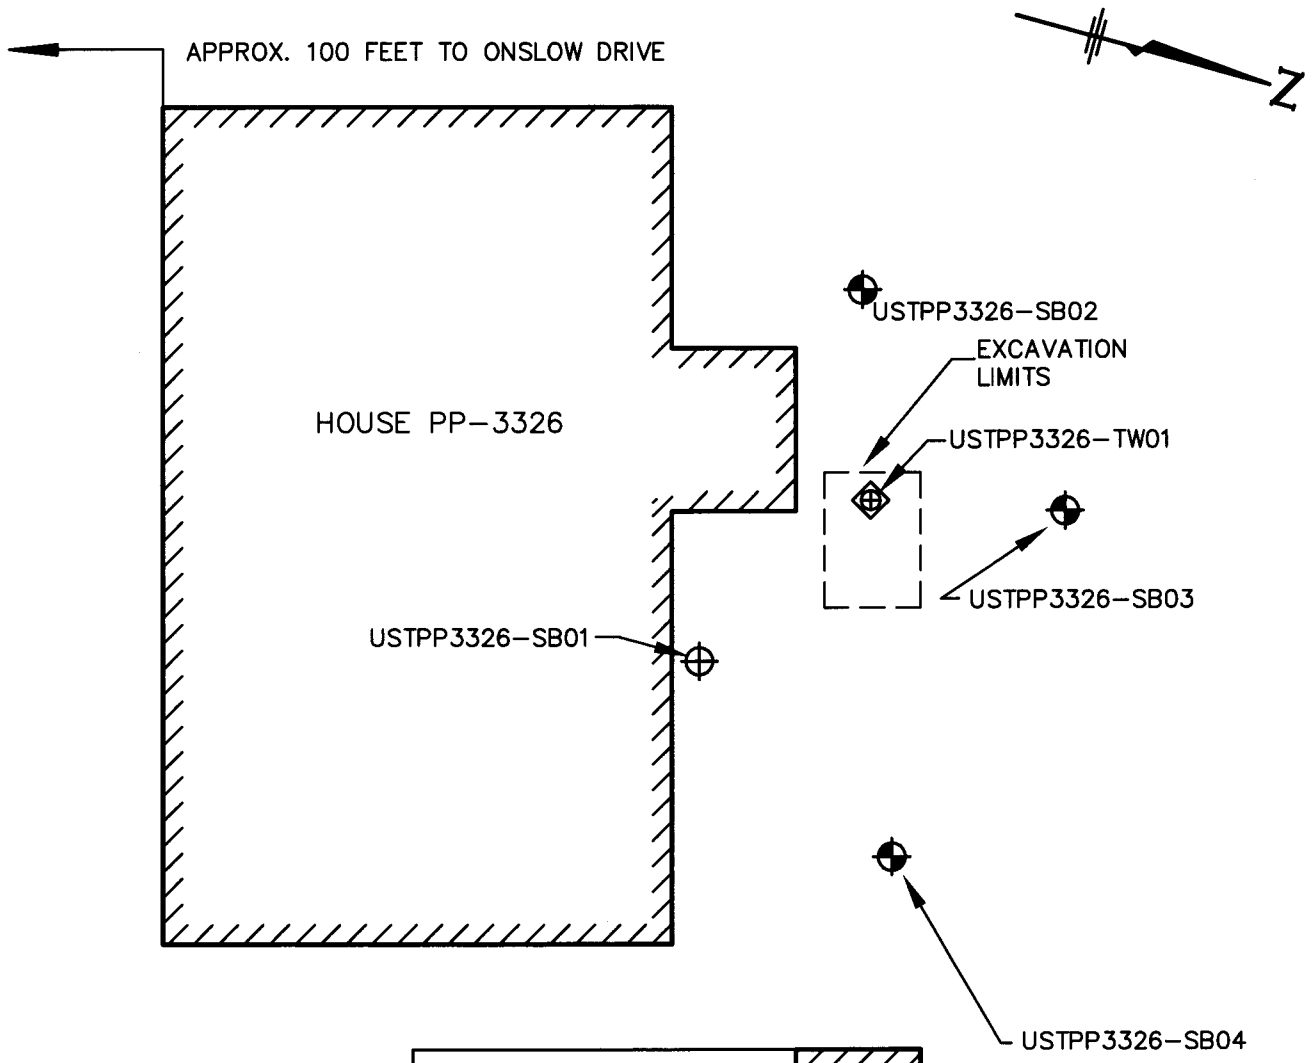
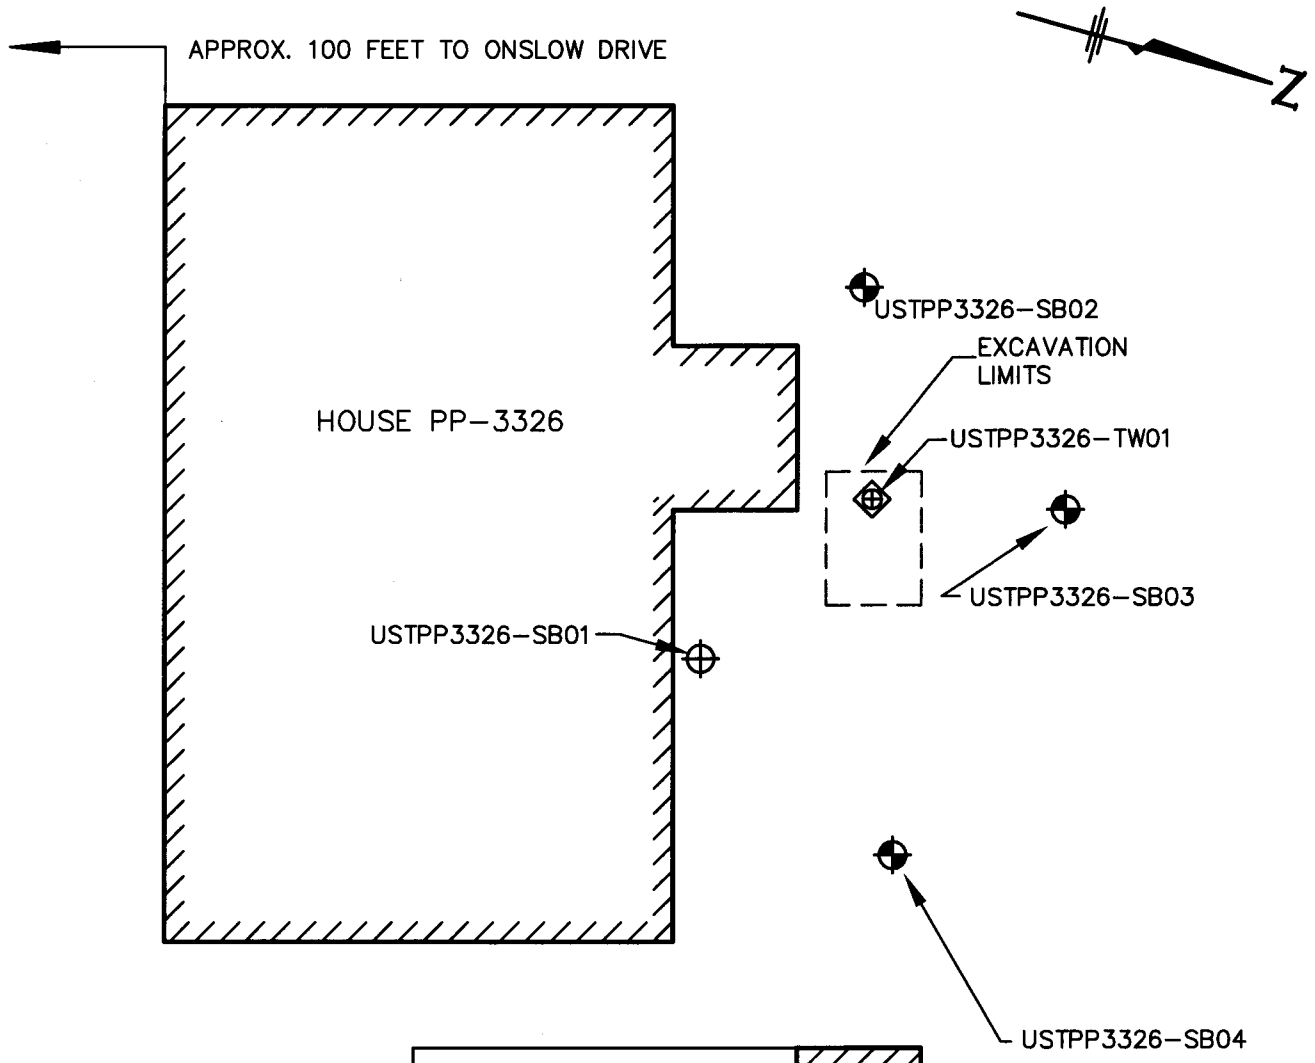
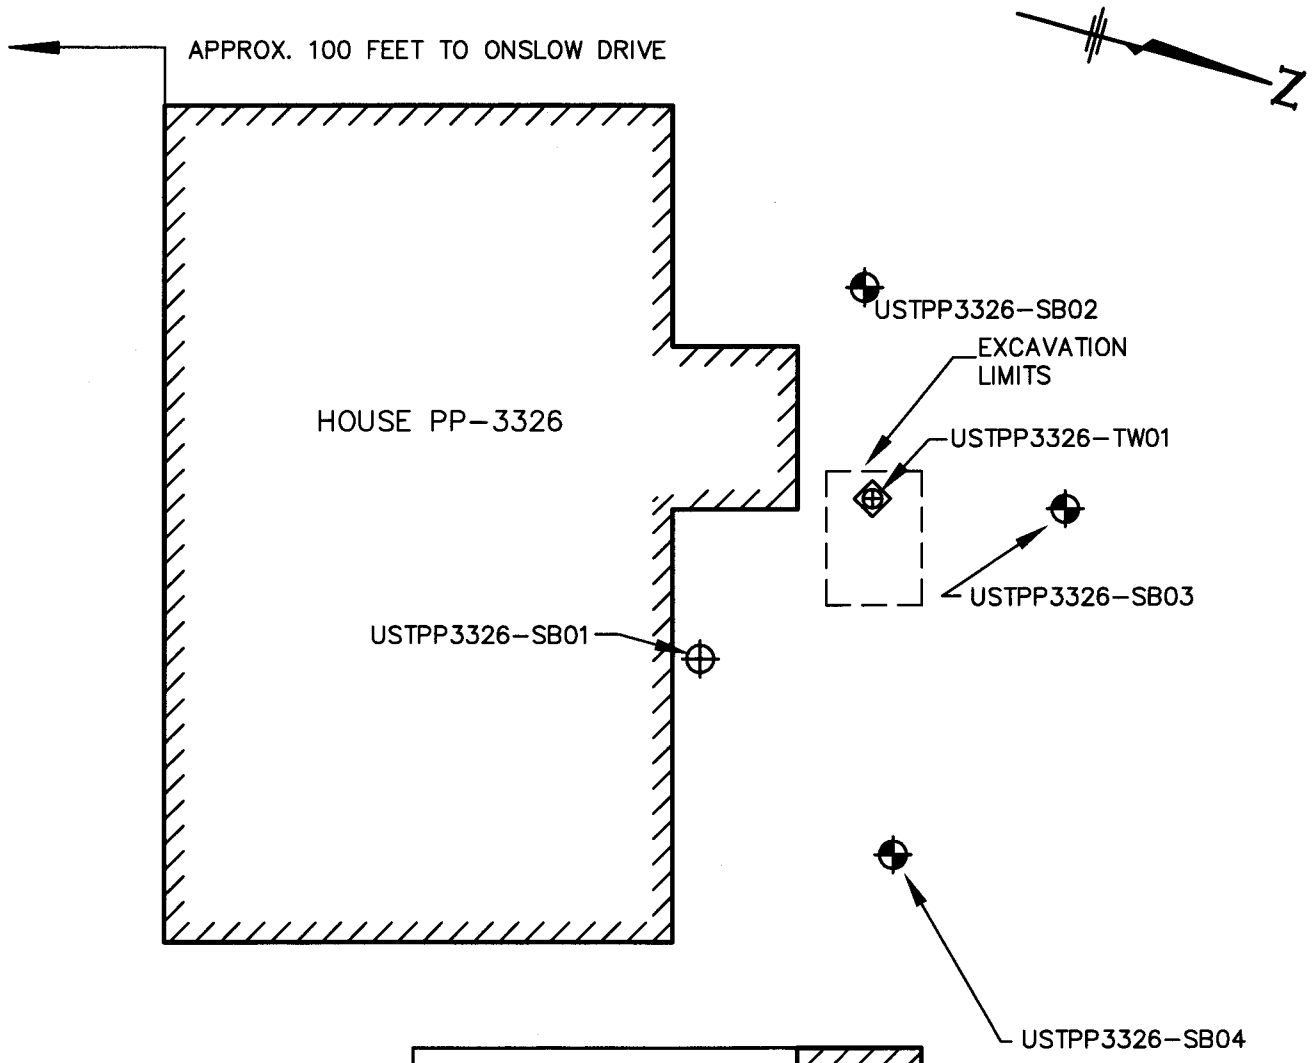
On March 24, 2003, CATLIN personnel conducted a soil sampling event at the site as proposed in the Phase I LSA. It was intended that the collected soil samples delineate the horizontal and vertical extent of the petroleum release within the soils of the study area. The three soil borings were advanced to the water table utilizing hand auger technologies at the locations indicated on Figures 4A through 4C. At the time of the sampling event, the water table was noted at 2.0 feet BLS. Due to the seasonal high water table fluctuation, the soil samples were collected from 0-1 feet BLS for laboratory analysis. The soil samples were identified in the field and labeled on the chain of custody as USTPP3326-SB02 (0-1), USTPP3326-SB03 (0-1), and USTPP3326-SB04 (0-1). The laboratory reports and chain of custody documentation are provided in Appendix E.

Based on the findings of this Soil Assessment Report, the levels of the hydrocarbons within the soils of the study area have been delineated. Soil contamination is reasonably assumed to exist in limited areas adjacent to the western, northern and eastern sidewalls of the former tank basin. It is recommended that these contaminated soils be remediated to the Residential MSCCs. Following soil remediation, the site will meet the requirements for closure and No Further Action Status will be requested as part of a Soil Cleanup Report and Site Closure Request.

Due to the apparent limited extent of soil contamination, soils with contaminant concentrations in excess of Residential MSCCs are proposed for excavation. Approximately 12 cubic yards of soils are expected to require removal and disposal. As the site is classified as Residential and Low Risk, following soil excavation and verification of clean up, this site will meet the requirements for closure and No Further Action Status will be requested as part of a Soil Cleanup Report and Site Closure Request.

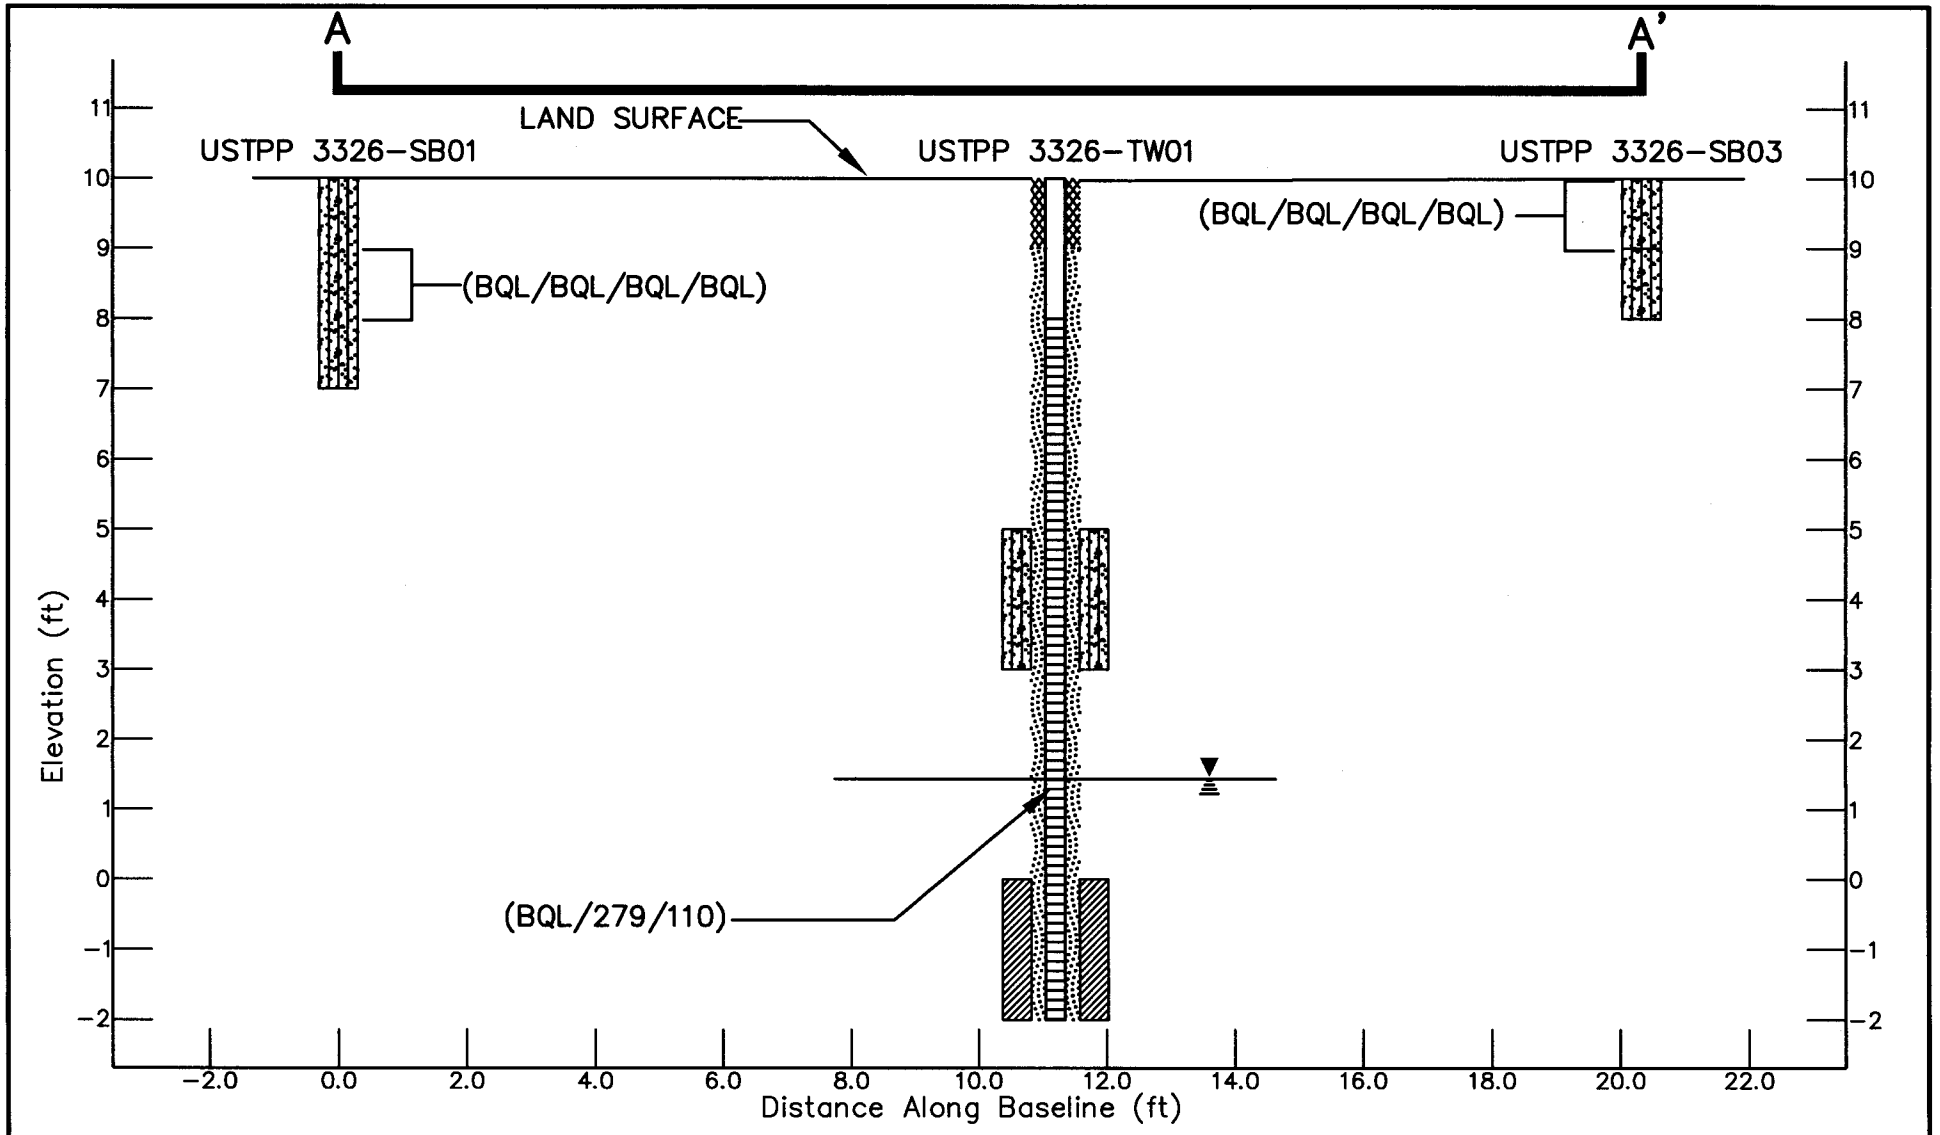
PROJECT: S.A.R. PP-3326 MARINE CORPS BASE CAMP LEJEUNE, N.C.		TITLE: CROSS SECTION A-A'			FIGURE 6B
JOB NO: 203012-01	DATE: MAY 2003	SCALE: 1"=10'	DRAWN BY: GRD	CHECKED BY: MEM

Hand augered borings for this investigation indicate very fine grained, silty sand to boring termination at 2 feet BLS. Boring logs for USTPP3326-SB02 through USTPP3326-SB04 are included in Appendix A. Geologic cross-sections of the study site have been prepared and are shown on Figures 6A through 6C.
