INITIAL ASSESSMENT STUDY OF
MARINE CORPS BASE CAMP LEJEUNE
NORTH CAROLINA

NEESA 13-011

INITIAL ASSESSMENT STUDY
OF MARINE CORPS BASE CAMP LEJEUNE, NORTH CAROLINA
UIC-M67001

Prepared by:
WATER AND AIR RESEARCH, INC.
Gainesville, Florida

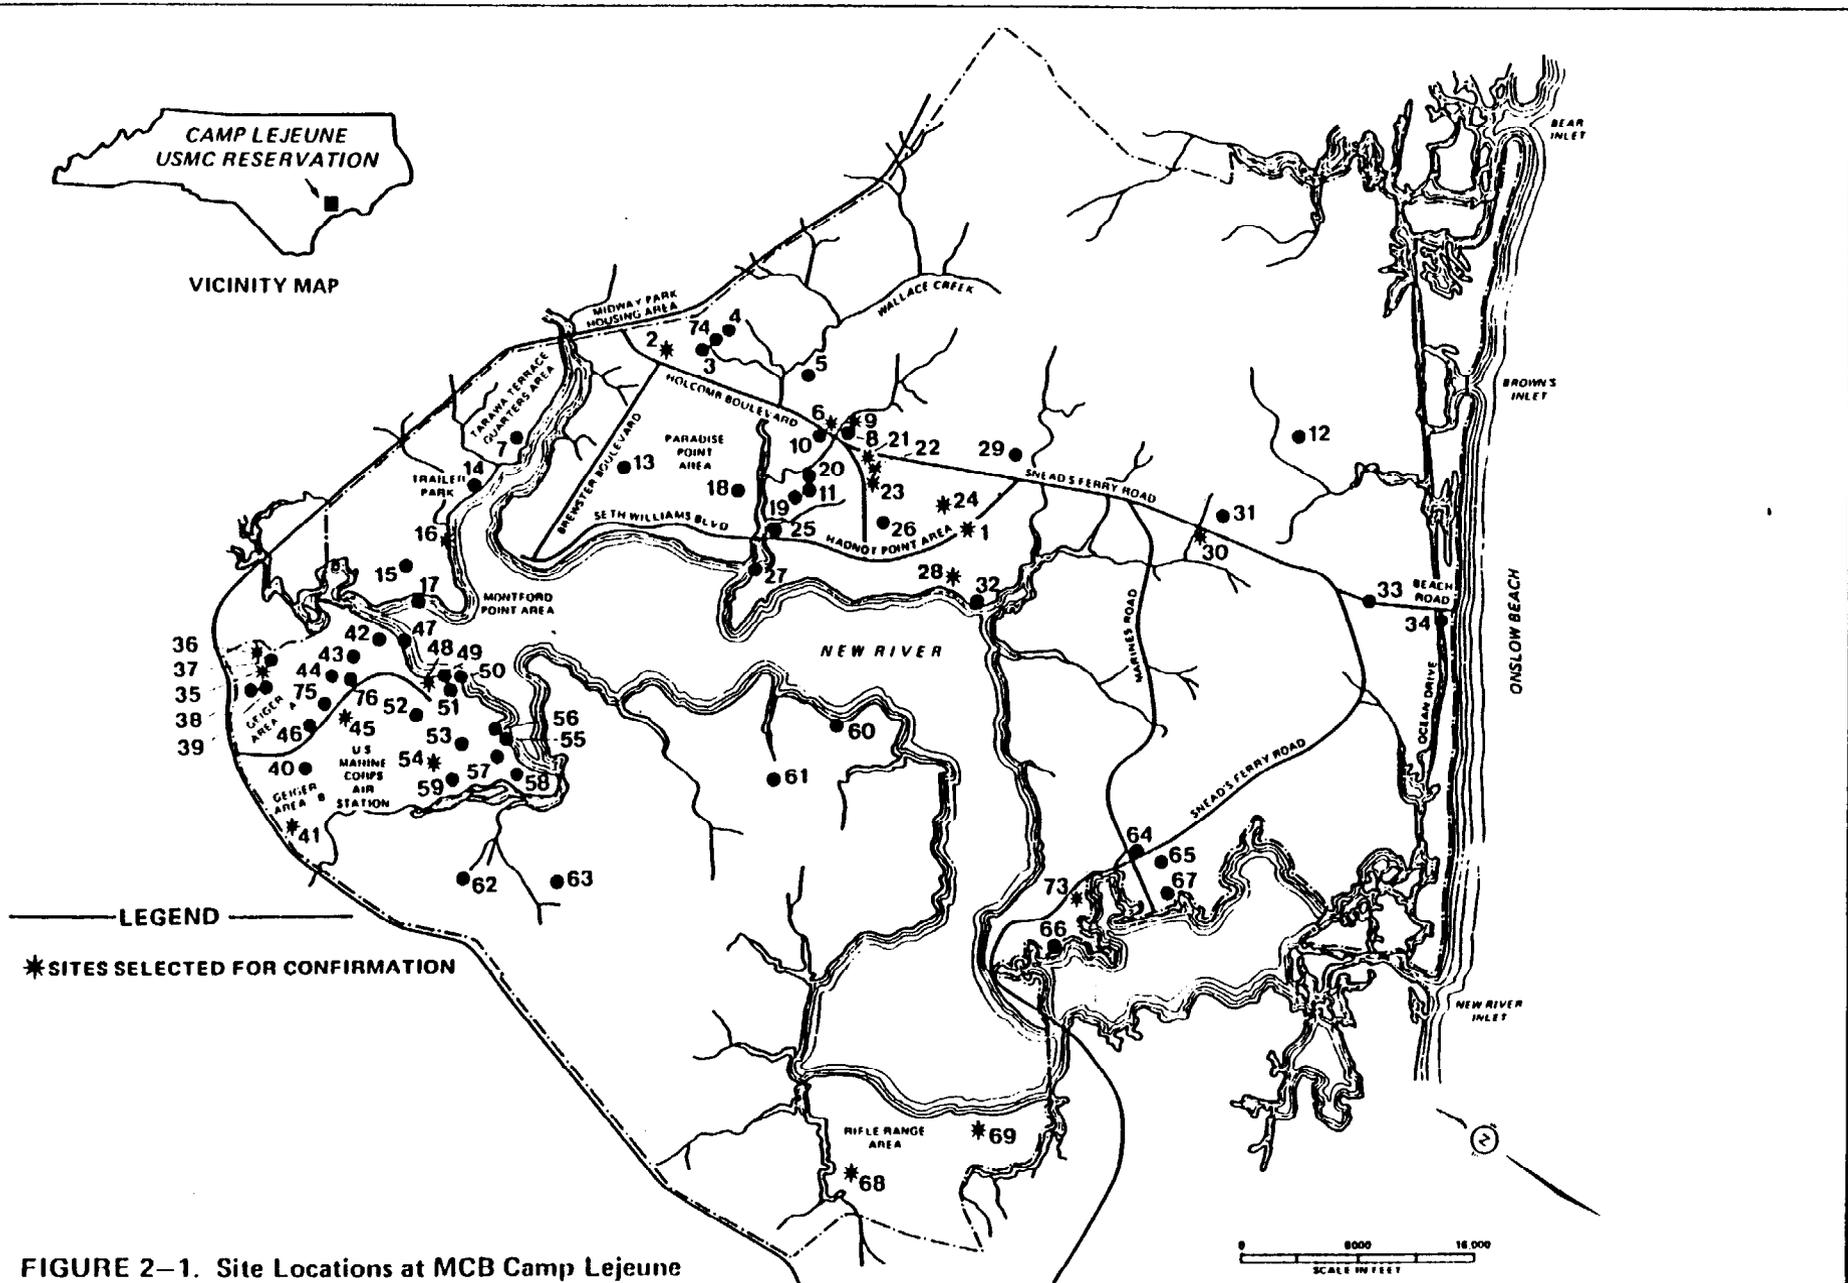
FIGURE 2-1. Site Locations at MCB Camp Lejeune

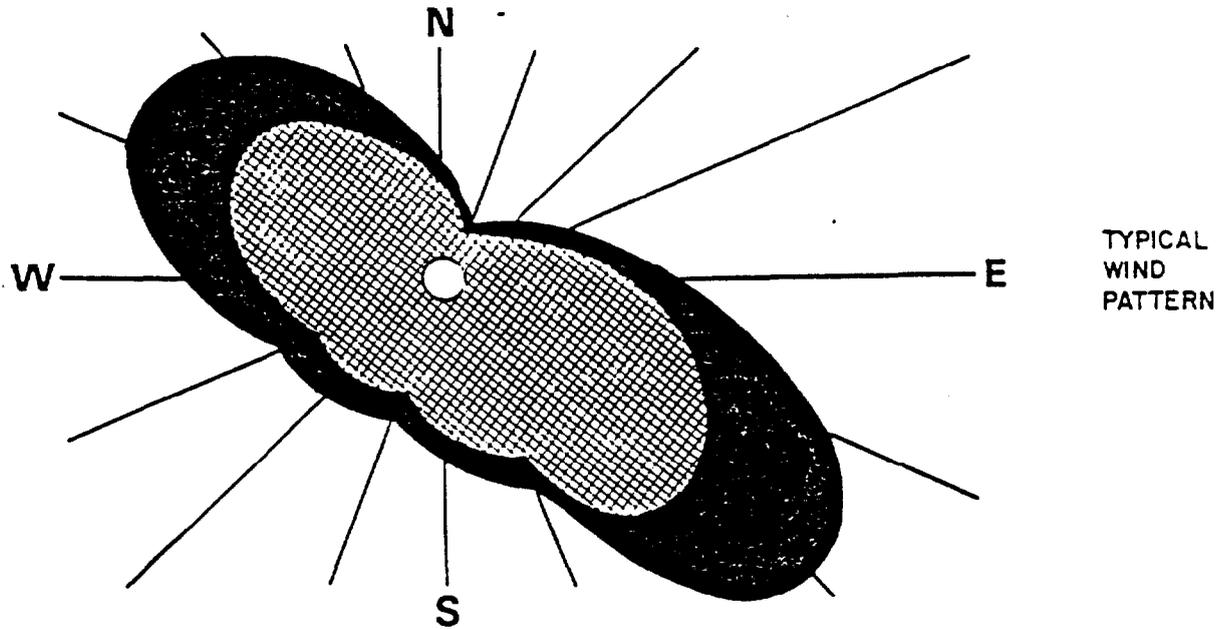
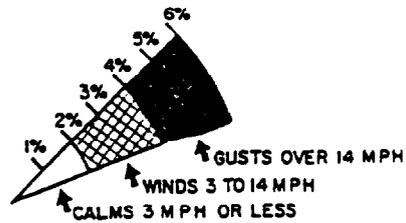
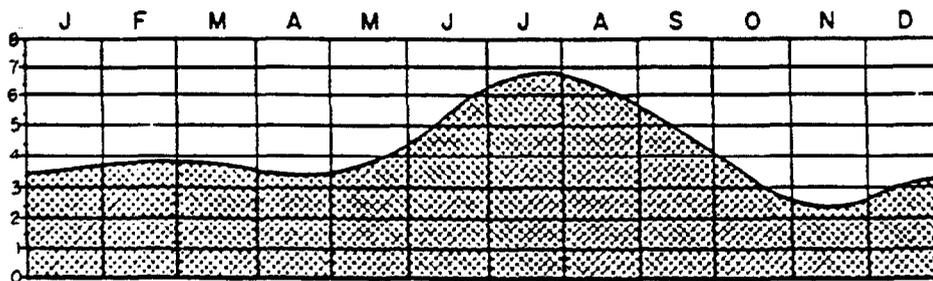
FIGURE 5-1
Regional Climatic Conditions in the Vicinity of MCB Camp Lejeune

% OF WIND COMING FROM INDICATED DIRECTION

AVERAGE MONTHLY TEMPERATURE

AVERAGE MONTHLY RAINFALL

Winds during the warm seasons are generally south-southwesterly while north-northwest winds predominate in winter. There is a relatively long growing season of 230 days. A summary of regional climatic conditions is shown in Figure 5-1.

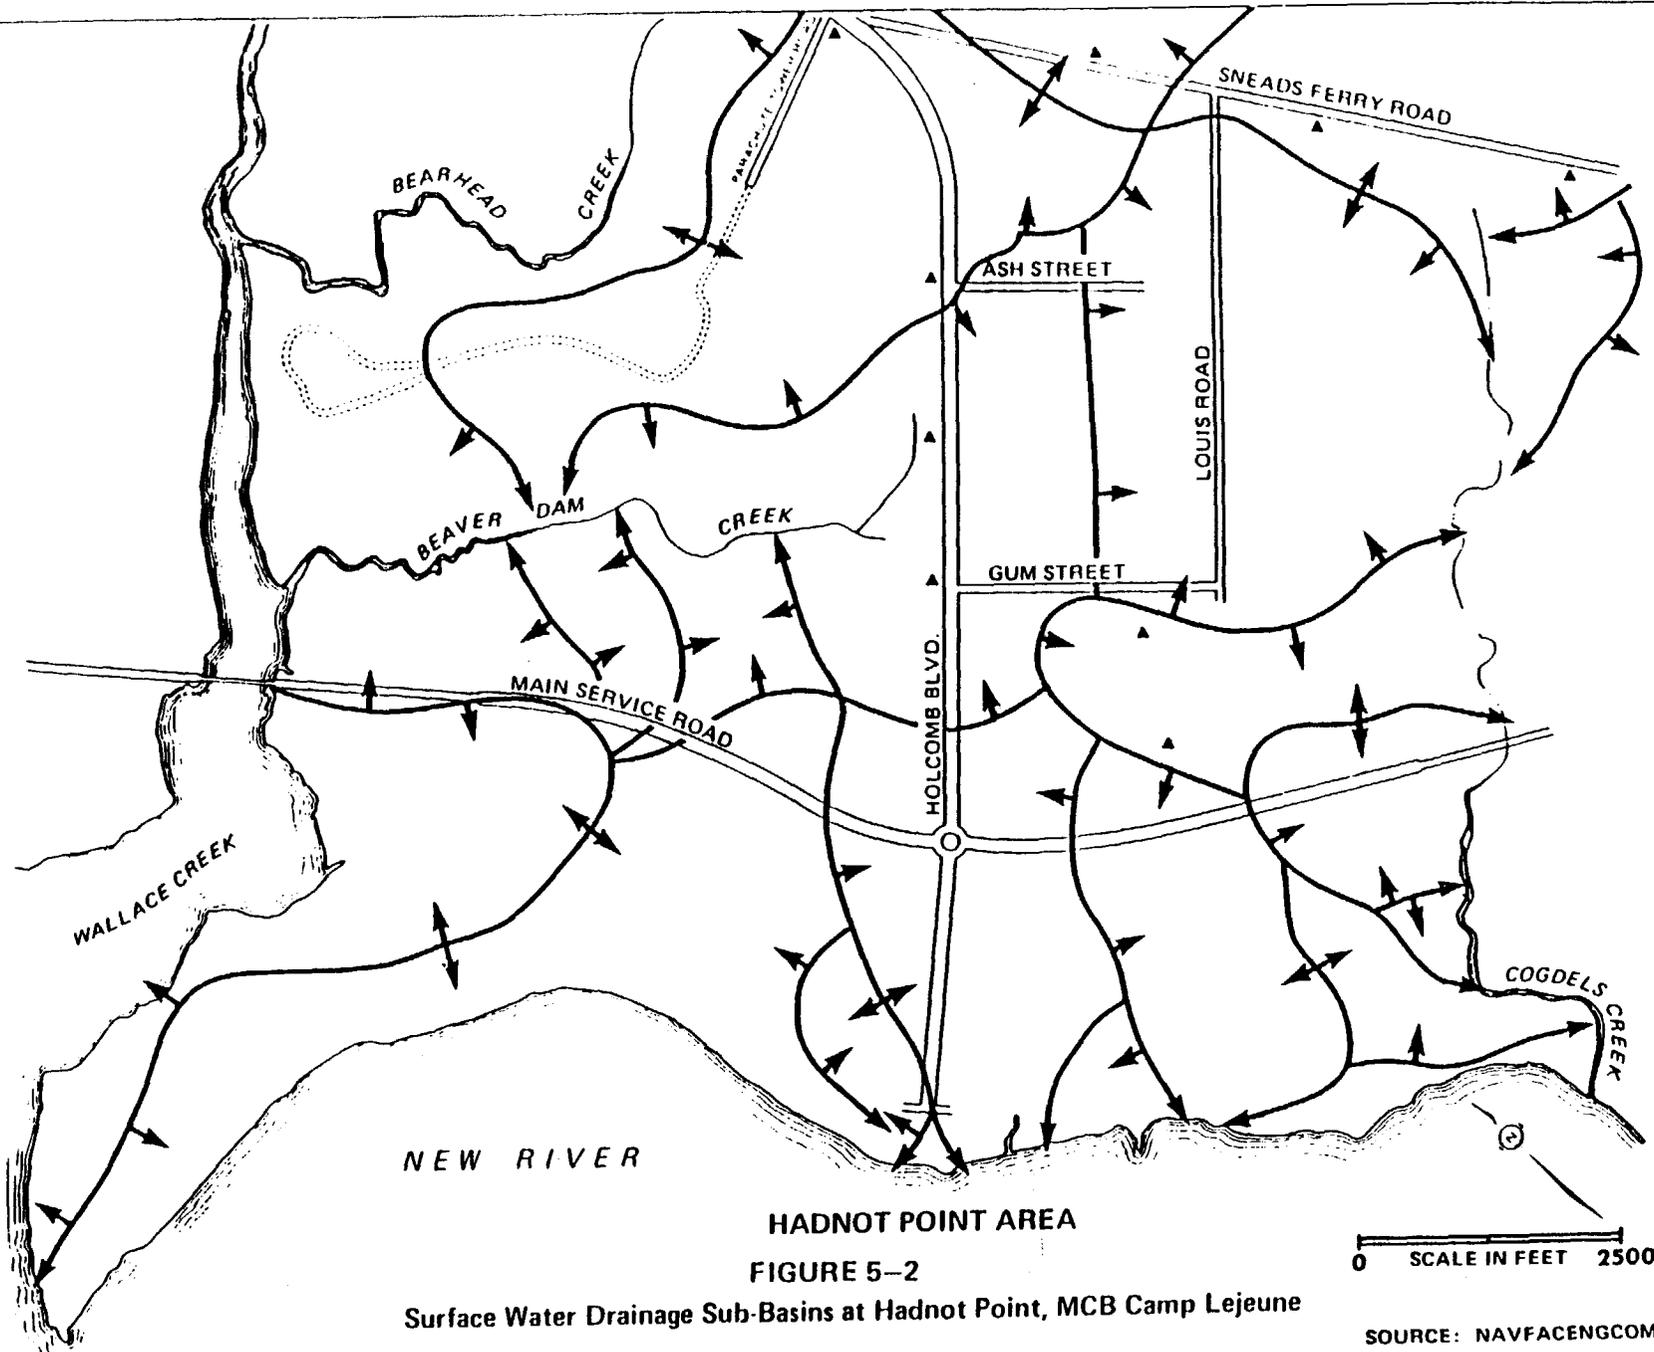
FIGURE 5-2

HADNOT POINT AREA

5.3.2 Topography and Surface Drainage. The generally flat topography of the Camp Lejeune complex is typical of the seaward portions of the North Carolina coastal plain. Elevations on the base vary from sea level to 72 feet above msl; however, the elevation of most of Camp Lejeune is between 20 and 40 feet above msl. The coast is guarded by a 200- to 500-foot-wide barrier island complex. Elevations of the dune field on the barrier islands range from 10 to 40 feet above msl. Drainage at Camp Lejeune is predominately toward the New River, although areas near the coast drain directly toward the Atlantic Ocean through the Intracoastal Waterway. In developed areas, natural drainage has been changed by drainage ditches, storm sewers, and extensive concrete and asphalt areas. Drainage sub-basins for Hadnot Point area and MCAS New River are shown in Figures 5-2 and 5-3, respectively. Most sites evaluated in this study are in these two areas.

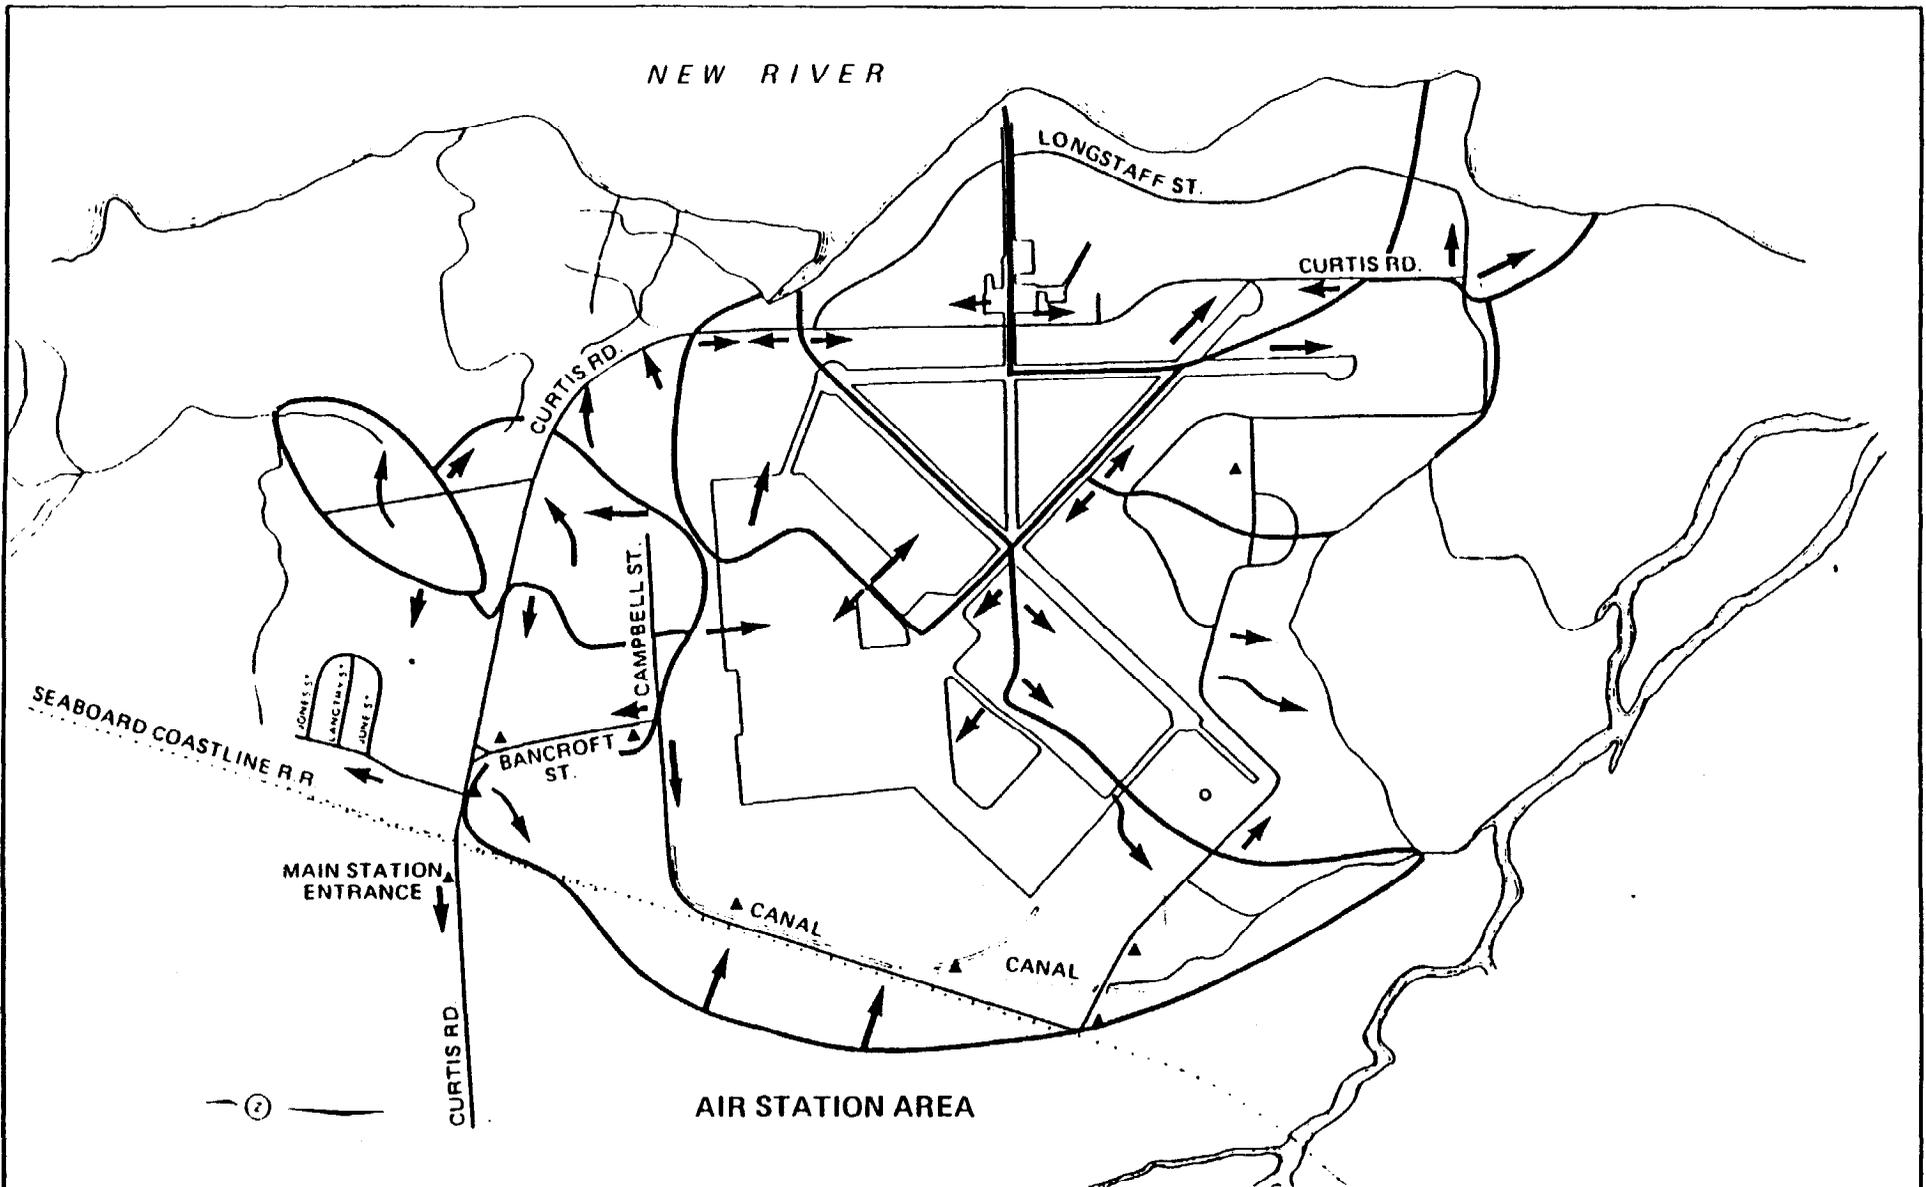
FIGURE 5-3

Surface Water Drainage Sub-Basin at MCAS New River, MCB Camp Lejeune

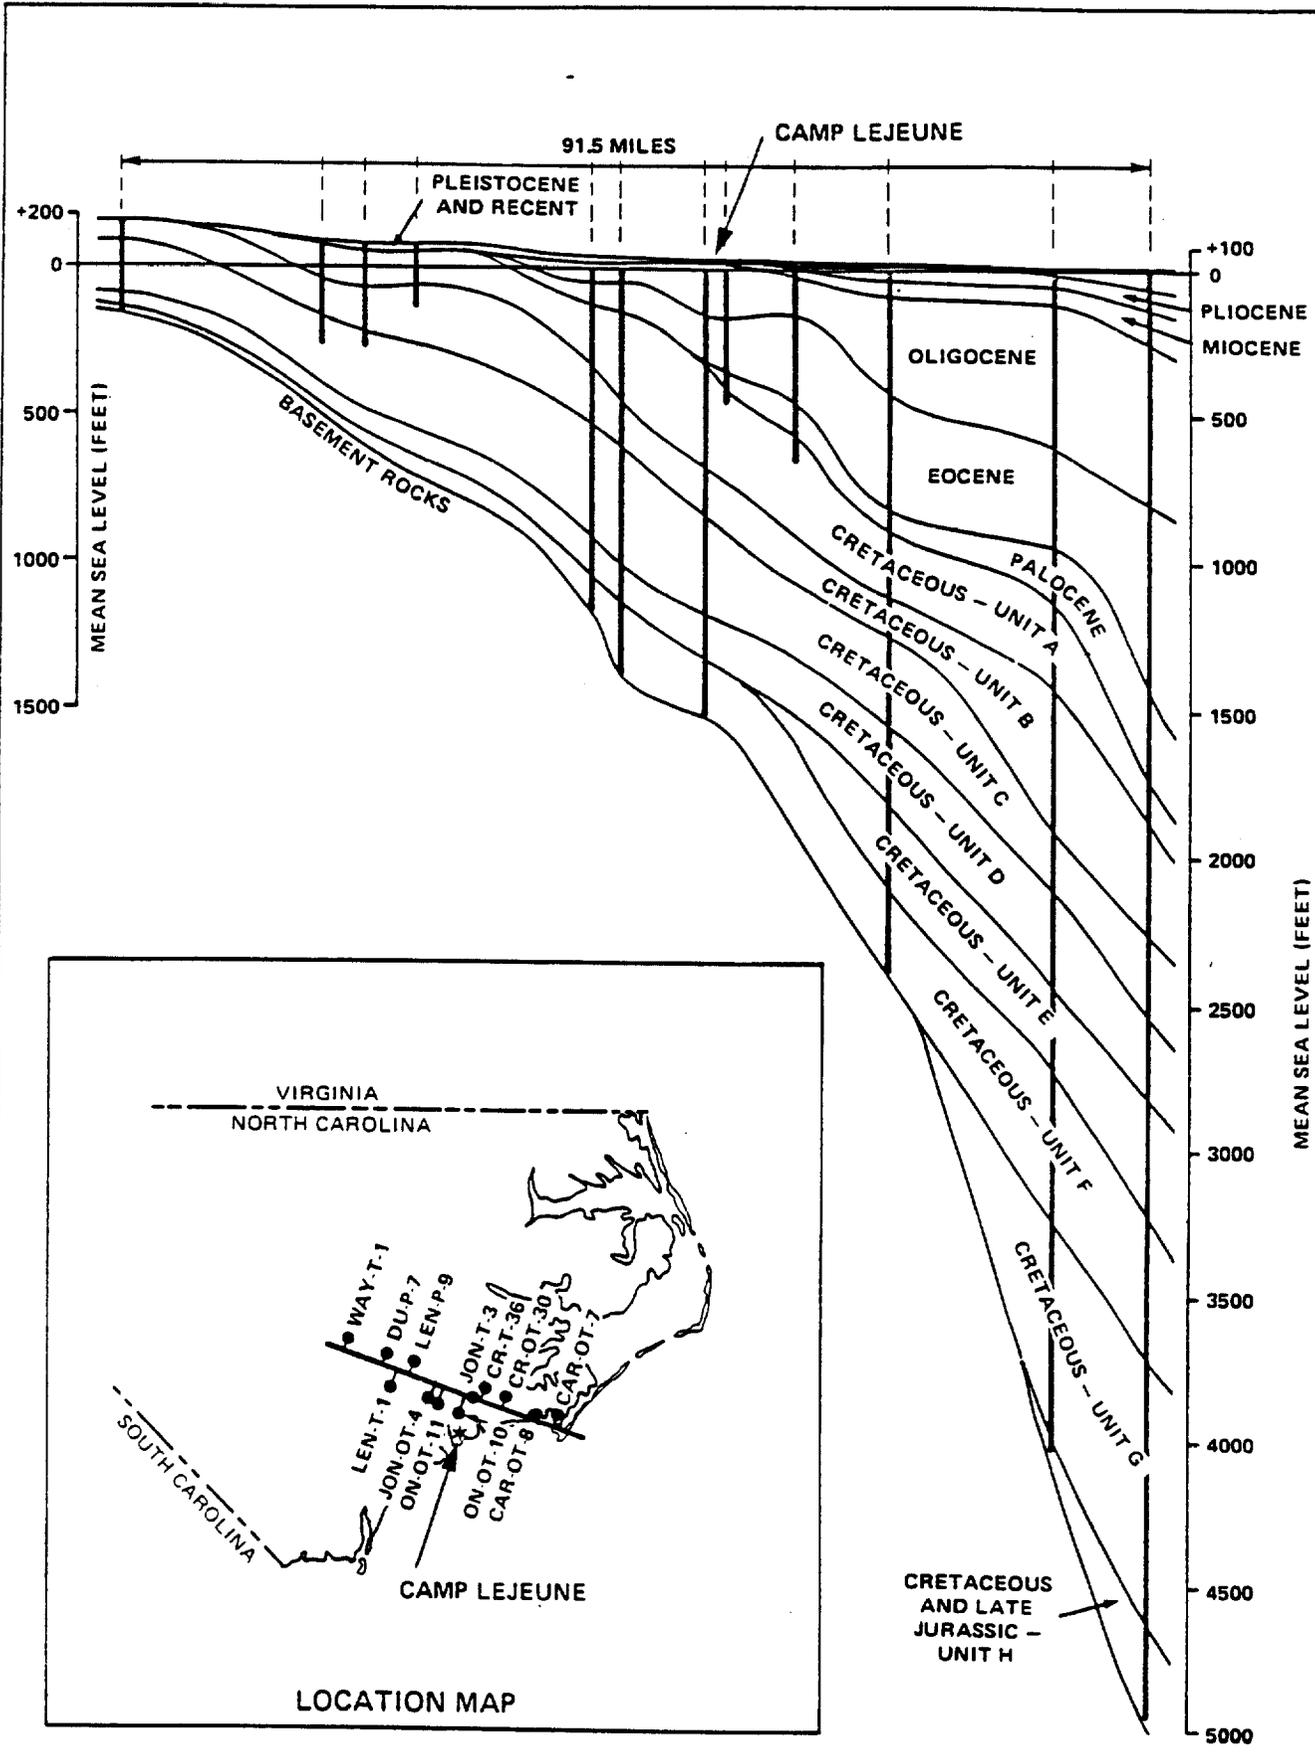
FIGURE 5-4
 Geologic Cross Section From Wayne County, N.C. to Carteret County, N.C.

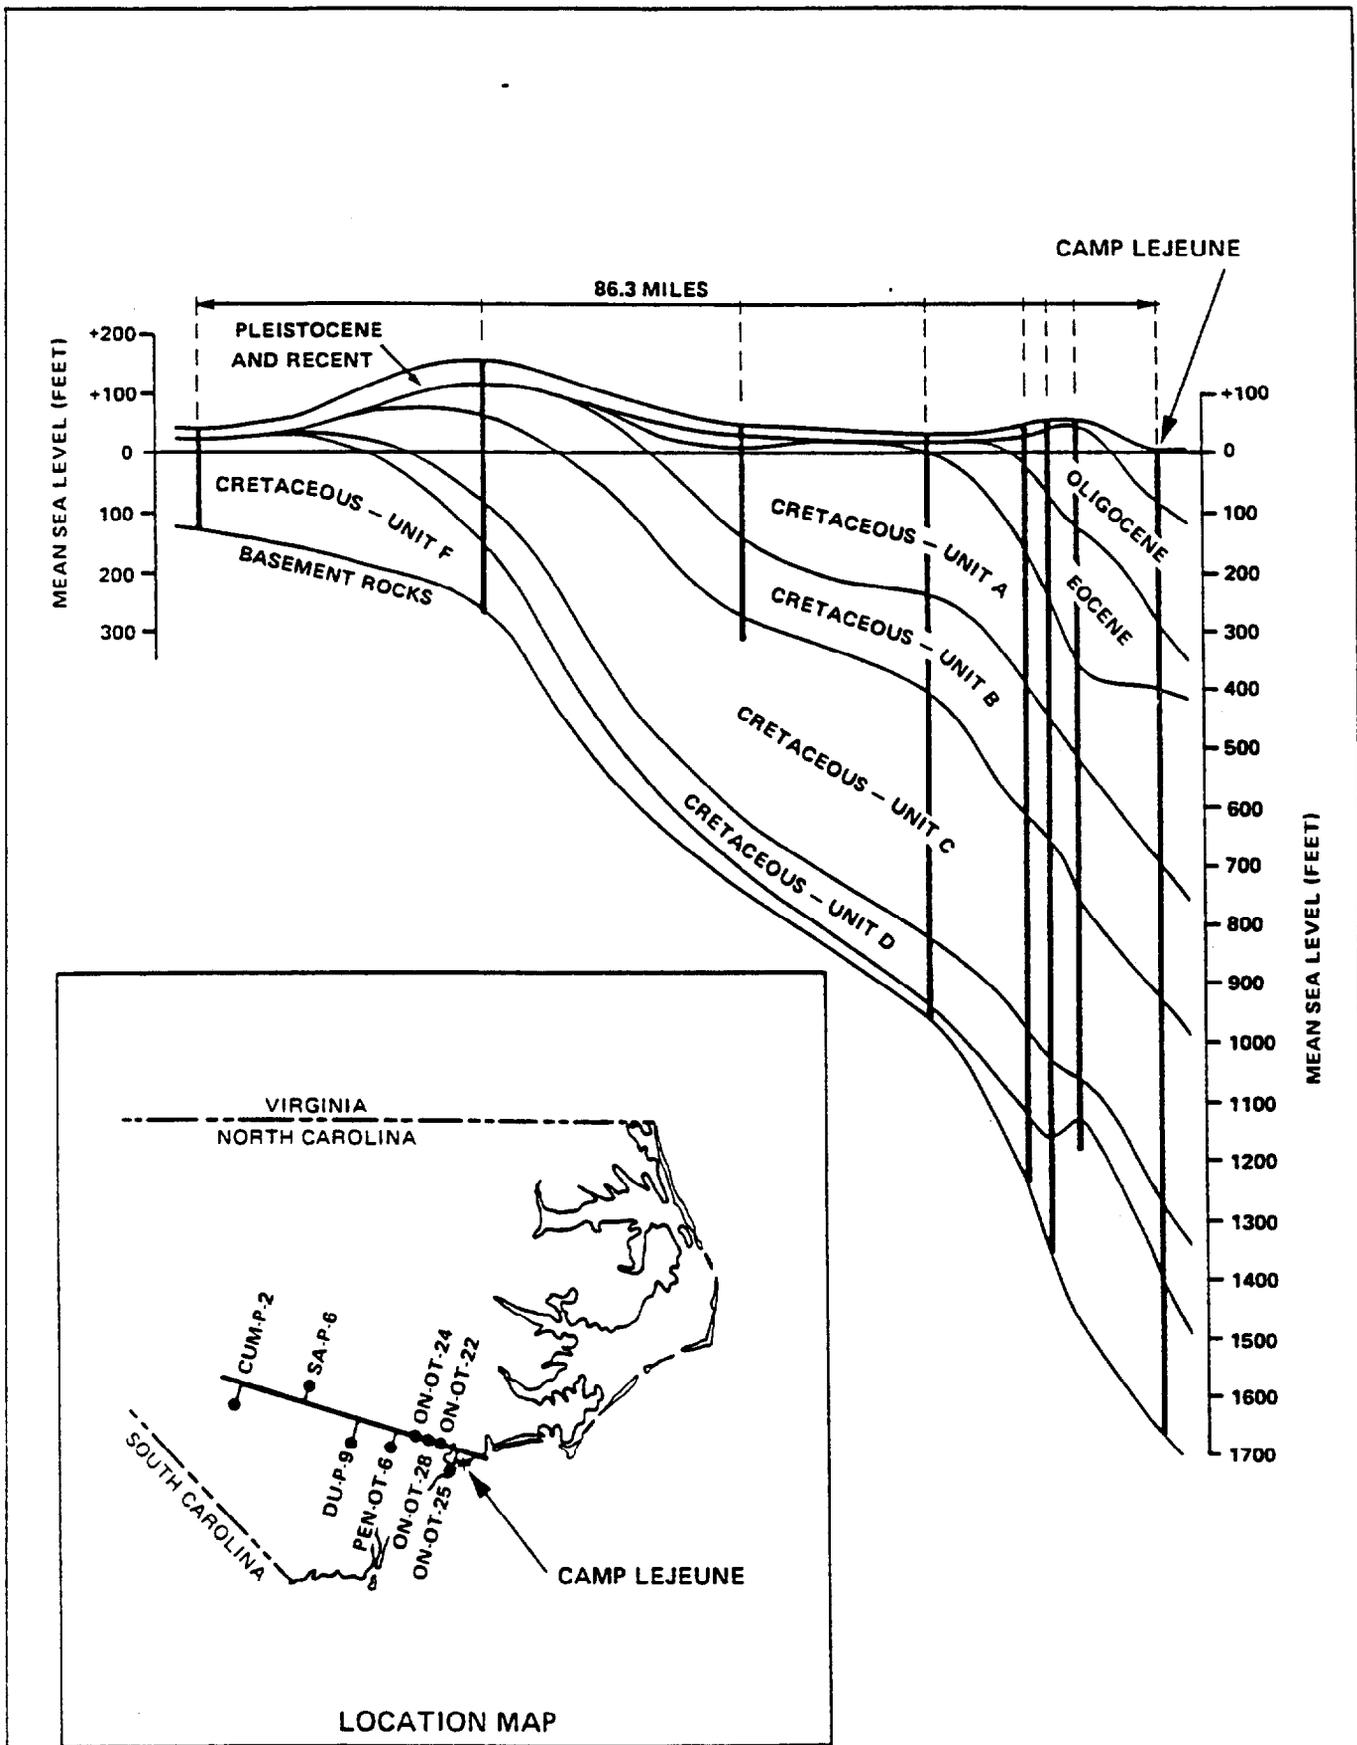
FIGURE 5-5
 Geologic Cross Section From Cumberland County, N.C. to Onslow County, N.C.

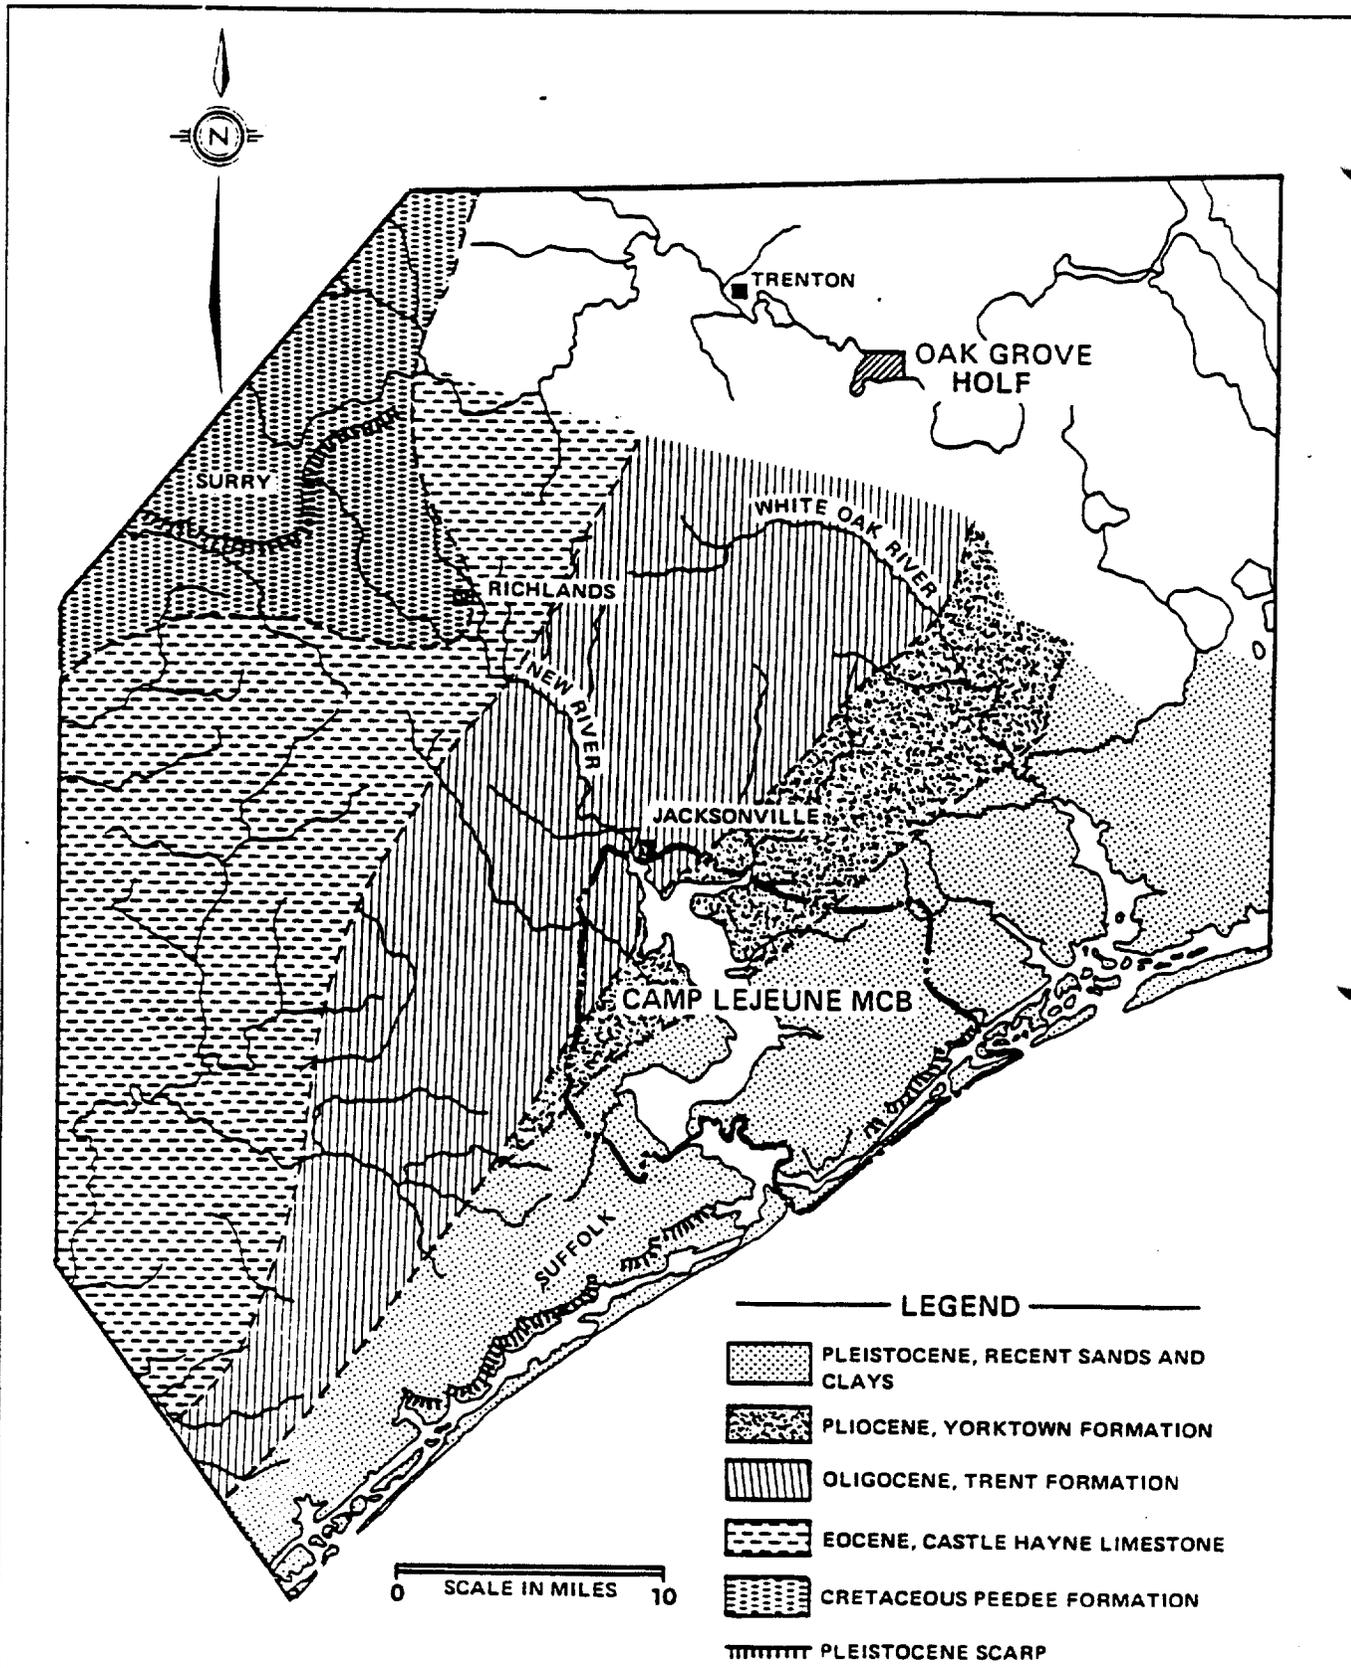
FIGURE 5-6
New River Area Geology

A mantle of Pleistocene and Recent sands and clays commonly covers the older sediments of the area. Beneath this mantle is a belted subcrop pattern with Cretaceous sediments nearest the surface in the west and progressively younger sediments nearest land surface toward the coast (Figure 5-6).

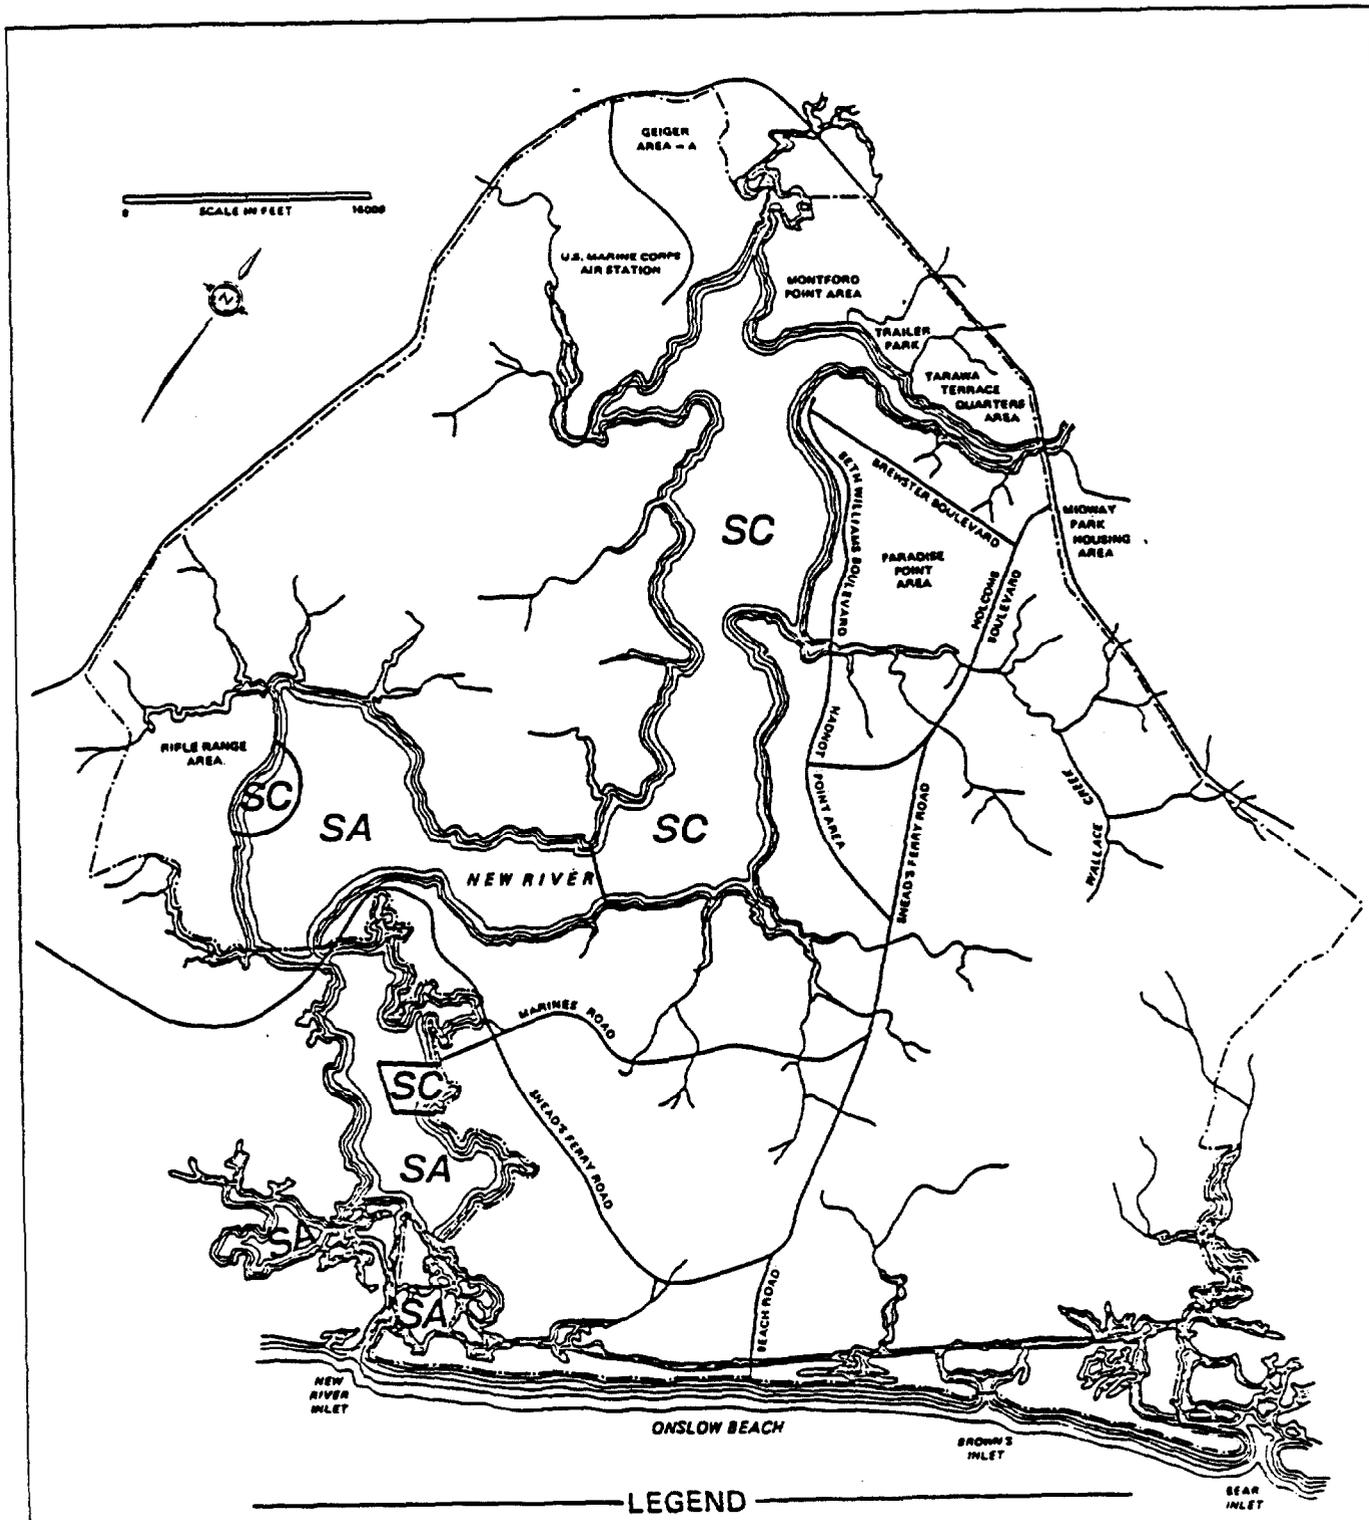
FIGURE 5-7
Water Quality Classifications for the New River at MCB Camp Lejeune

Water quality criteria for surface waters in North Carolina have been published under Title 15 of the North Carolina Administrative Code. The New River at MCB Camp Lejeune falls into two classifications (Figure 5-7). Classification SC applies to three areas of the New River at MCB Camp Lejeune. The best usage of Class SC waters is "fishing, secondary recreation, and any other usage except primary recreation or shellfishing for market purposes." The rest of the New River at MCB Camp Lejeune is Class SA, the highest estuarine classification. The best usage of Class SA waters is "shellfishing for market purposes and any other usage specified by the SB or SC classification."

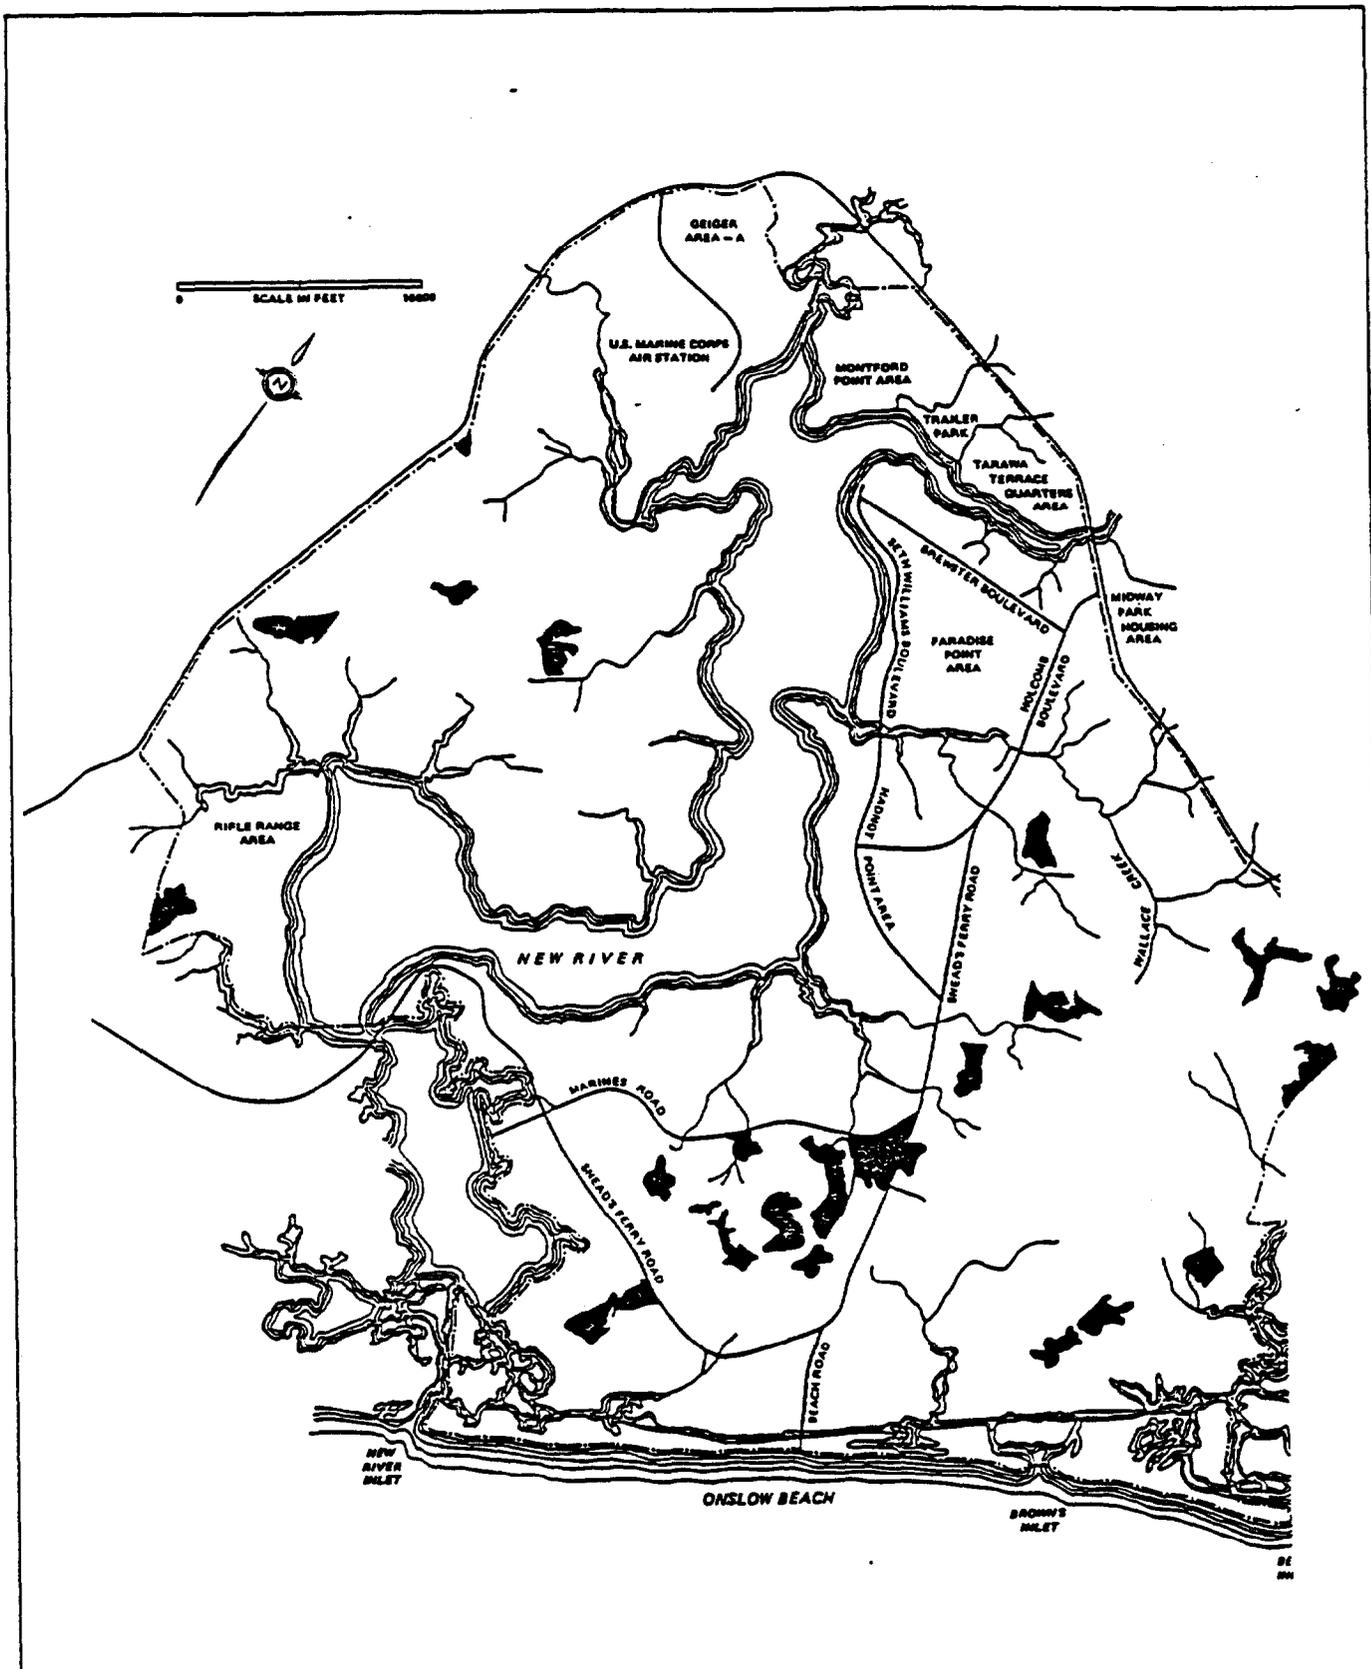
FIGURE 5-9
Red-Cockaded Woodpecker Colony Areas at MCB Camp Lejeune

As part of the rare and endangered species management program, special emphasis is placed on habitat and sightings of alligators, osprey, bald eagles, cougars, dusky seaside sparrows, and red-cockaded woodpeckers. The red-cockaded woodpecker is present in pine forests on MCB Camp Lejeune as noted in Table 5-3. This small woodpecker subsists on insects and is important in controlling insect pests which attack pine trees. Nesting cavities used by these birds are usually in overmature pine trees with red-heart disease. In some colonies, all the cavity trees are within 300 feet of each other, but in other colonies, they may be 0.5 mile apart (Hooper *et al.*, 1980). Numerous red-cockaded woodpecker colonies on Camp Lejeune have been mapped and marked (Natural Resource Management Plan, 1975). These areas are shown in Figure 5-9.

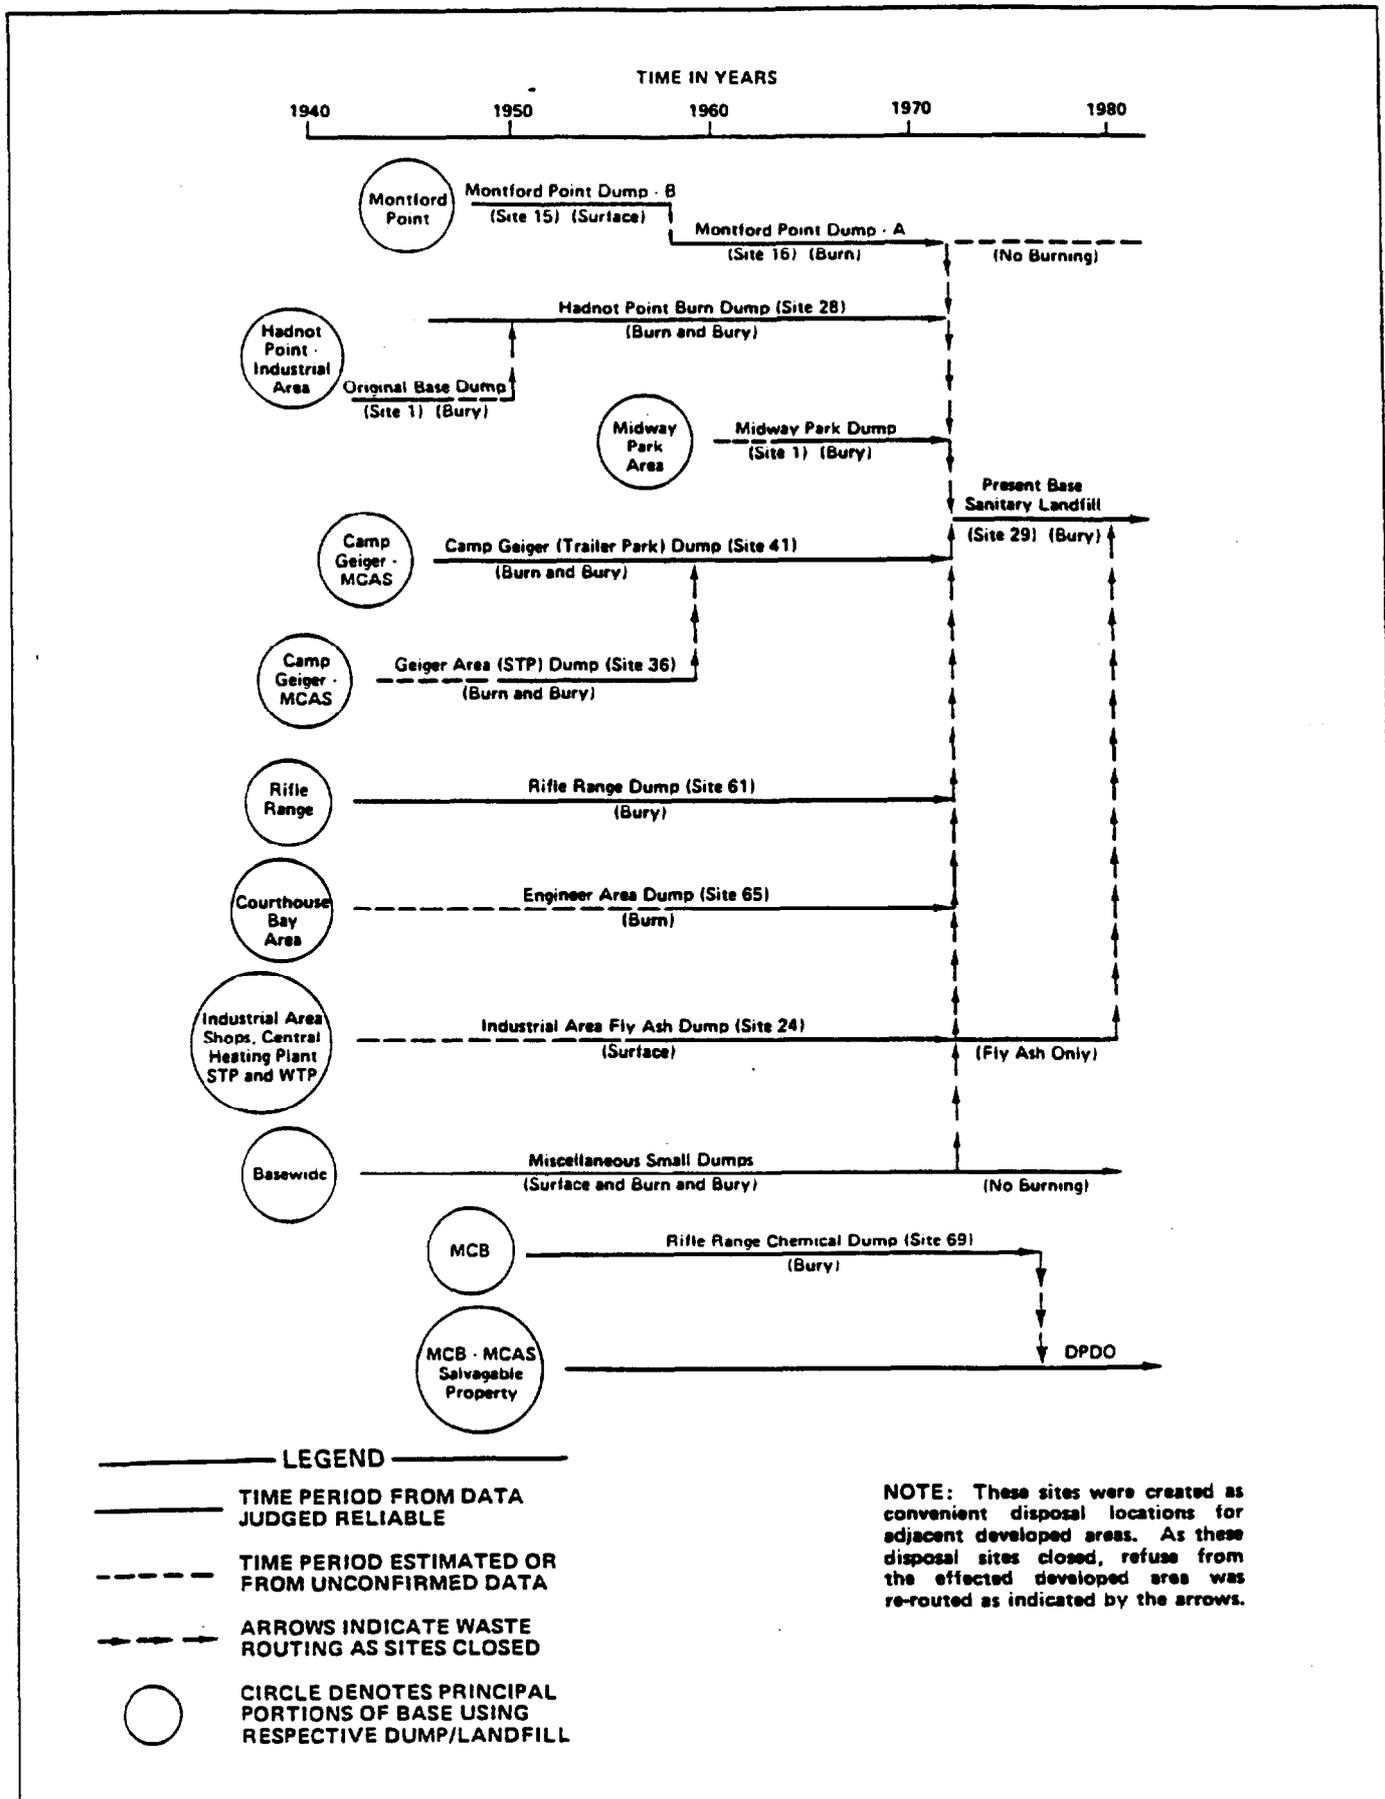
FIGURE 6-1
 Chronology of Solid Waste Disposal Sites and Waste Routing at Camp Lejeune, N.C.

6.6.2 Solid Wastes and POL Disposal. Solid waste disposal in the base complex has been on land in the past. Past practice has not been well regulated, and unauthorized disposal sites were used for many substances, some of which were hazardous. A chronology of principal waste disposal areas is given in Figure 6-1. The original base waste disposal site (prior to 1950) was off Holcomb Boulevard across from Storage Lot 203 (See Site No. 10). The site was a borrow pit used for disposal of construction debris. Following construction, which began in 1941, disposal areas were located near individual activities (see Site Nos. 1, 7, 10, 13, 15, 16, 19, 24, 25, 36, 37, 40, 42, 43, 44, 46, 55, 57, 61, 62, 63, 65, and 68). As a result, a number of sites were active simultaneously. In the early 1970s, a central landfill (Site No. 29) was established to receive wastes from the entire complex while other landfills were gradually phased out. One possible exception is the Chemical Dump in the Rifle Range area (Site No. 69) at which disposal continued.
