INITIAL ASSESSMENT STUDY OF
MARINE CORPS BASE CAMP LEJEUNE
NORTH CAROLINA

NEESA 13-011

INITIAL ASSESSMENT STUDY
OF MARINE CORPS BASE CAMP LEJEUNE, NORTH CAROLINA
UIC-M67001

Prepared by:
WATER AND AIR RESEARCH, INC.
Gainesville, Florida

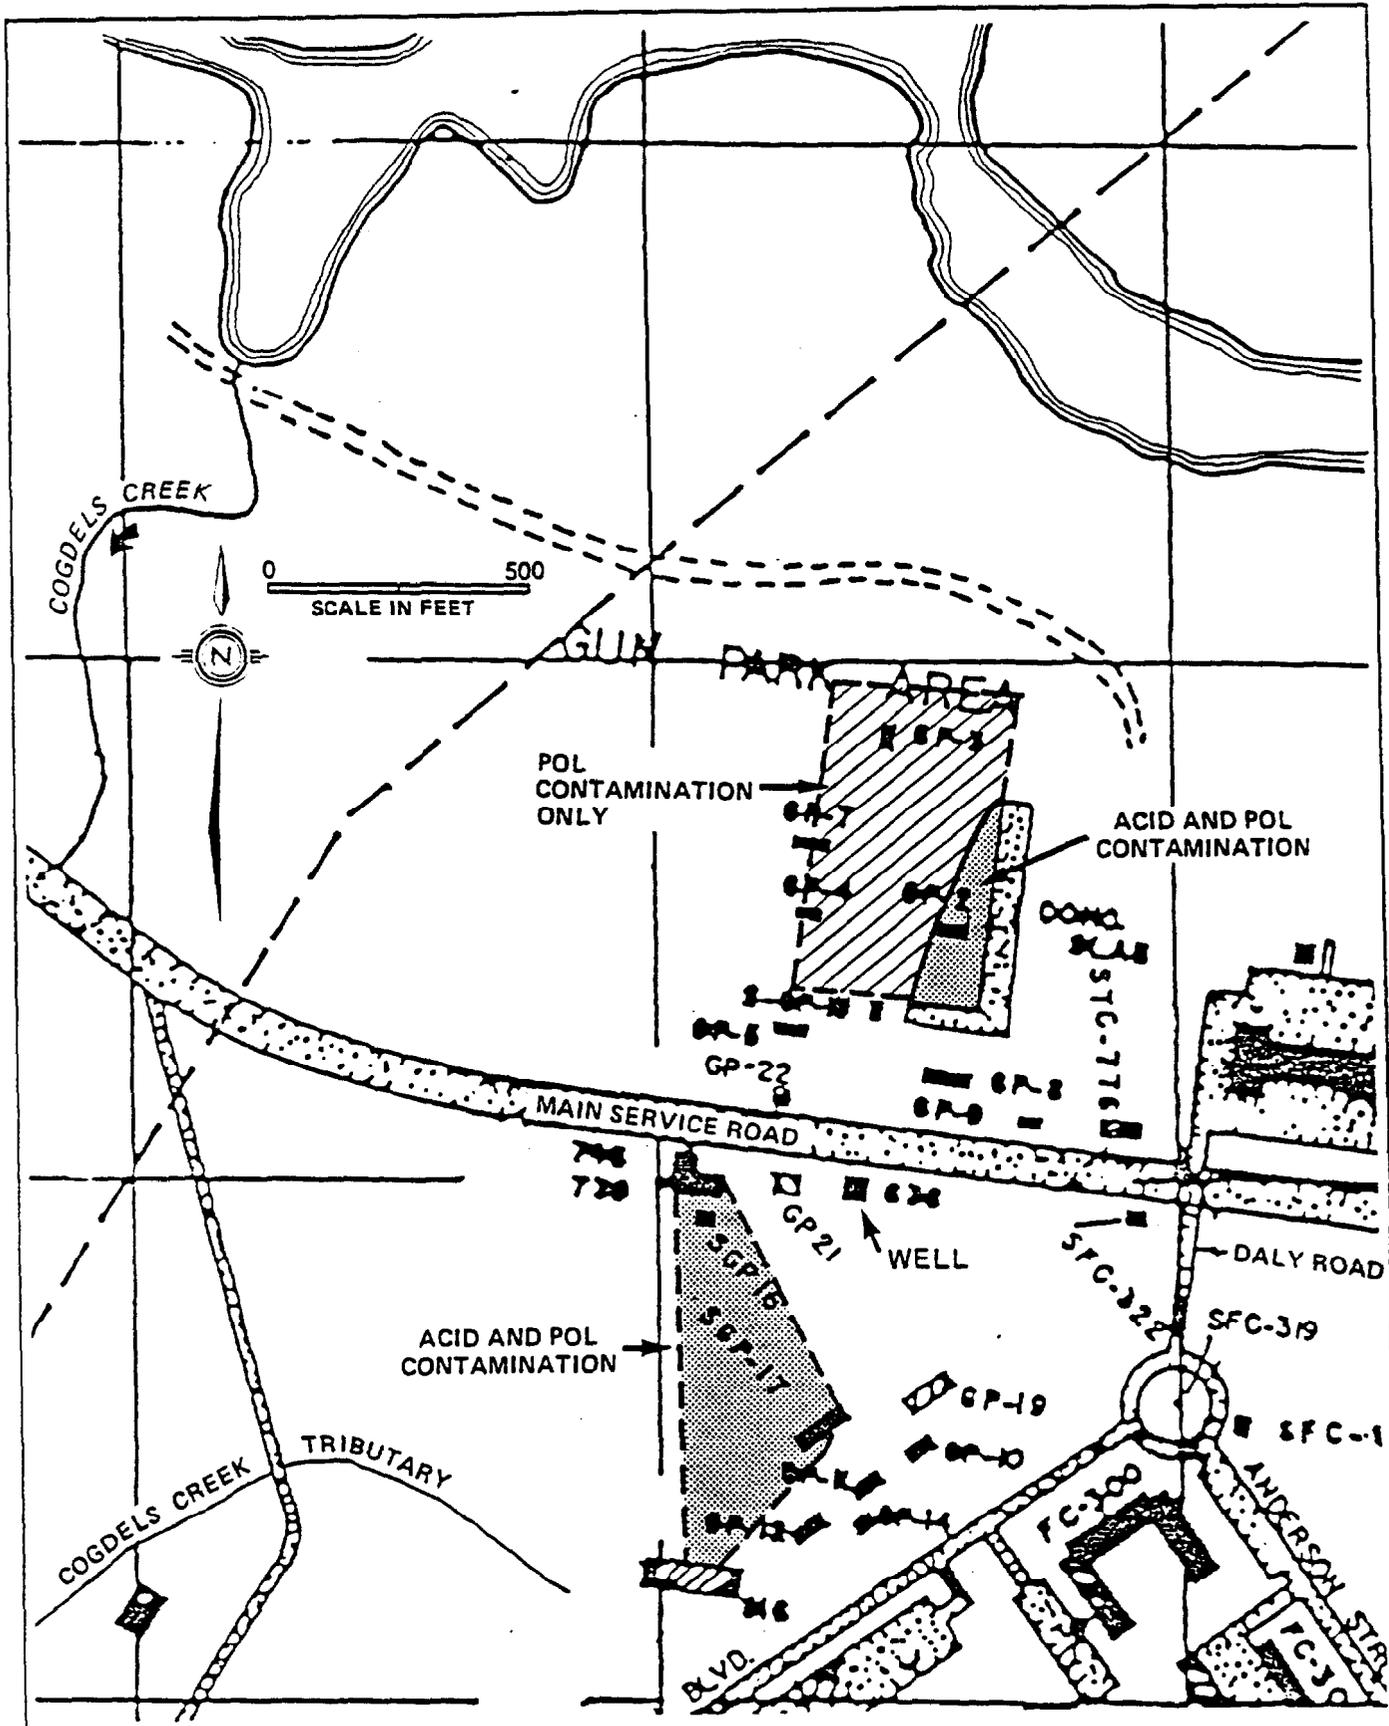
Comments: This area has been used by many different Marine organizations over three decades. These groups included motor transportation; armored personnel carriers, tank battalions, and self-propelled guns. Liquids waste disposal at this site was similar to practices at Courthouse Bay (Site No. 73). The transient nature of the units assigned to this area make it difficult to more accurately estimate waste quantities. Based on Courthouse Bay data, estimated POL quantity is probably low if the estimated waste acid volume is in the correct range. A potable water well is located within about 100 yards and between these disposal areas.

FIGURE 6-2
Detail of Site No. 1, French Creek Liquids Disposal Area

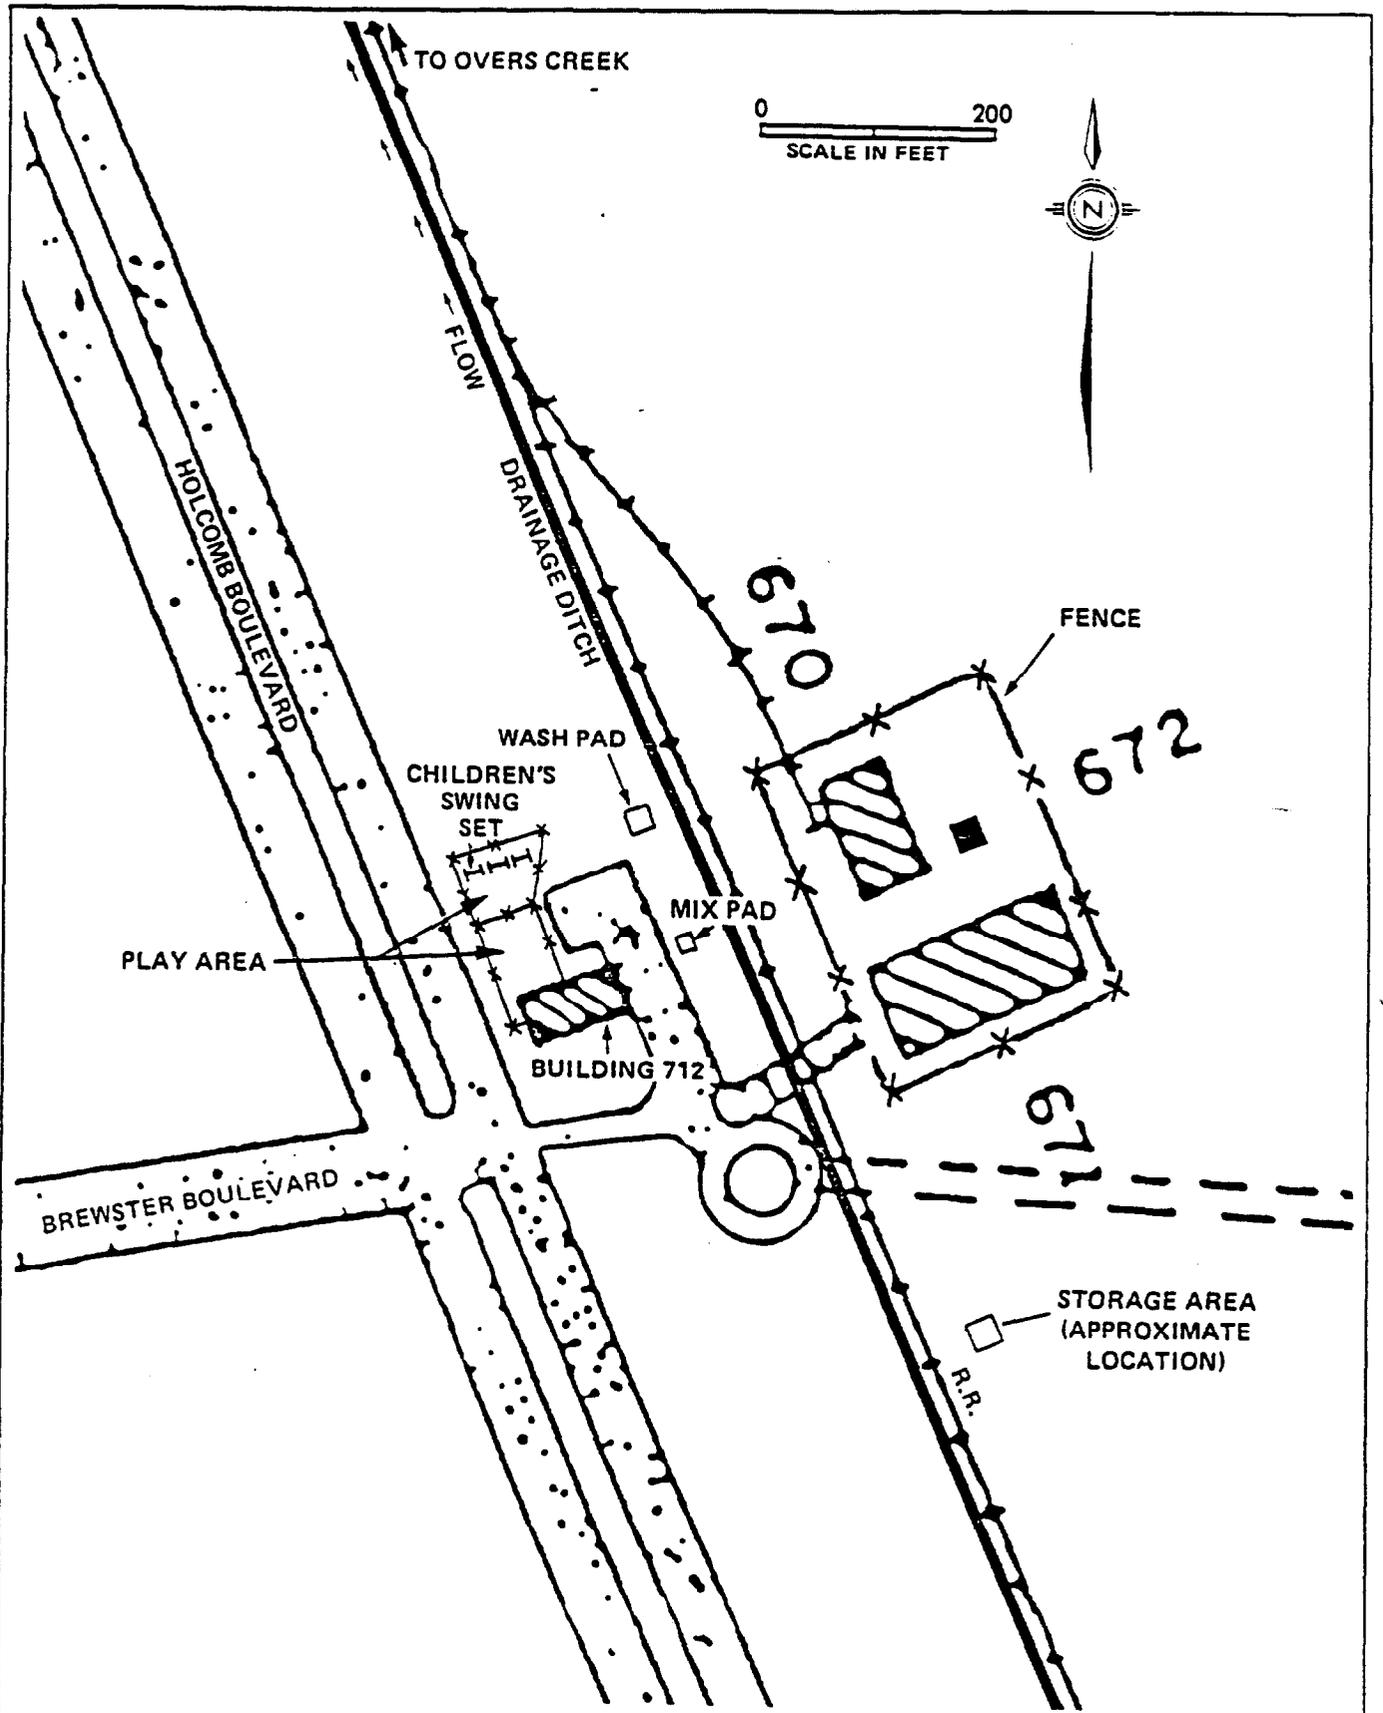
* Since the IAS team on-site visit, the Nursery/Day-Care Center has been relocated. Table 2-1 shows soil pesticide levels around Building 712. Sampling locations are indicated on Figure 6-4. More testing has been performed at this site.

FIGURE 6-4
 Detail of Site No. 2, Former Nursery/Day Care Center

2.4.2 Site No. 2: Former Nursery/Day-Care Center (Building 712). This site is at PWDM coordinates 5, K10. This area had been recently operated as a day care center. From 1945 to 1958, pesticides of various kinds were stored, handled, and dispensed here. Residuals are present but reliable data from which to quantify residuals or spill volumes have not been found. Chemicals used in significant amounts include Chlordane, DDT, Diazinon, and 2,4-D. Stored only or used to a minor extent were Dieldrin, Lindane, Malathion, Silvex, and 2,4,5-T. Contaminated areas are the fenced playground, approximately 6,300 square feet; the mixing pad covering approximately 100 square feet; and the wash pad, approximately 225 square feet. An adjacent drainage ditch possibly received washout and spills. Table 2-1 presents results of a preliminary sampling program in April 1982. Based on test data, the day care activities were ceased in April 1982.

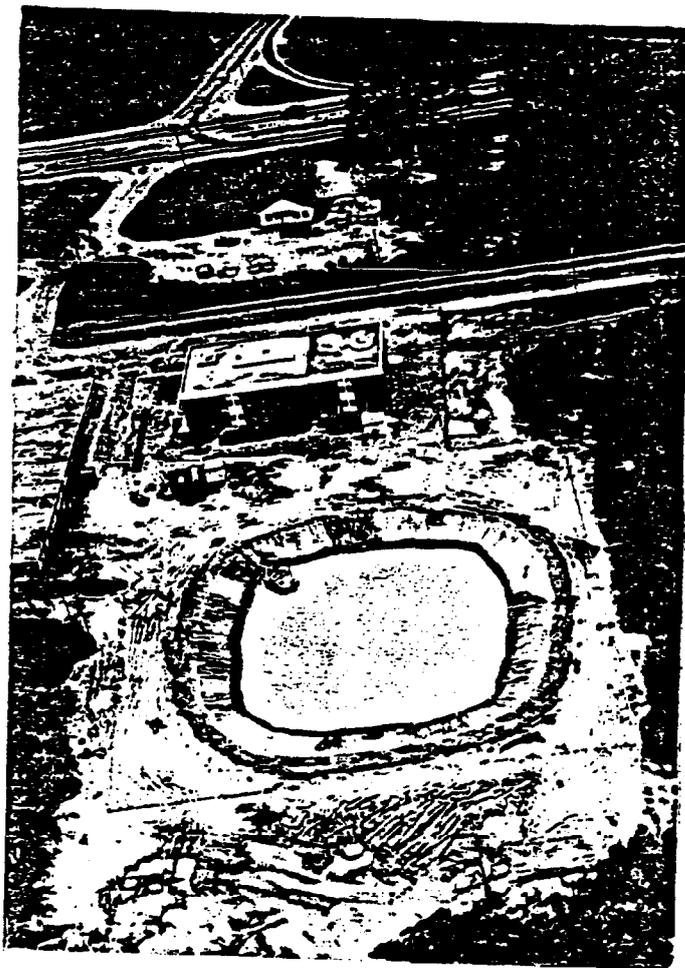
FIGURE 6-6
Site No. 2 – Former Nursery/Day Care Center at Building 712
Water Treatment Plant in Foreground

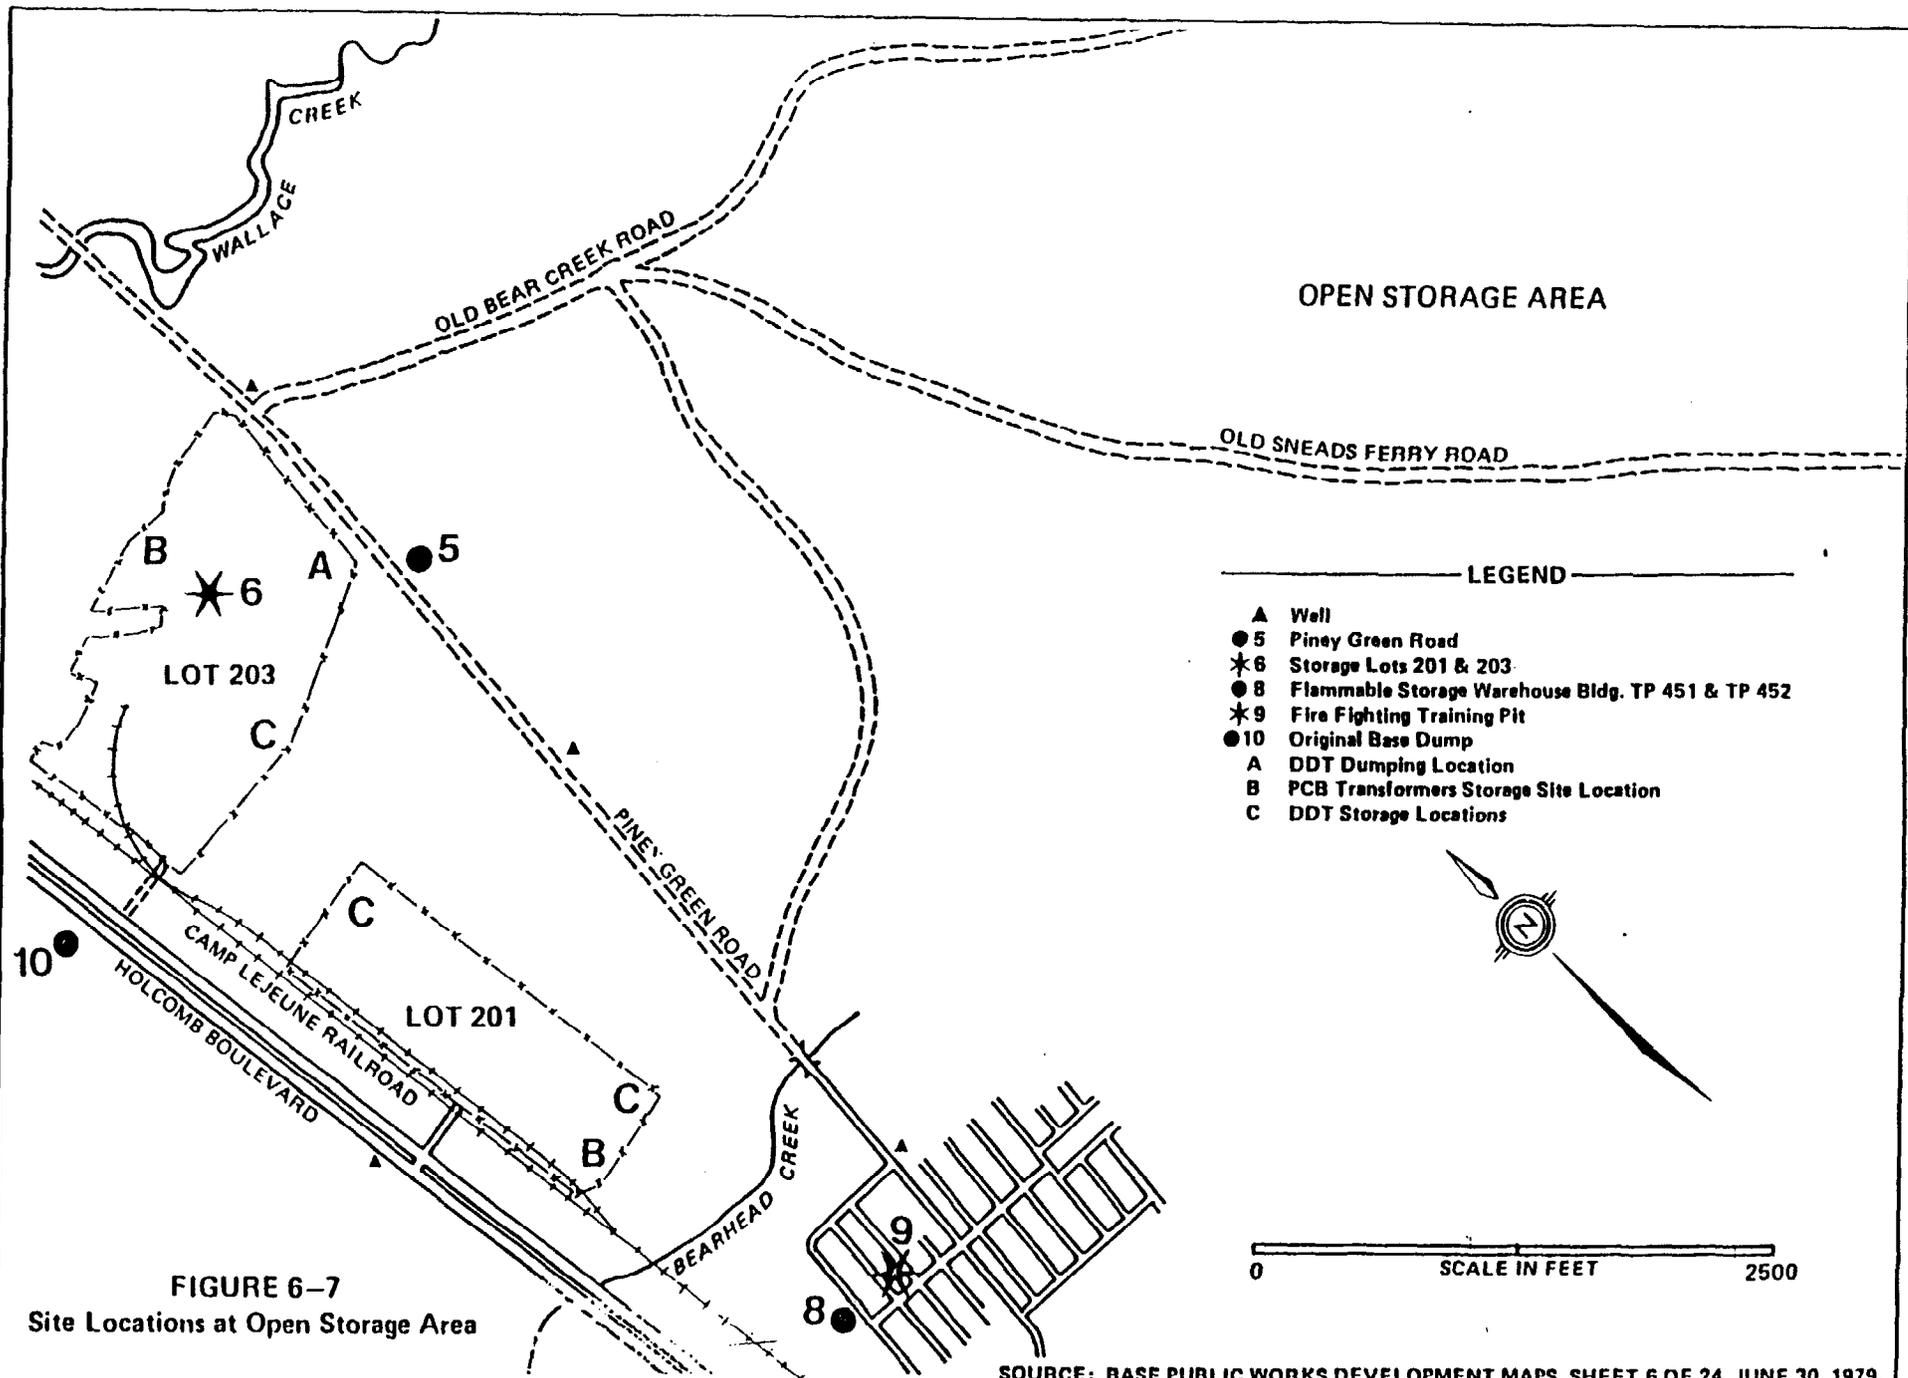
There are 4 areas at the 2 sites which have highest likelihood of DDT contamination, if any contamination exists. These are identified on Figure 6-7. Representative photo is given in Figure 6-8a.

FIGURE 6-7
Site Locations at Open Storage Area

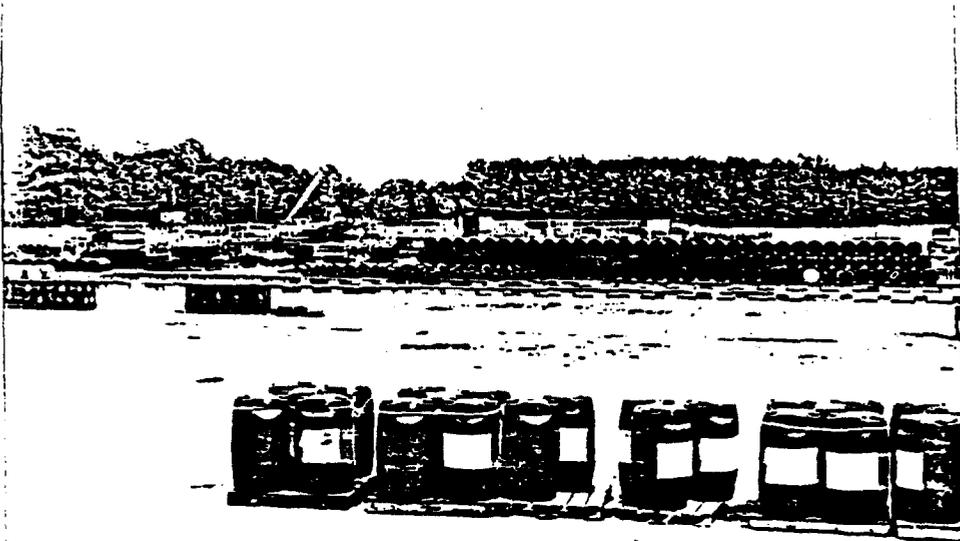
FIGURE 6-8a
Site No. 6 – Storage Lots 201-203

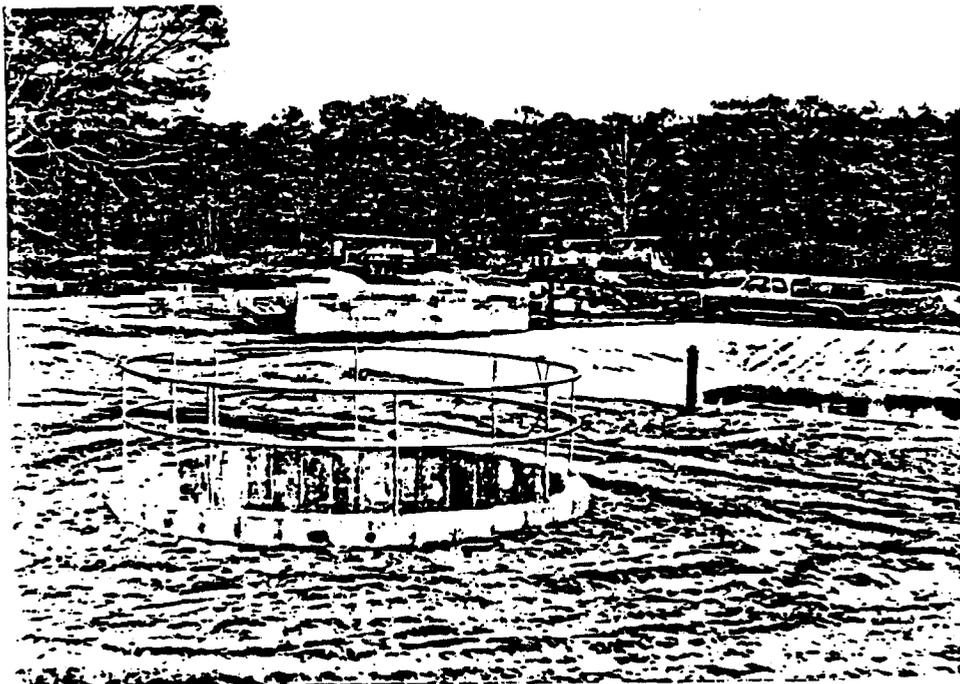
FIGURE 6-8b
Site No. 9 – Fire Fighting Training Pit near Piney Green Road.
Oil Water Separation Pit in Foreground

2.4.4 Site No. 9: Fire Fighting Training Pit at Piney Green Road. This site (PWDM coordinates 6, K3/L3) has been in operation from the 1960s to the present. Pollution abatement devices, including an oil-water separator and an impermeable liner in the training pit (approximately 800 square feet), have been installed. About 30,000 gallons per year of used oil, solvents, and contaminated fuels are burned during training exercises. Until the mid- to late 1960s, the pit was unlined. The entire site is about 1 to 2 acres in size. The soils are sandy and without ground cover.

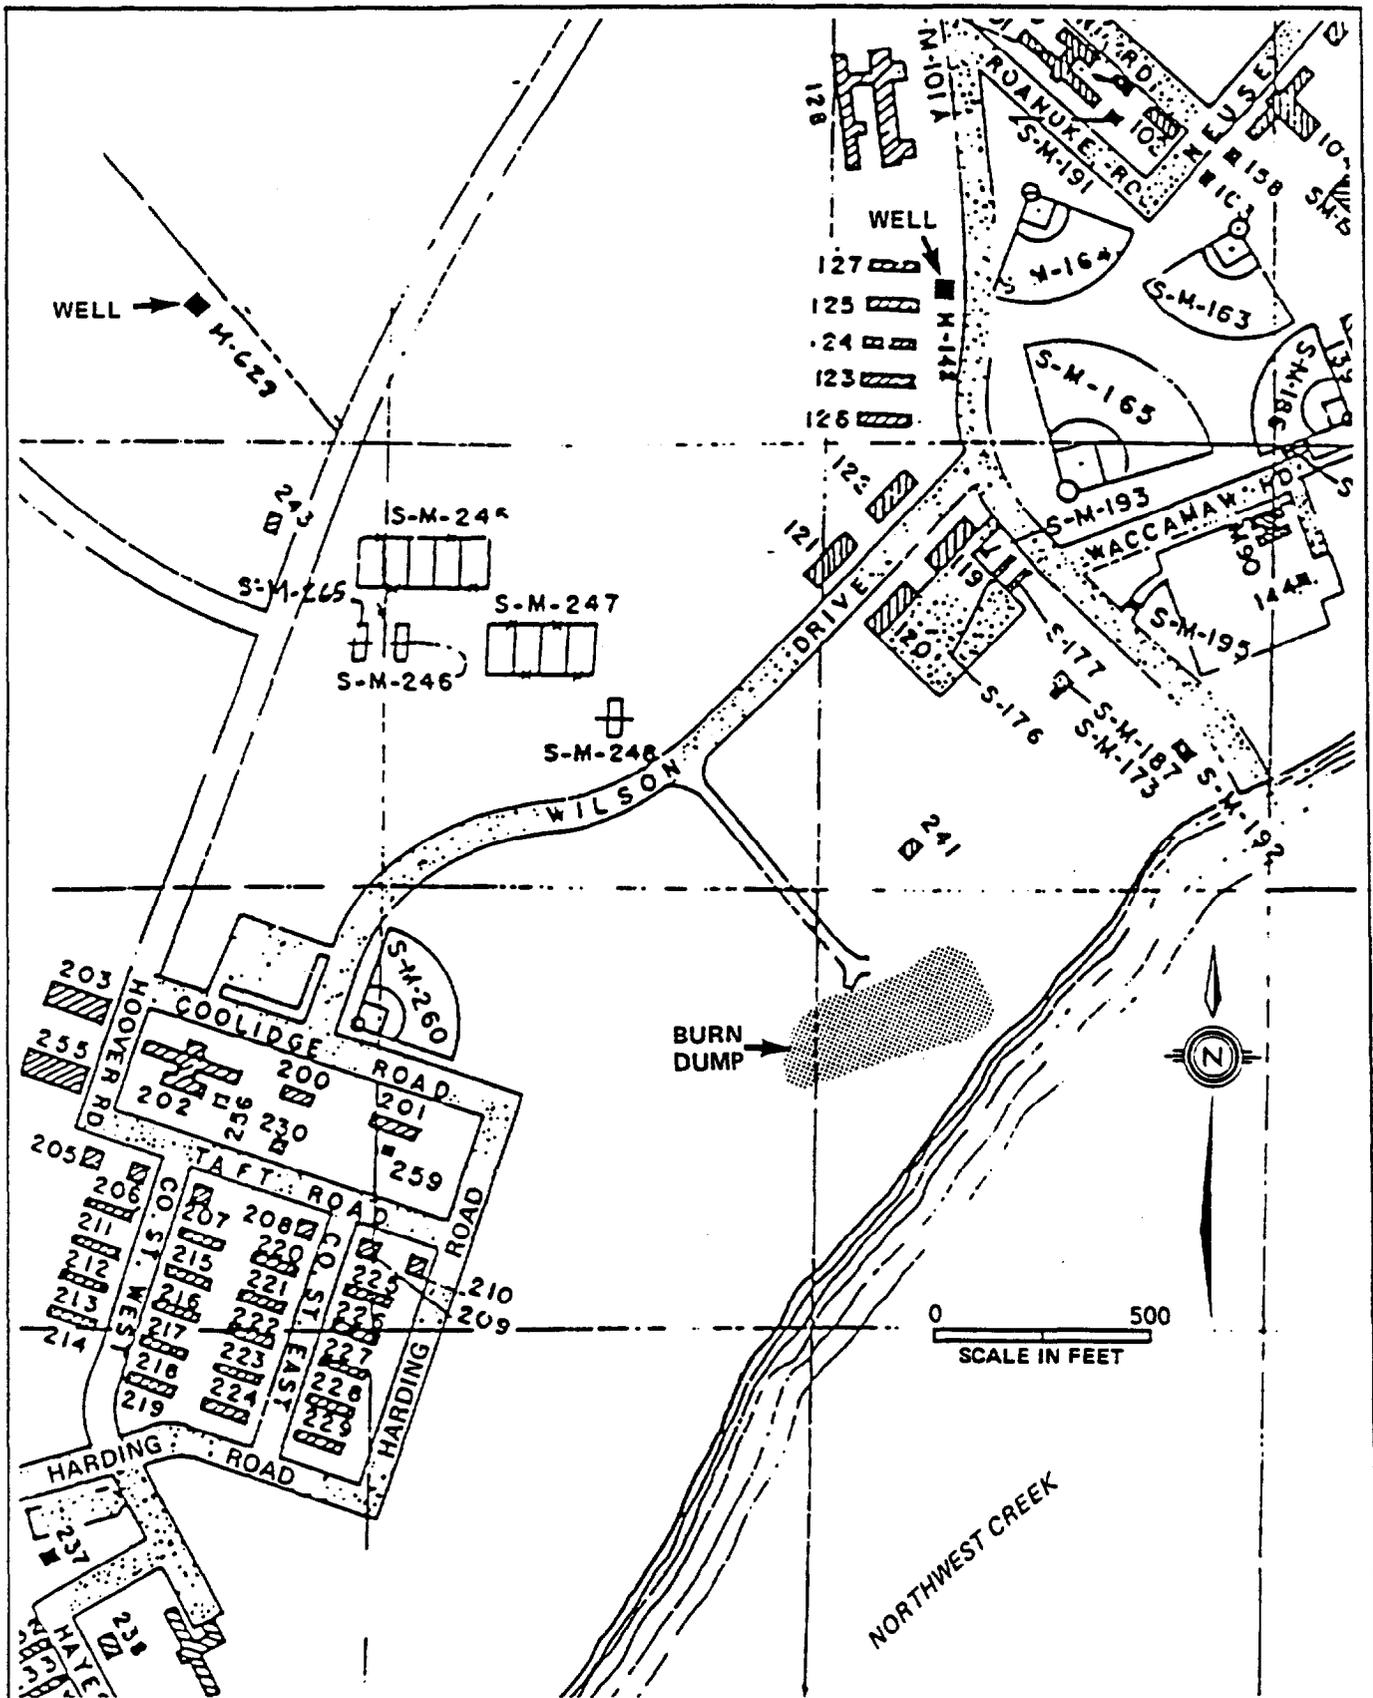
Comments: Mitigation has been undertaken. Site has been used occasionally for unauthorized disposal of debris since 1972.

FIGURE 6-9
Detail of Site No. 16, Montford Point Burn Dump

2.4.5 Site No. 16: Montford Point Burn Dump--The dump (PWDM coordinates 2, N11-12) was opened around 1958 and was closed in 1972, although unauthorized dumping has subsequently occurred. The site contains building debris, garbage, tires, and waste oils. The quantity of these wastes is unknown, but the amount of oil buried here is considered insignificant. Materials have been dumped on the surface and include asbestos insulating material (estimated at less than 1 cubic yard) for pipes. (Note: Mitigation has been undertaken.) The site covers about 4 acres.

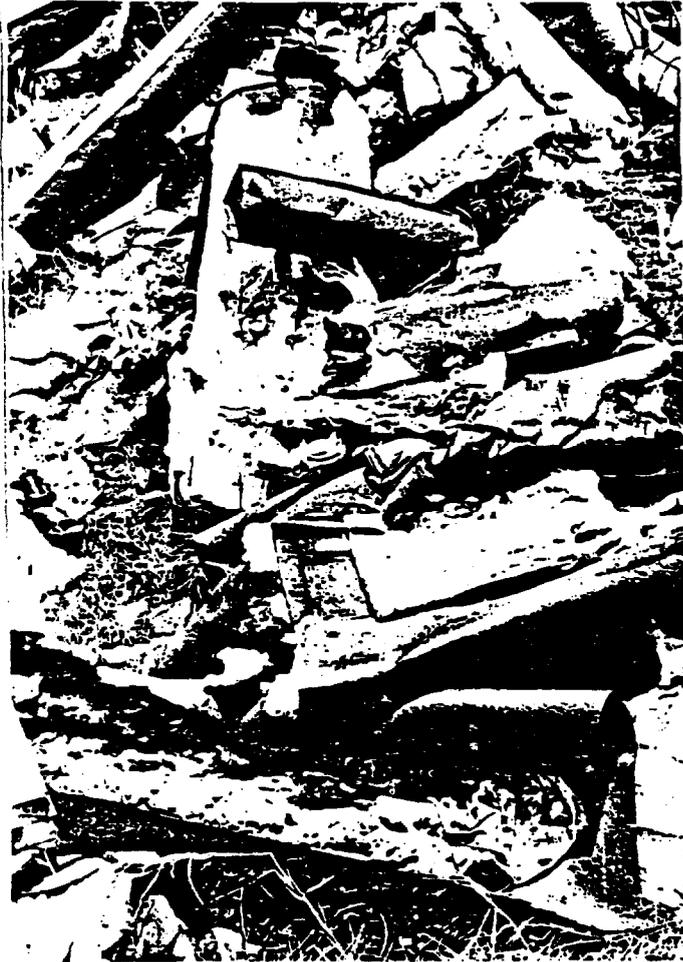
FIGURE 6-11
Site No. 16 – Montford Point Burn Dump
Showing Asbestos Pipe Insulation

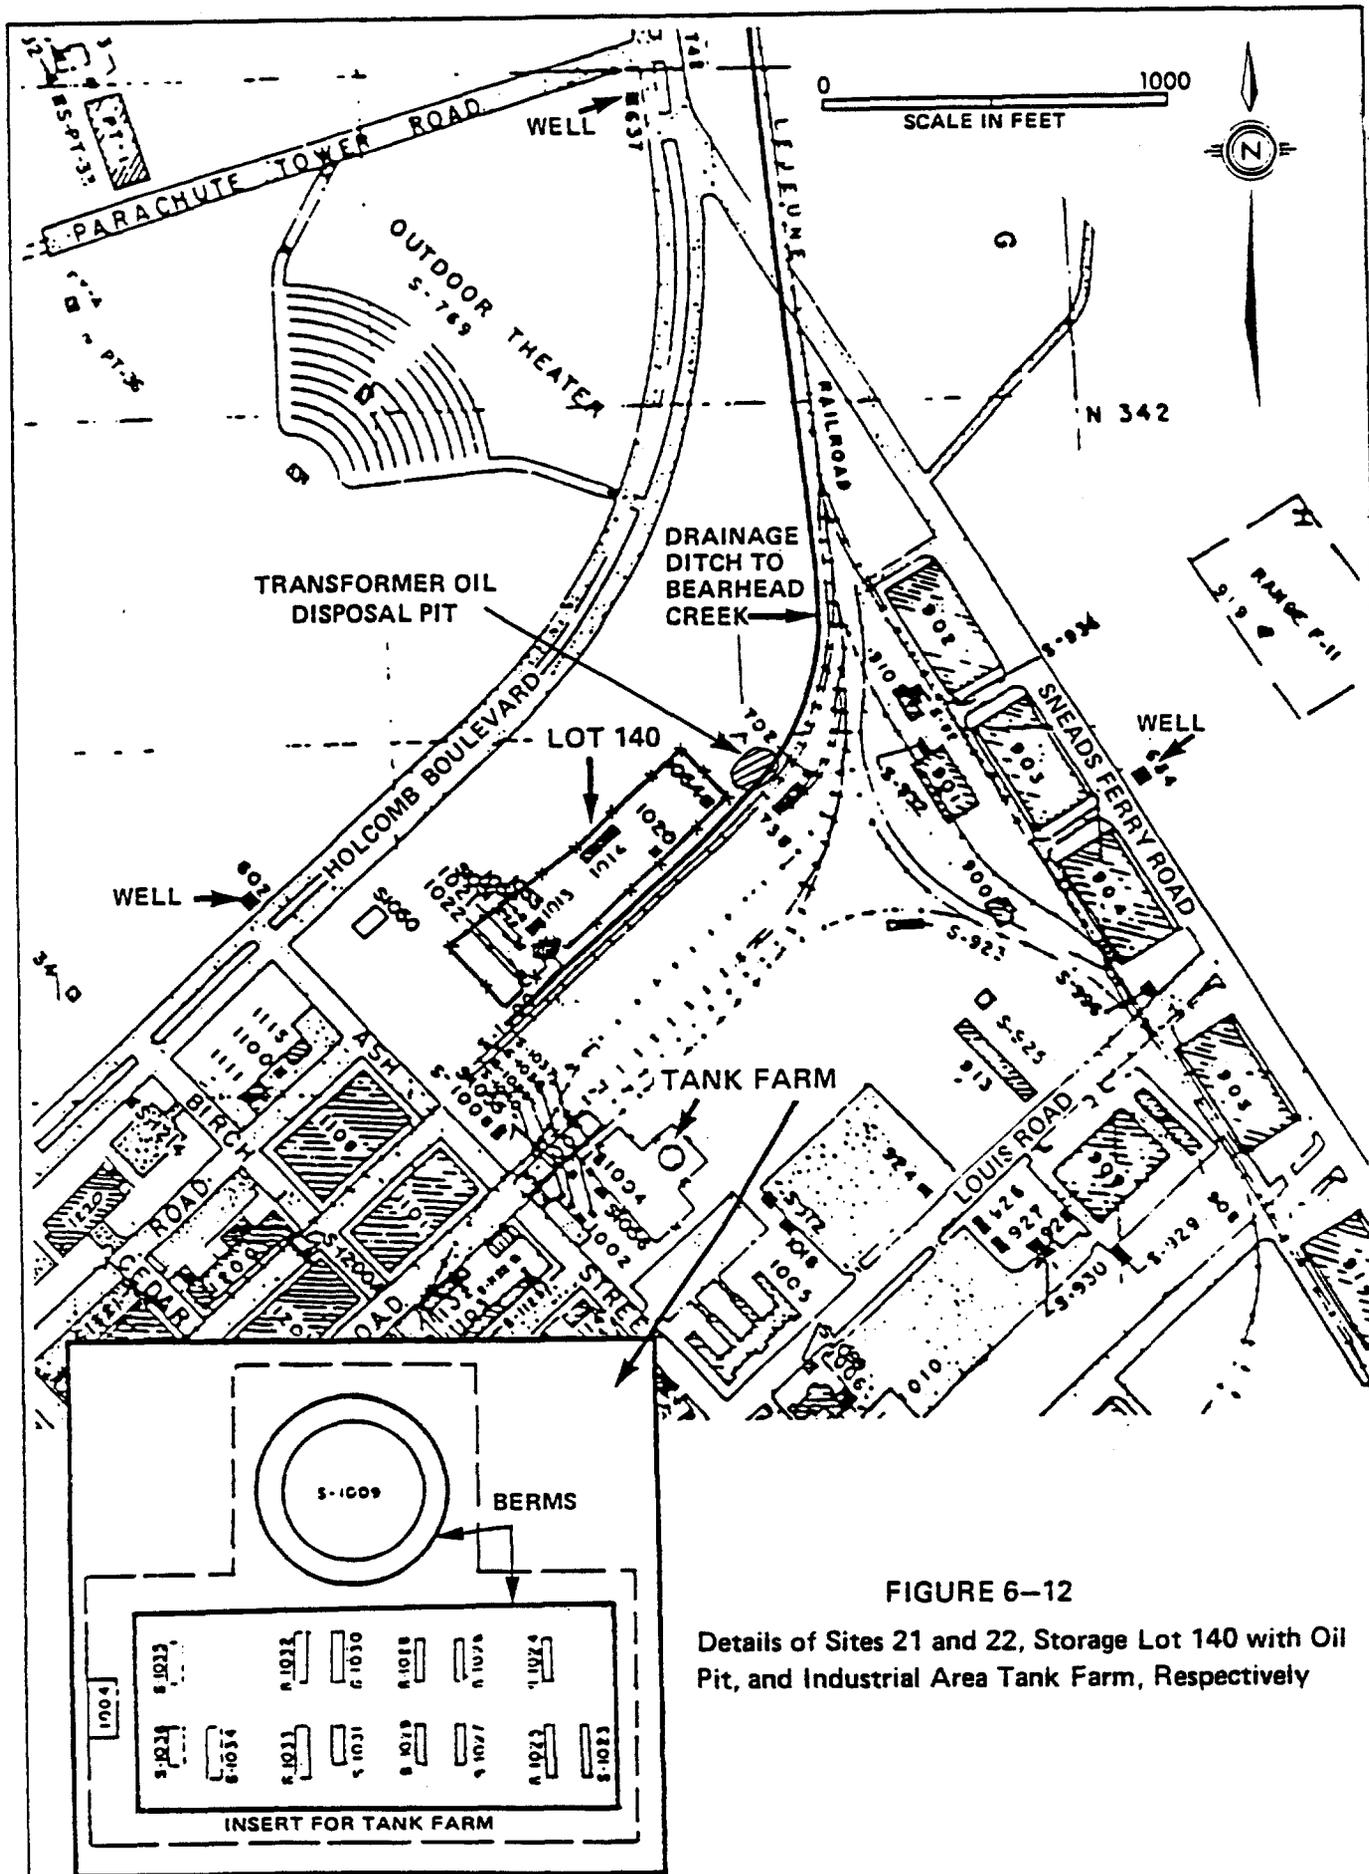
Lot 140 is bounded on its longer sides by dirt roads. An adjacent railroad drainage ditch is a possible off-site and off-base migration route for pesticide-contaminated water and sediment.

FIGURE 6-12
 Details of Sites 21 and 22, Storage Lot 140 with Oil Pit, and Industrial Area Tank Farm, Respectively

Also, surface discharge of transformer oils has been reported. In response to this, the upper 4 inches of soil at Lot 140 was sampled for PCBs in 1980. One part per million PCB or less was found in this topsoil layer.

2.4.7 Site No. 22: Industrial Area Tank Farm. The tank farm (PWDM coordinates 10, J15) is currently in operation. In 1979, a fuel leak estimated at 20,000 to 50,000 gallons occurred. The leak was in an underground line slightly behind the tank truck loading facility, between the building and the large above-ground fuel tank. The site covers about 4 acres.

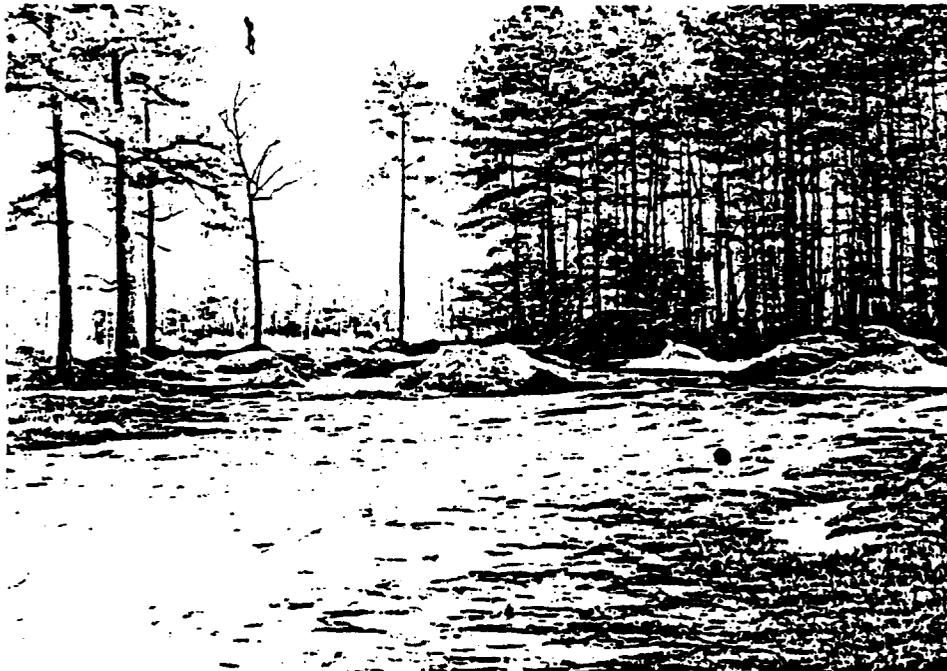
FIGURE 6-13b
Site No. 24 – Industrial Area Fly Ash Dump

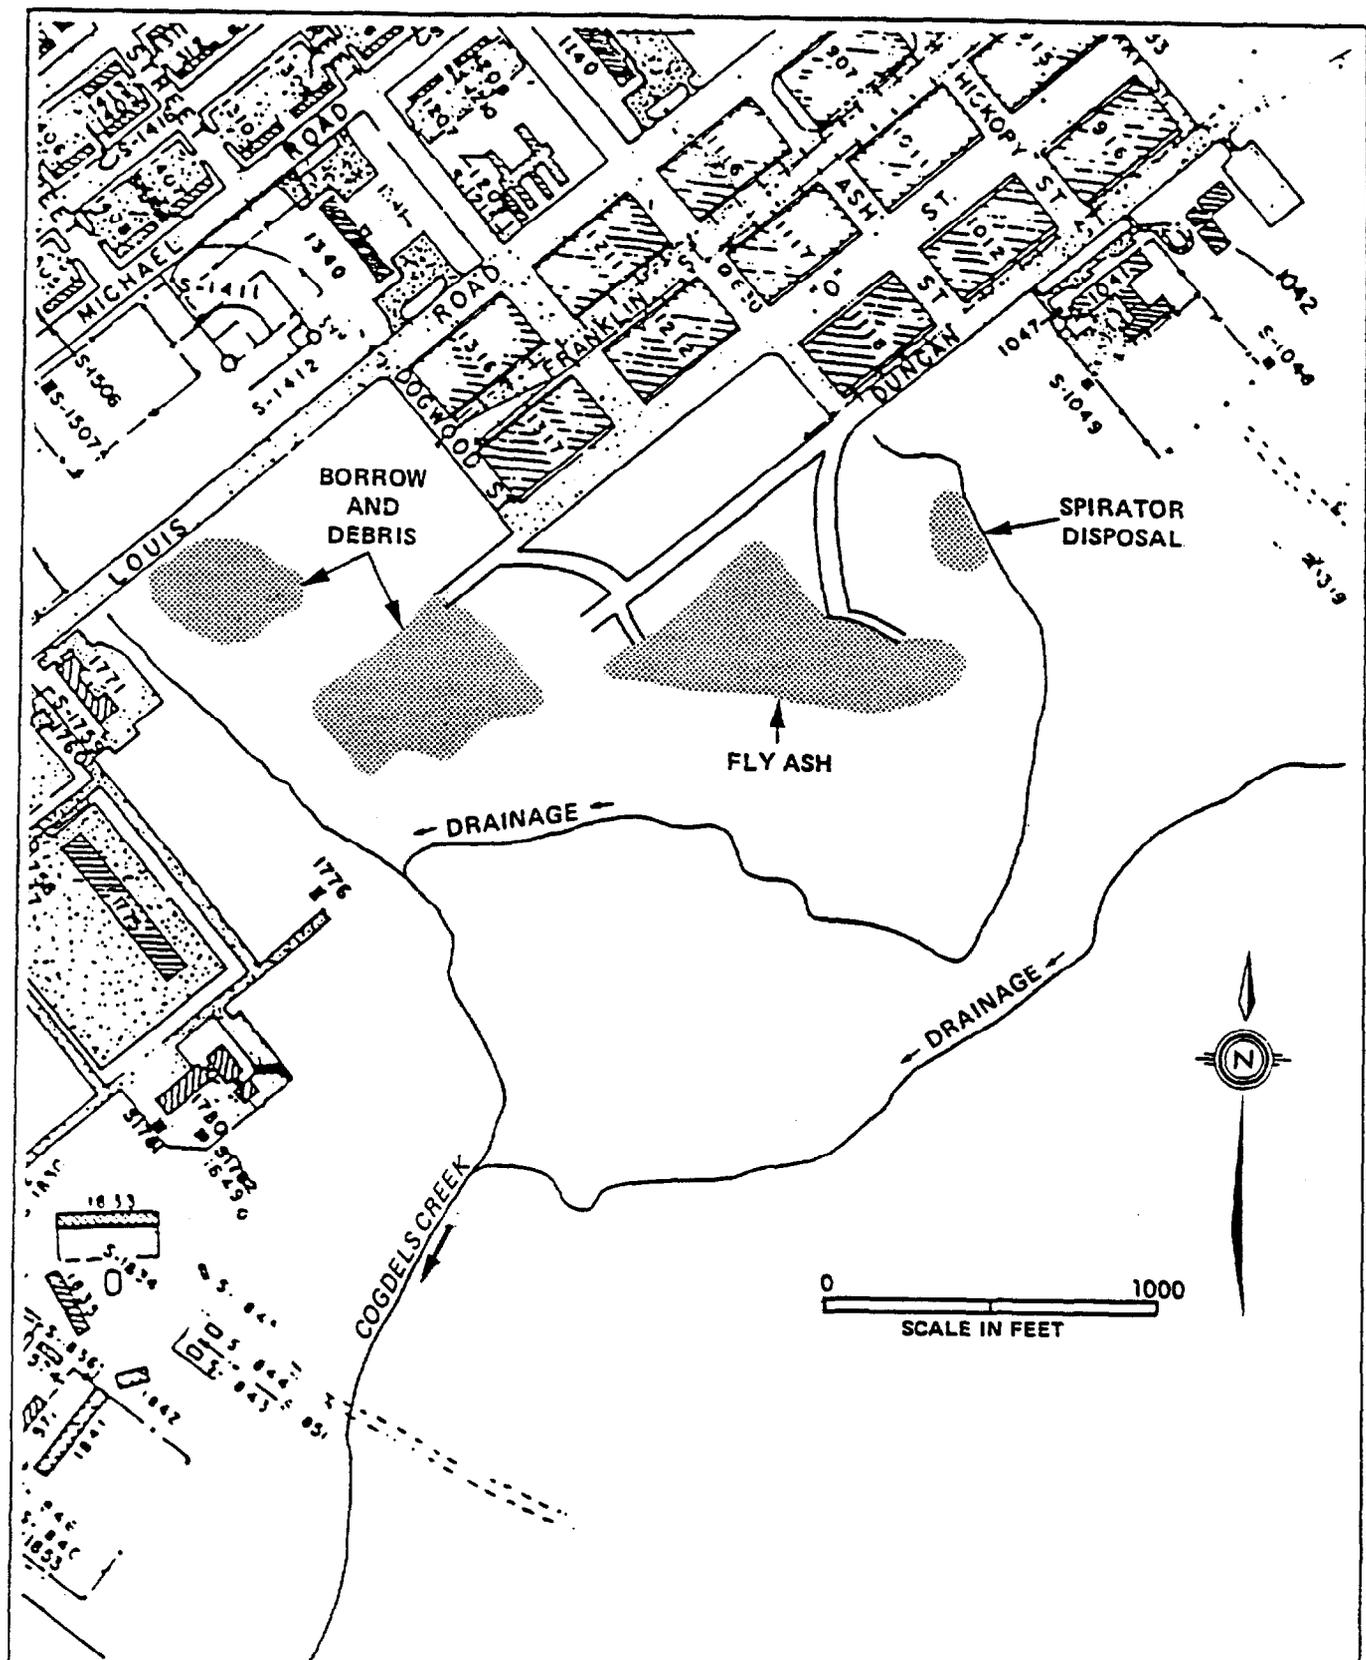
Fly ash and bottom ash contain heavy metals that may be mobilized by dissolution in rain water. No thorough mixing of the various solid wastes disposed of at this site is believed to have occurred. Insufficient data exists to try to speculate on possible chemical interactions between these various wastes or to try to define which wastes went to which of the four areas.

FIGURE 6-14
 Detail of Site No. 24, Industrial Area Fly Ash Dump

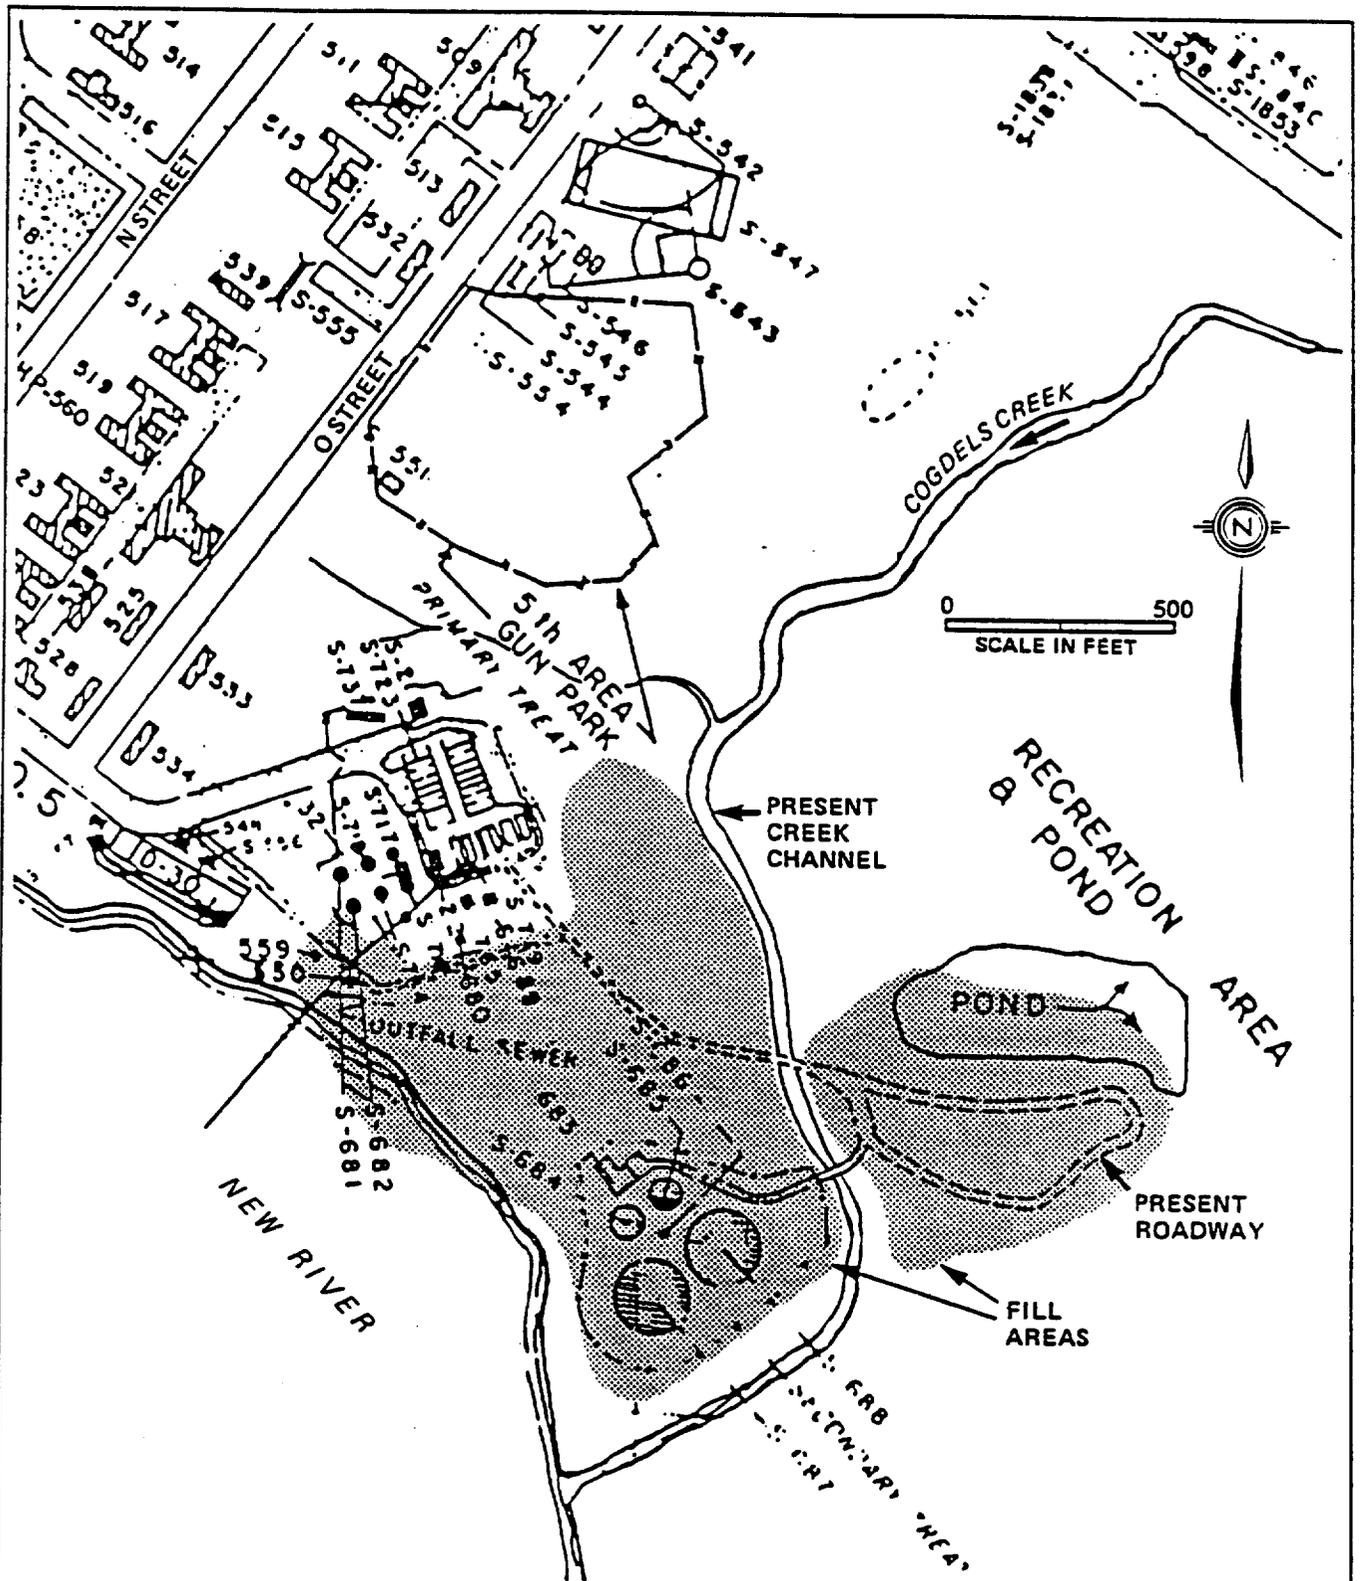
FIGURE 6-15
 Detail of Site No. 28, Hadnot Point Burn Dump

2.4.9 Site No. 28: Hadnot Point Burn Dump. This disposal site (PWDM coordinates 10, Q13-14) was used for industrial area waste from 1946 to 1971. A variety of industrial waste (estimated between 185,000 to 370,000 cubic yards) was burned and covered. The area has been graded, seeded with grass, and now supports a good ground cover. Its proximity to Cogdels Creek and the New River poses health and environmental risks. Leachate and seepage to Cogdels Creek have been observed.

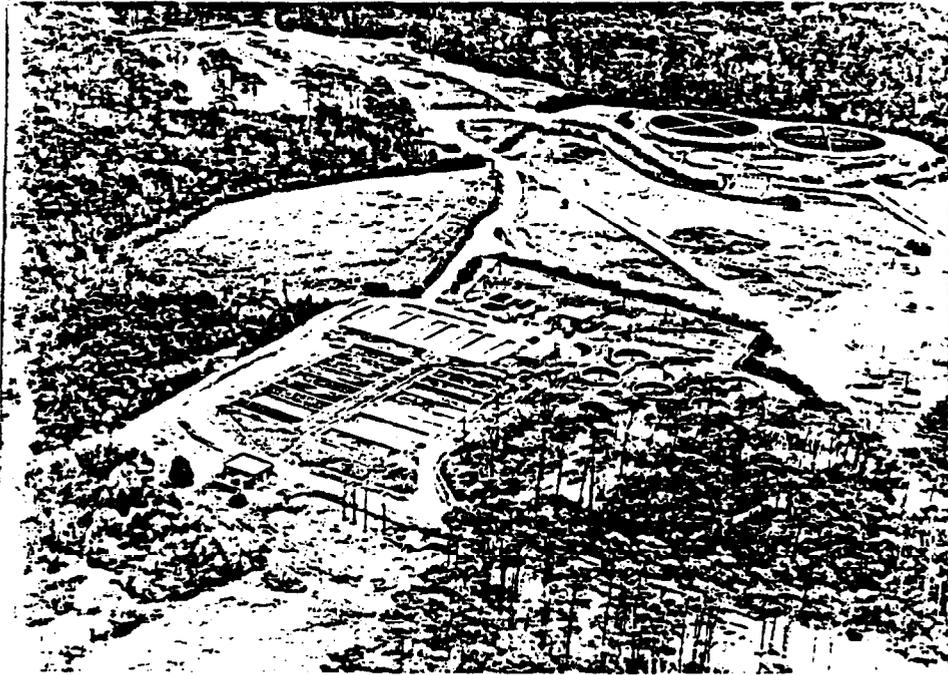
FIGURE 6-16a
Site No. 28 – Hadnot Point Burn Dump
