INITIAL ASSESSMENT STUDY OF
MARINE CORPS BASE CAMP LEJEUNE
NORTH CAROLINA

NEESA 13-011

INITIAL ASSESSMENT STUDY
OF MARINE CORPS BASE CAMP LEJEUNE, NORTH CAROLINA
UIC-M67001

Prepared by:
WATER AND AIR RESEARCH, INC.
Gainesville, Florida

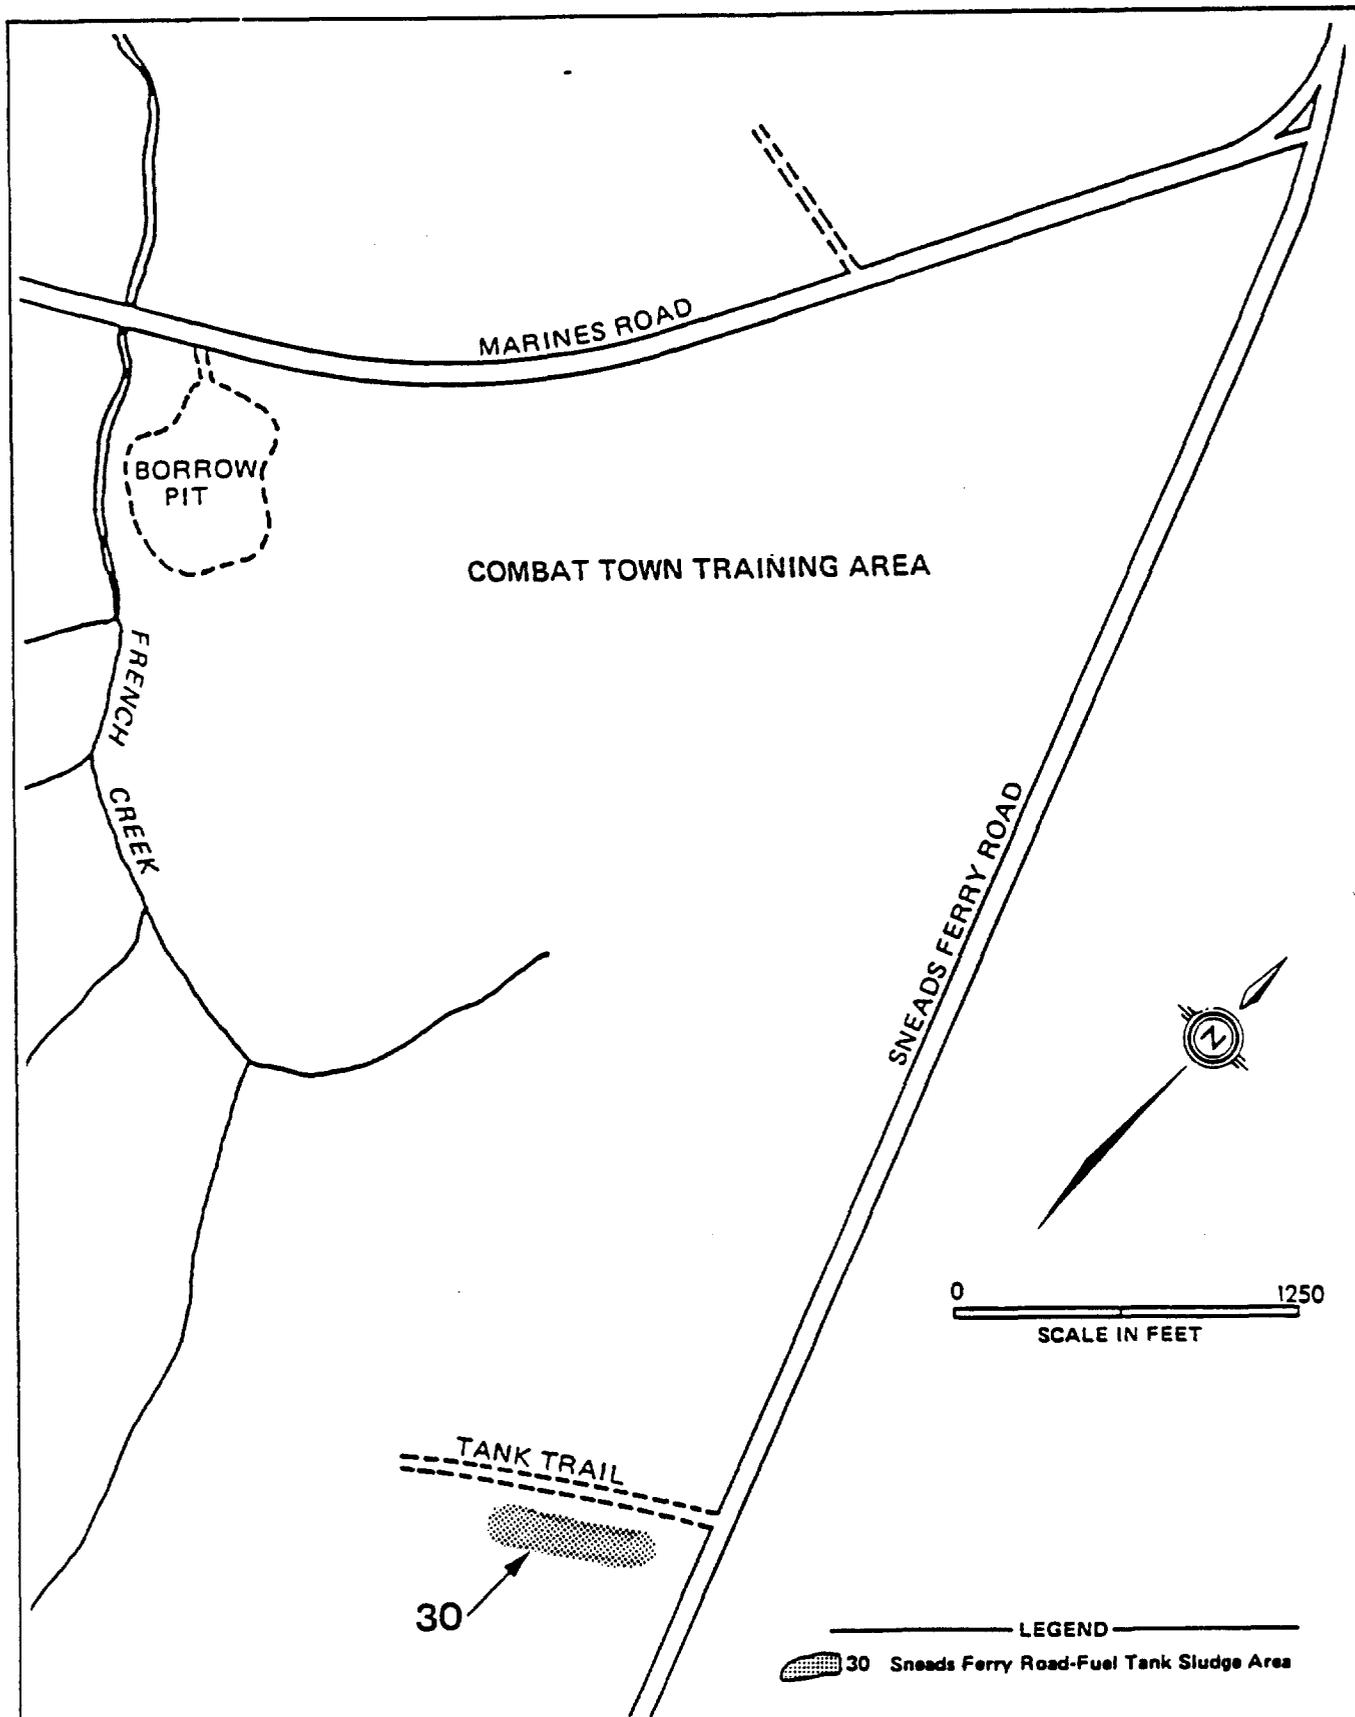
Comments: Soils conducive to migration. The hydraulic gradient in the water table aquifer is toward French Creek. A private contractor disposed of the sludge along the tank trail as an expedient measure. Trail alignment is parallel to groundwater gradient.

As yet no records (including contract documents) have been found to indicate amount of sludge disposed of at this site. Two 12,000-gallon tanks were involved. Tanks were pumped out while changing the type of fuel stored. Based on knowledge of tank capacity below tank outflow ports, about 600 gallons of sludge or tank bottoms were dumped. Additional washout water may have been present. There is additional information to suggest that the site has been used for similar wastes from other tanks. Therefore the 600 gallon amount must be considered a minimum. Composition of sludge and/or washout is unknown and may vary from containing substantial amounts of tetraethyl lead to containing mostly cleaning compounds.

FIGURE 6-17
Location of Site No. 30 at Combat Town Training Area

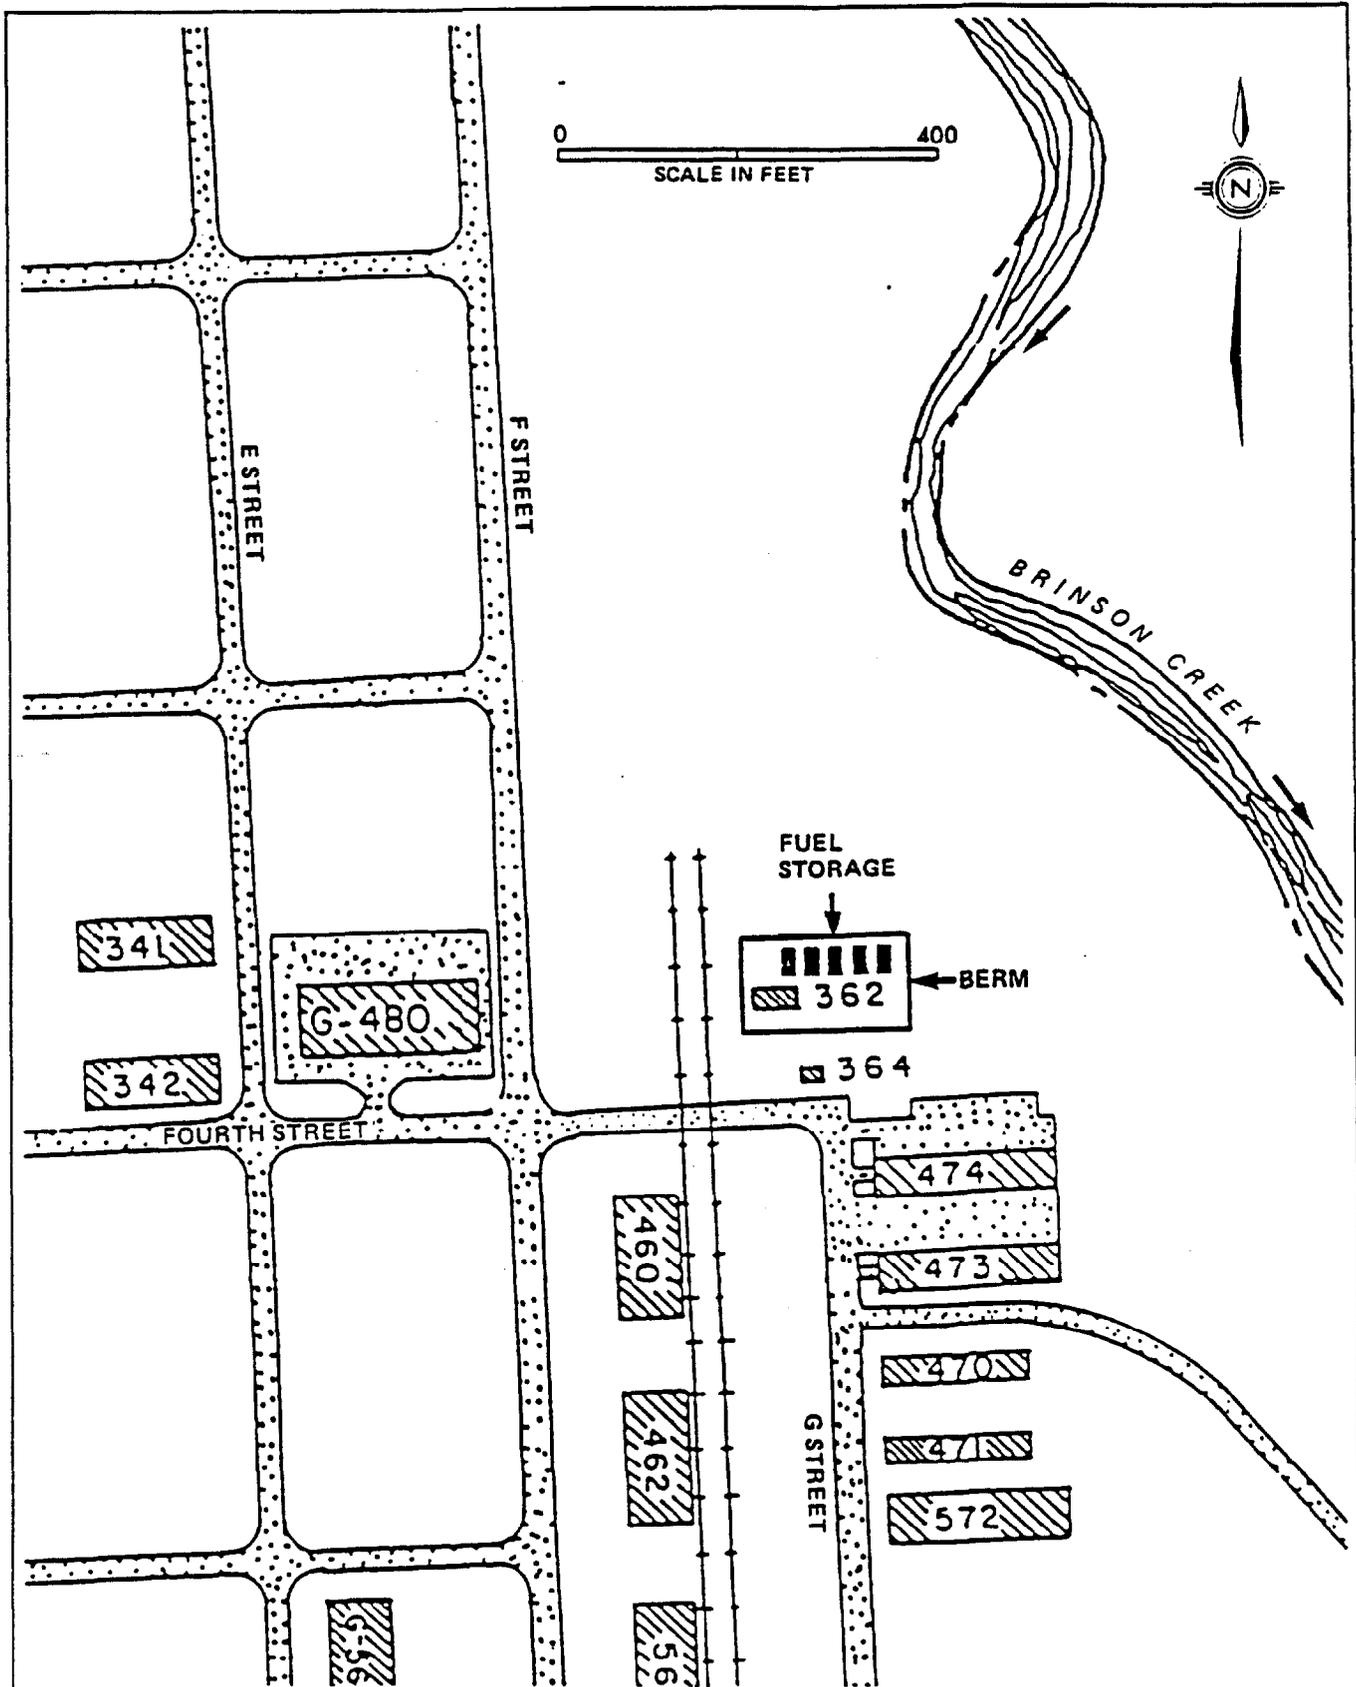
FIGURE 6-18
 Detail of Site No. 35, Camp Geiger Area Fuel Farm

2.4.11 Site No. 35: Camp Geiger Area Fuel Farm. The site is at PWDM coordinates 12, C11. A leak in an underground fuel line occurred in the late 1950s (probably 1958) near the pad supporting the overhead tanks. Amount of fuel is estimated to be in the thousands of gallons and the fuel moved east toward Brinson Creek. Holes were dug to the water table. Where fuel was floating on the groundwater surface, it was ignited and burned. Fuel contaminating Brinson Creek also was ignited and burned. Distance from the fuel farm to Brinson Creek is approximately 400 feet.

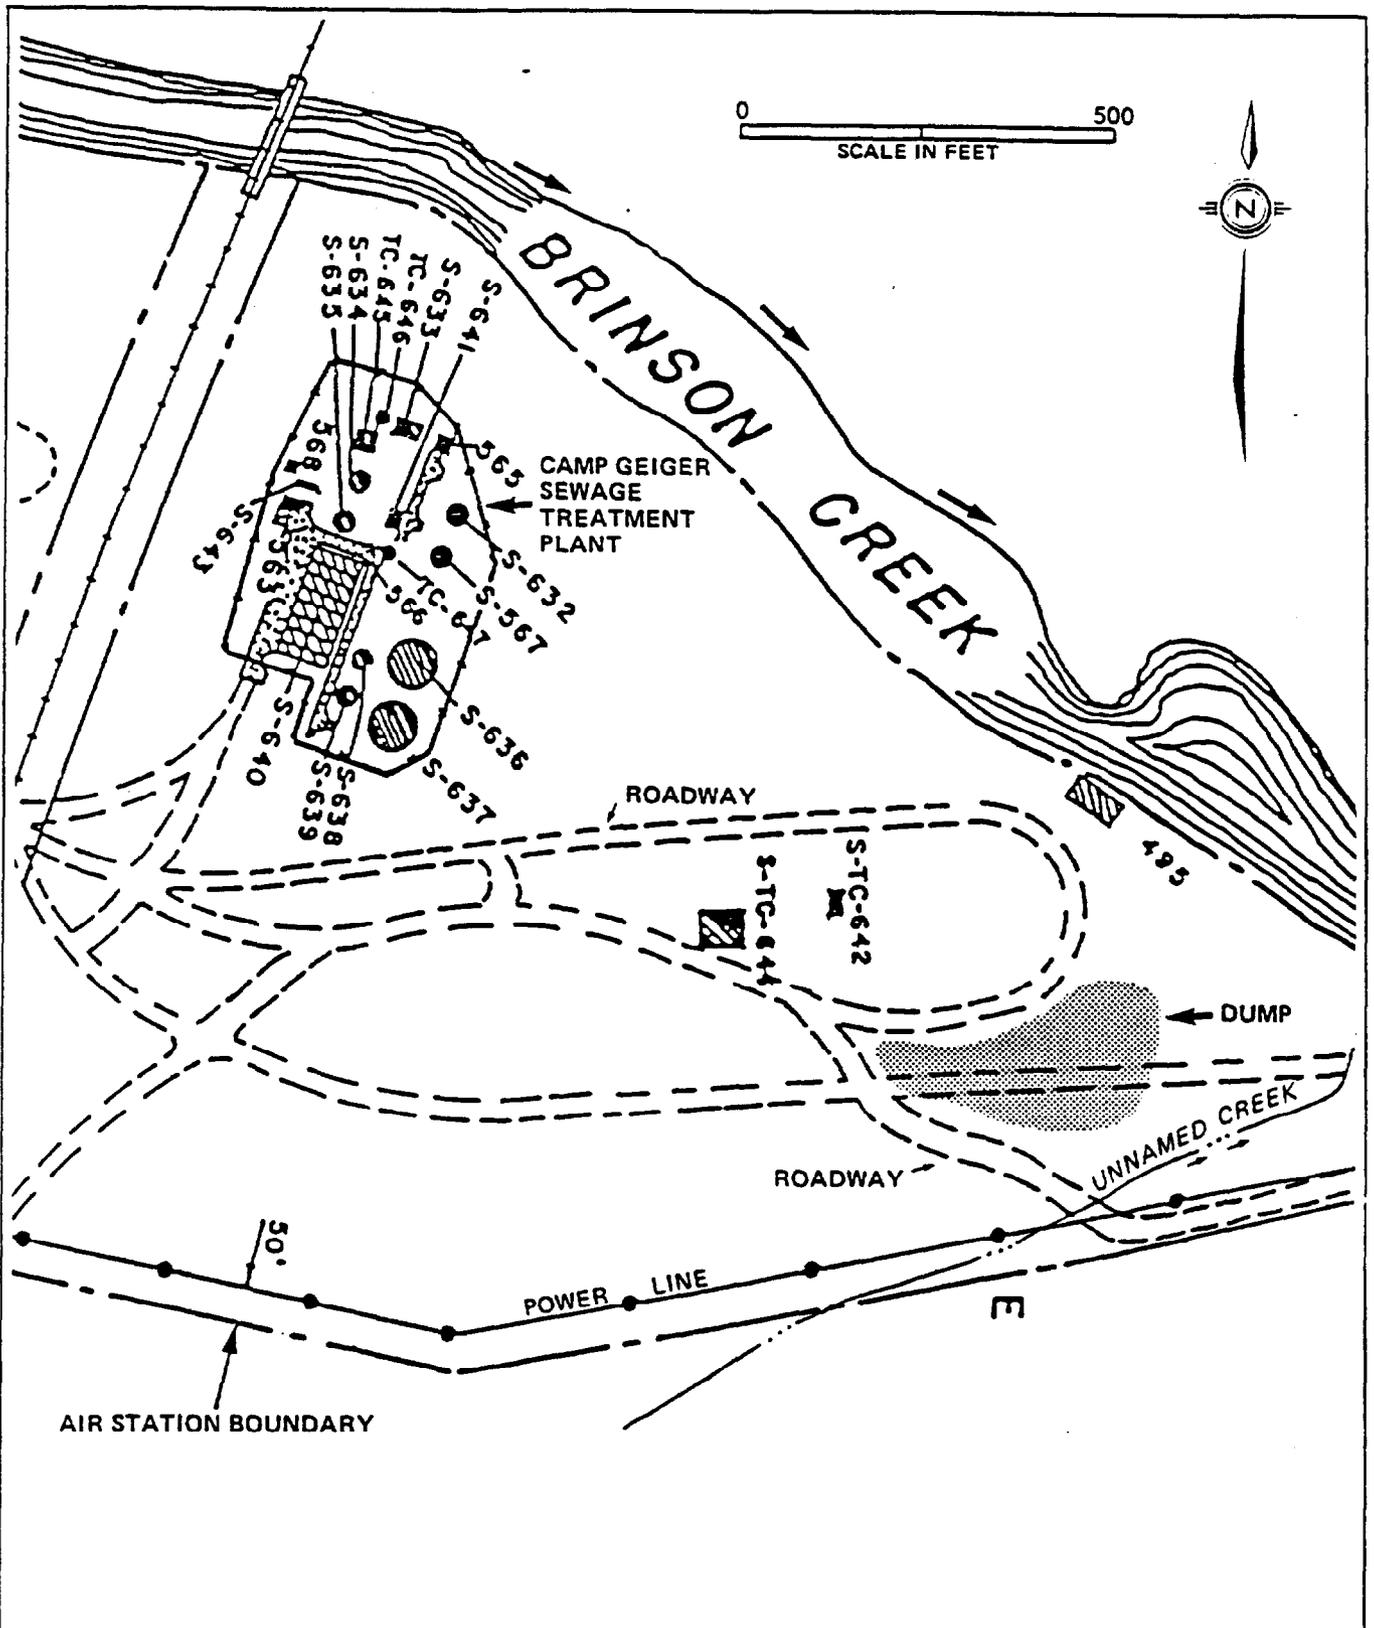
FIGURE 6-20
Detail of Site No. 36, Camp Geiger Area Dump (near STP)

2.4.12 Site No. 36: Camp Geiger Area Dump Near Sewage Treatment Plant. The site (PWDM coordinates 12, D13/E13) received mixed industrial and municipal wastes from 1950 and 1959. These were burned and later covered; however, some materials may have been deposited on the ground surface and covered unburned. The site is about 200 feet from Brinson Creek and a small roadside drainage ditch, located on the opposite side of the landfill, is less than 100 feet away. The site covers 25,000 square feet and rises 10 to 12 feet above grade. Estimated volume is 14,000 cubic yards. Wastes of concern are hydrocarbons (solvents, waste oils, and hydraulic fluids) that were generated at Camp Geiger or

MCAS New River. As many as 10,000 to 15,000 gallons may have been disposed of over 9 years. Most were probably burned.

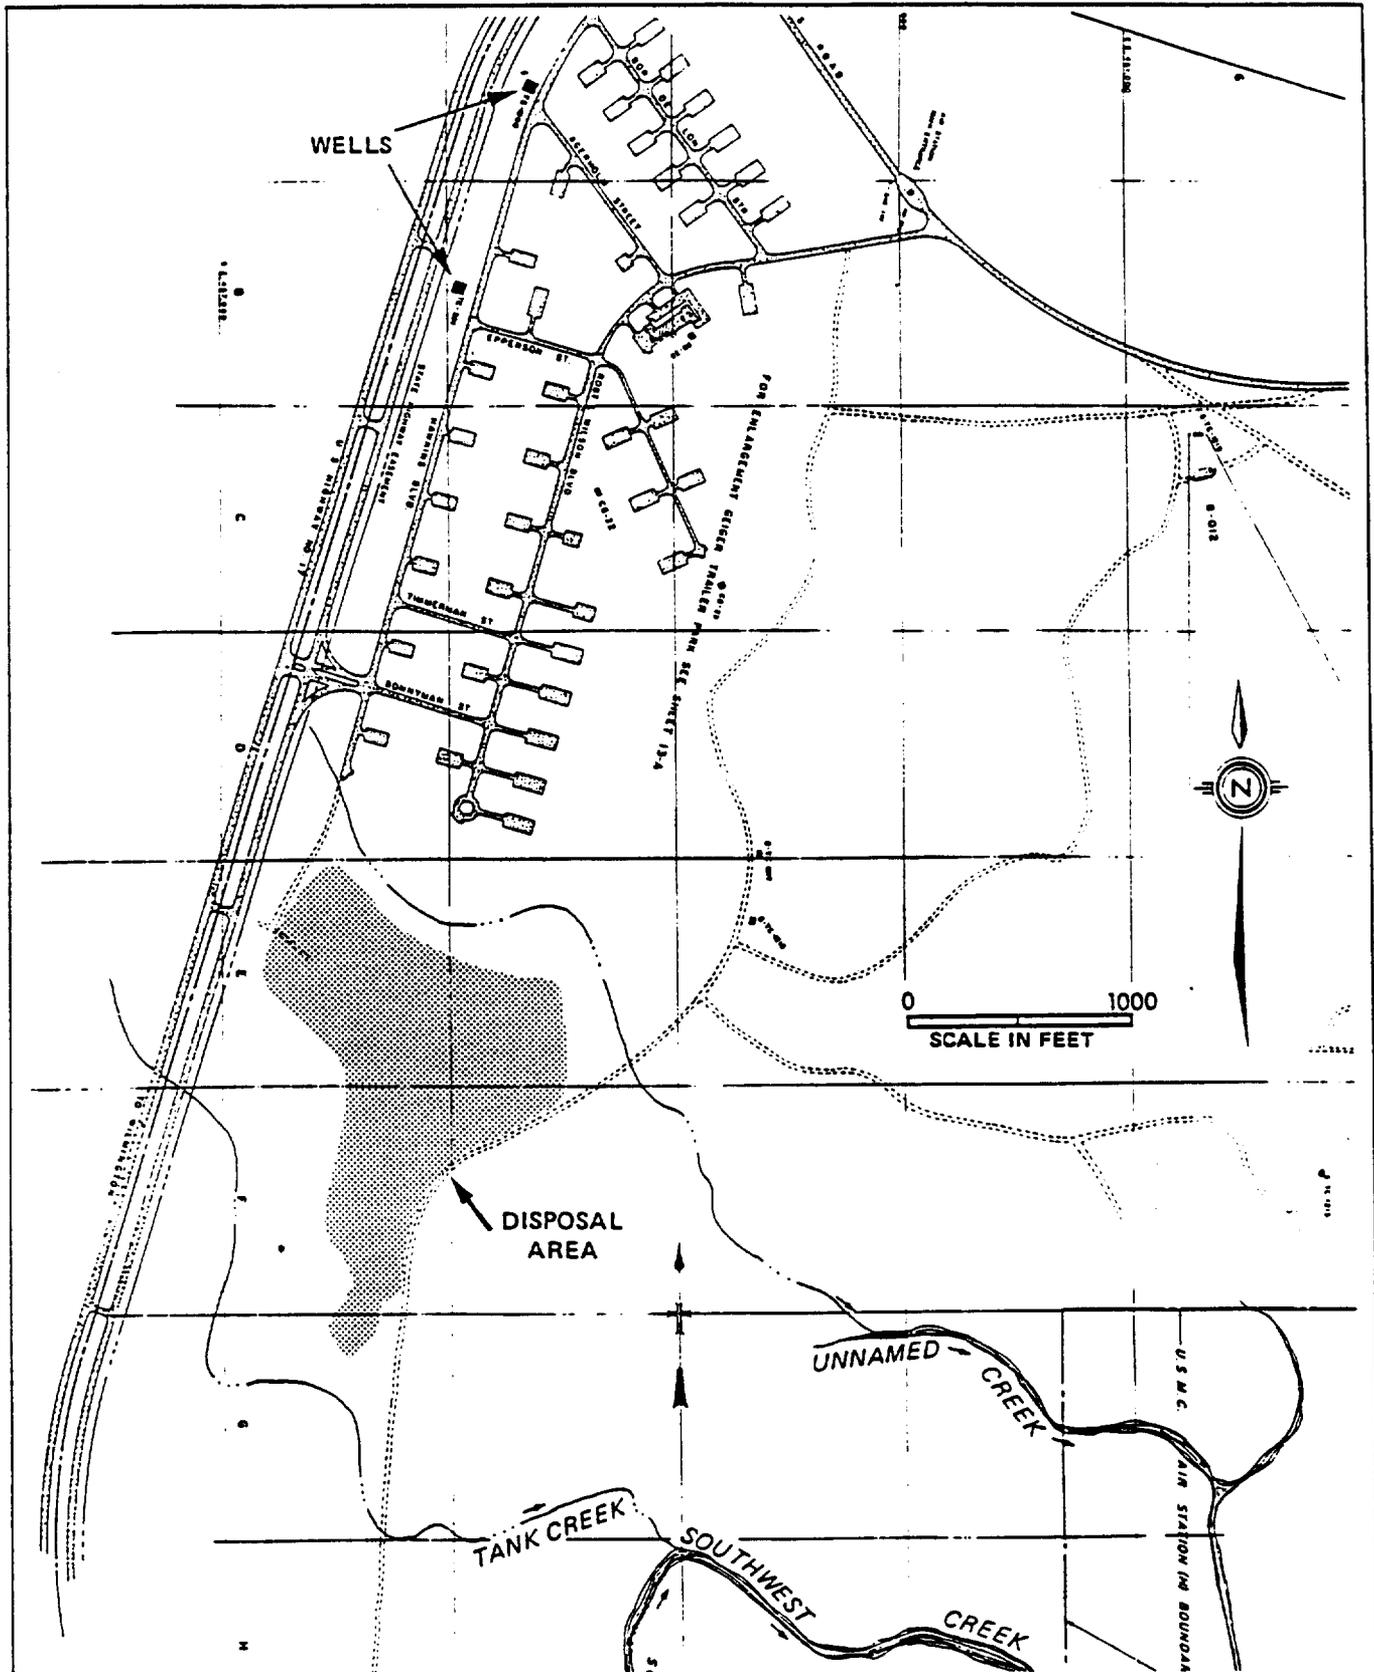
In the mid-1960s over a 1- to 2-year period, at least two waste disposal incidents occurred, during which two truckloads of drummed wastes were unloaded. At such times, a fire truck was present. These wastes were described as being similar to those disposed of at the Rifle Range Chemical Landfill (see Site No. 69). No better information regarding drum contents was obtained.

FIGURE 6-21
 Detail of Site No. 41, Camp Geiger Dump
 (near former trailer park)

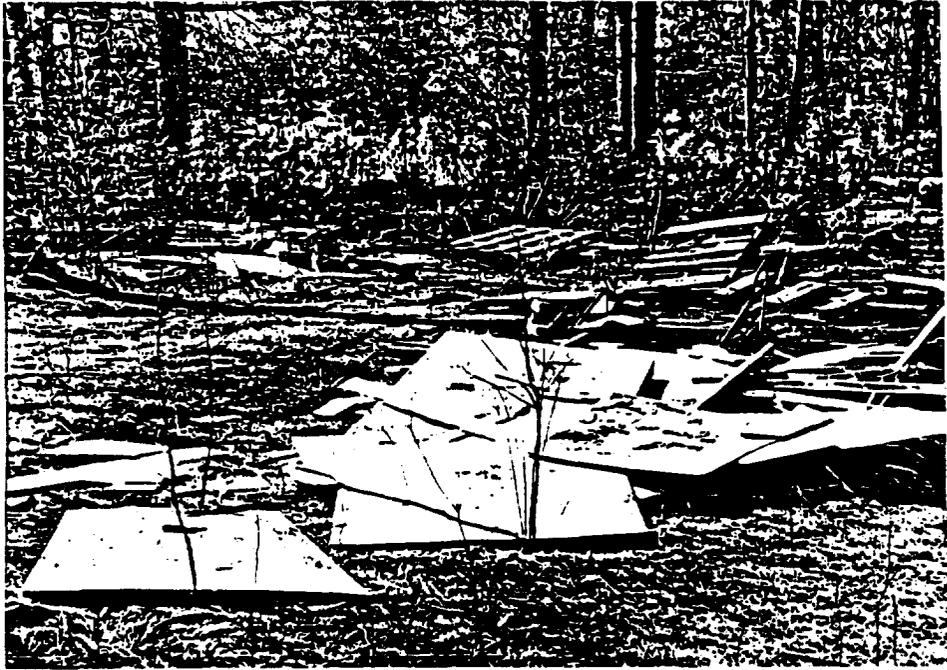
FIGURE 6-23a
Site No. 41 – Camp Geiger Dump Near the Trailer Park

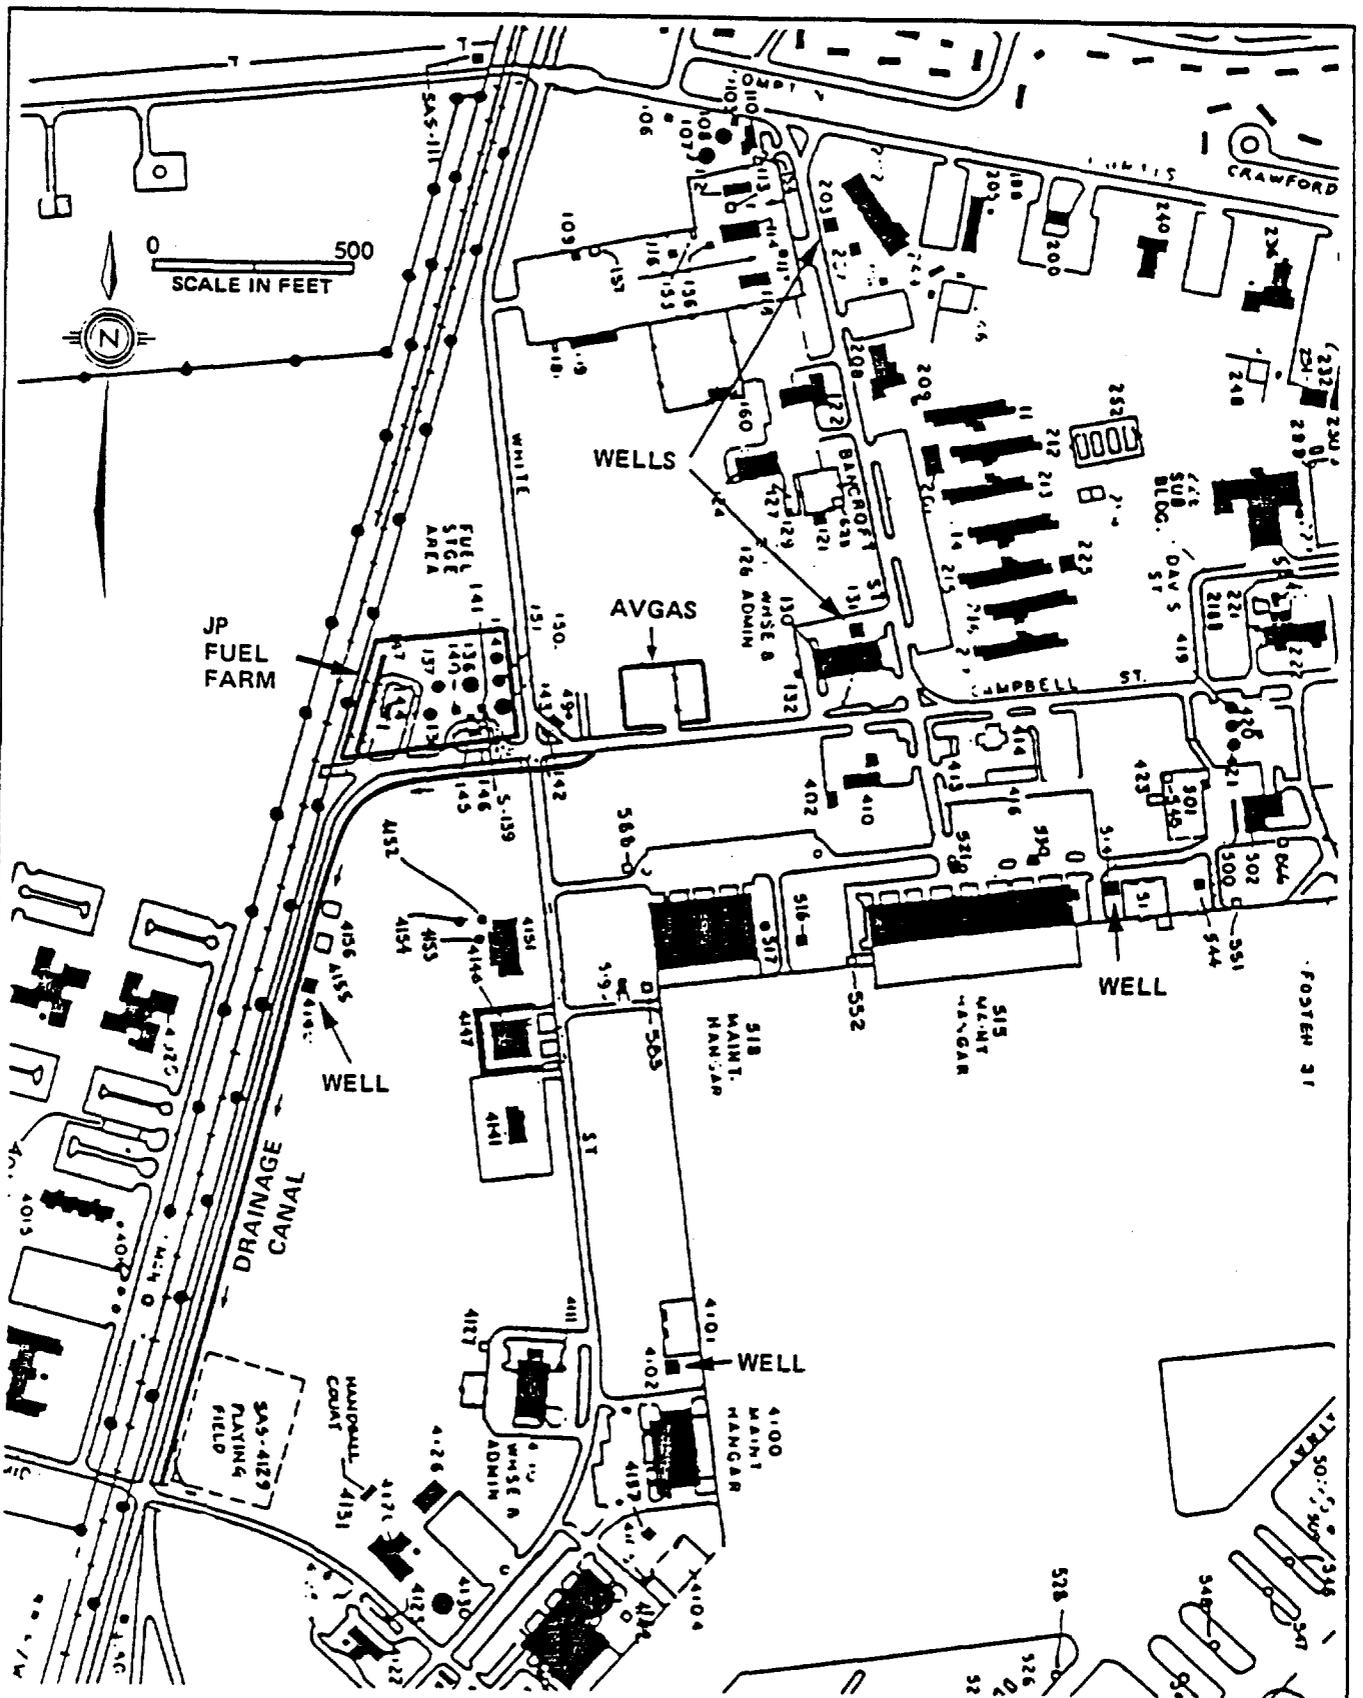
Comments: These two storage areas are close together and are considered as one site. Most recent leaks were JP-4 and JP-5 from underground pipes. These pipes have been replaced by an above-ground system in which leaks can be readily detected. An oil-water separator has been installed on the south boundary of the fuel farm, which now shows a substantial amount of oil. Drainage ditch and canal parallel Campbell Street, then flow southward.

FIGURE 6-24
 Detail of Site No. 45, Campbell Street Underground Avgas Storage and Adjacent JP Fuel Farm

2.4.14 Site No. 45: Campbell Street Underground Avgas Storage and Adjacent JP Fuel Farm. This site is at PWDM coordinates 23, O13-14/P13-14. The two facilities are on each side of White Street and on the north side of Campbell Street. In 1978, 200 to 300 gallons of Avgas were spilled or leaked from this facility. It is estimated that during 1981-1982 more than 100,000 gallons of fuel leaked into the surrounding soil due to corrosion of underground lines at the JP Fuel Farm. These lines have been replaced with an aboveground system. Although the volume of Avgas loss is low, the estimate may be conservative.

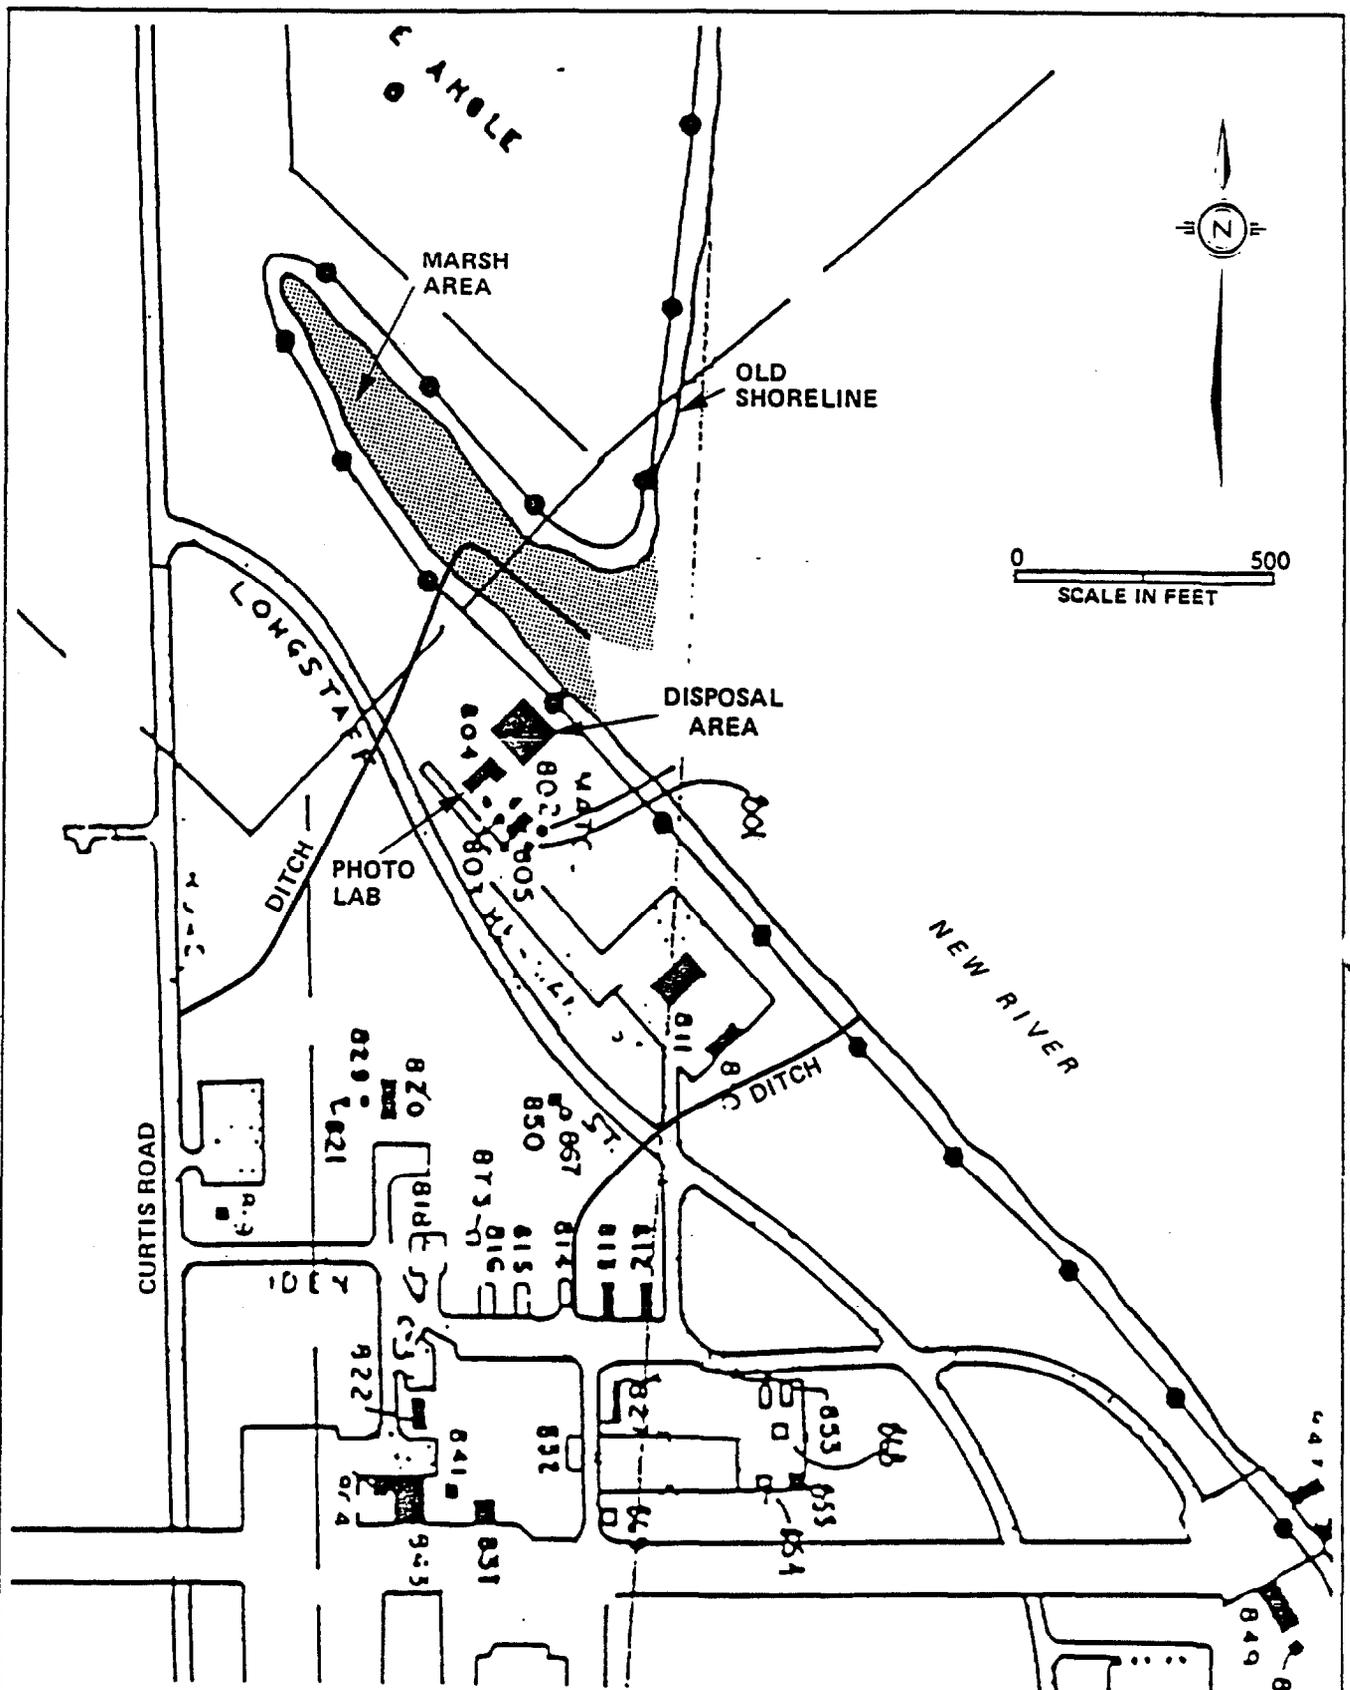
Comments: Best information indicates that material was carried by hand, probably to area between building and river, and dumped or buried in small quantities at randomly selected spots. The solubility of metallic mercury is about 25 ppb, at 25°C, although this may increase due to chloride or hydride complex formation under the proper environmental conditions. The biological transformations of mercury in the aquatic environment (water and sediment) are complex and can enhance bioaccumulation in the food chain. The EPA drinking water standard for mercury is 2 ppb. One thousand pounds (454 kg) of mercury could contaminate about 184,000 acre-feet ($227 \times 10^6 \text{ m}^3$) of water to this level.

FIGURE 6-26
Detail of Site No. 48, MCAS New River Mercury Dump Site

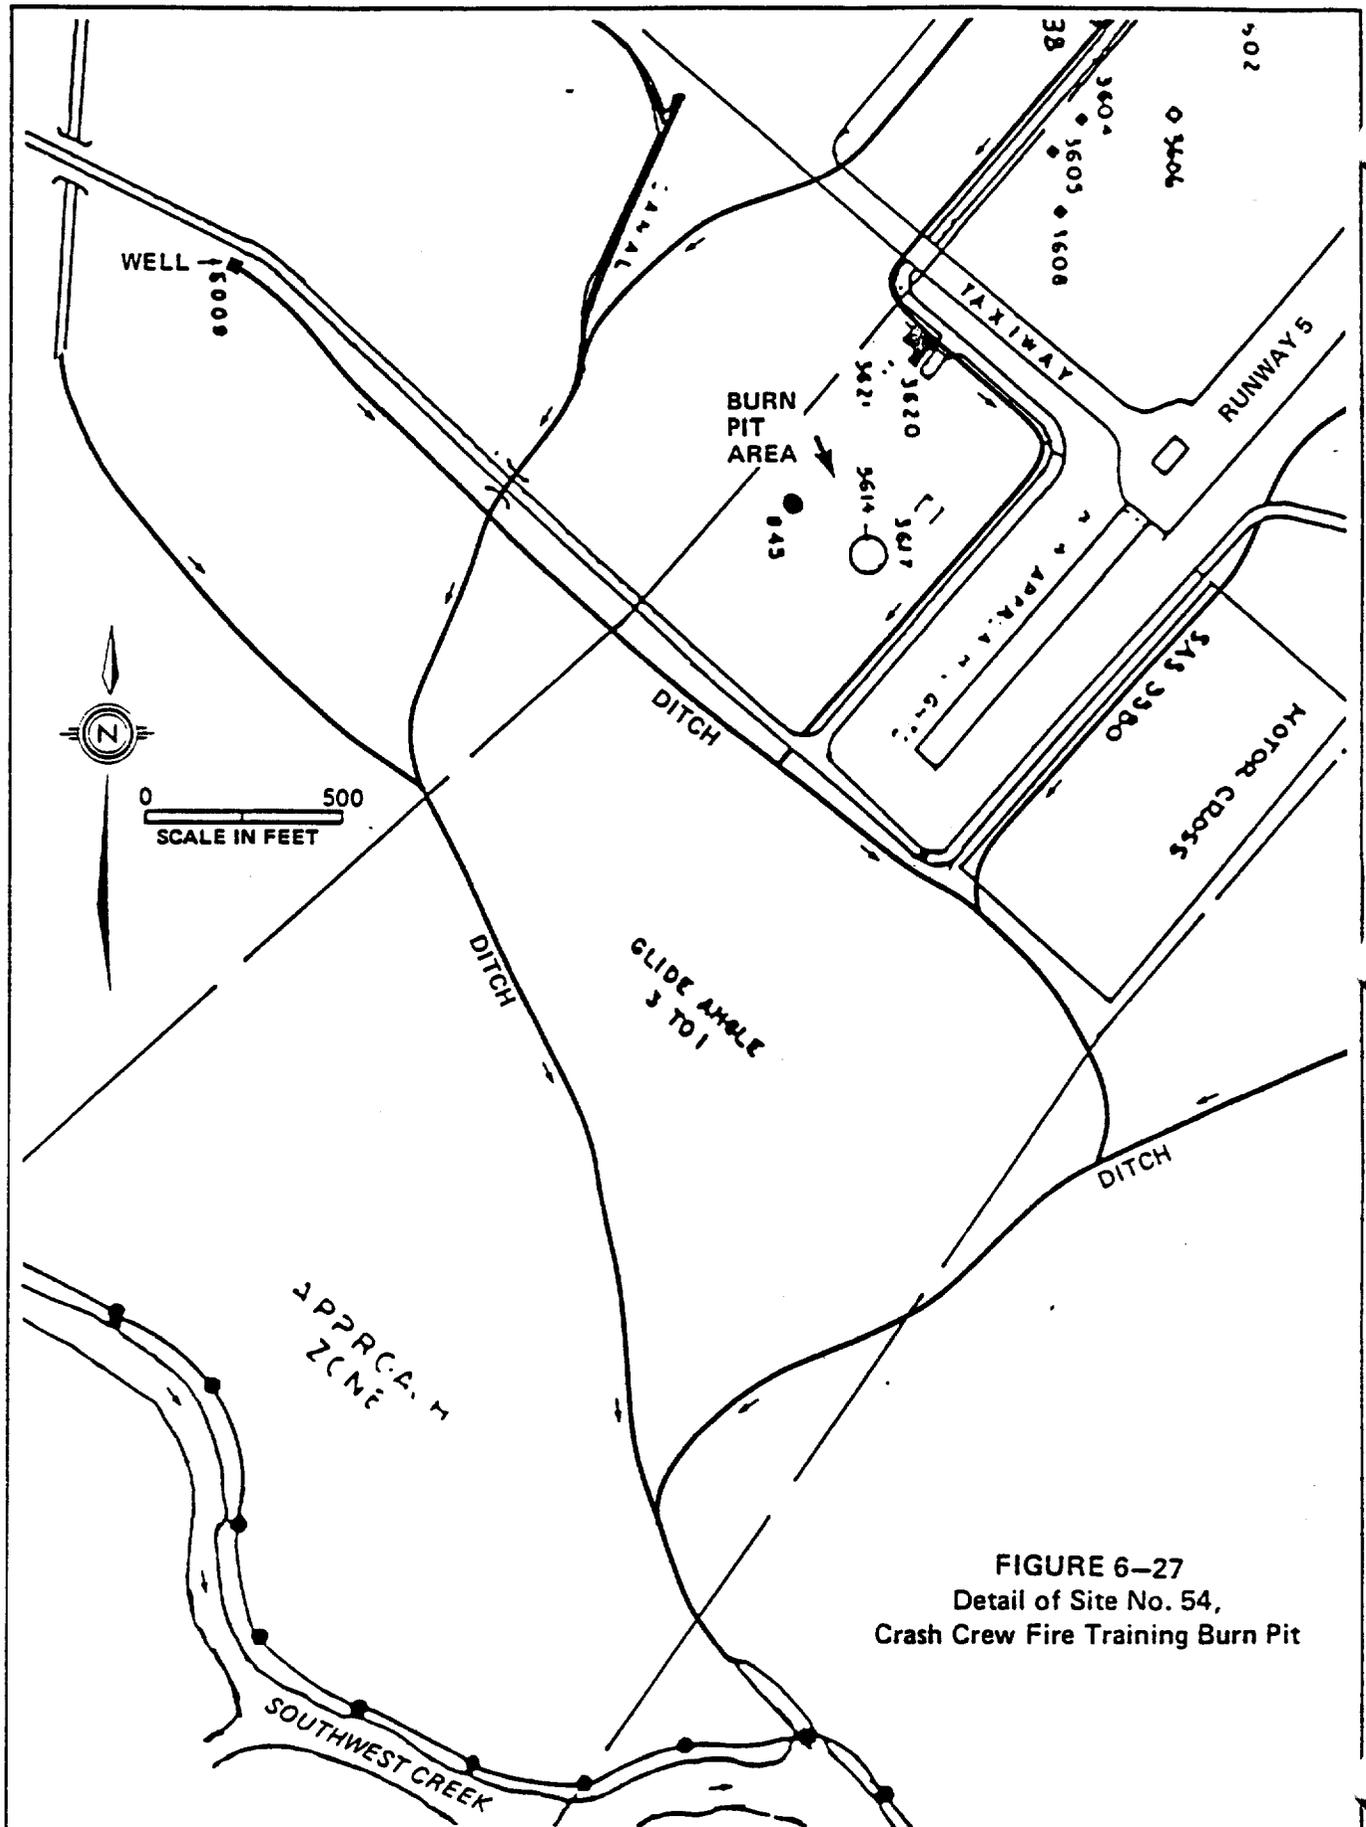
FIGURE 6-27
 Detail of Site No. 54,
 Crash Crew Fire Training Burn Pit

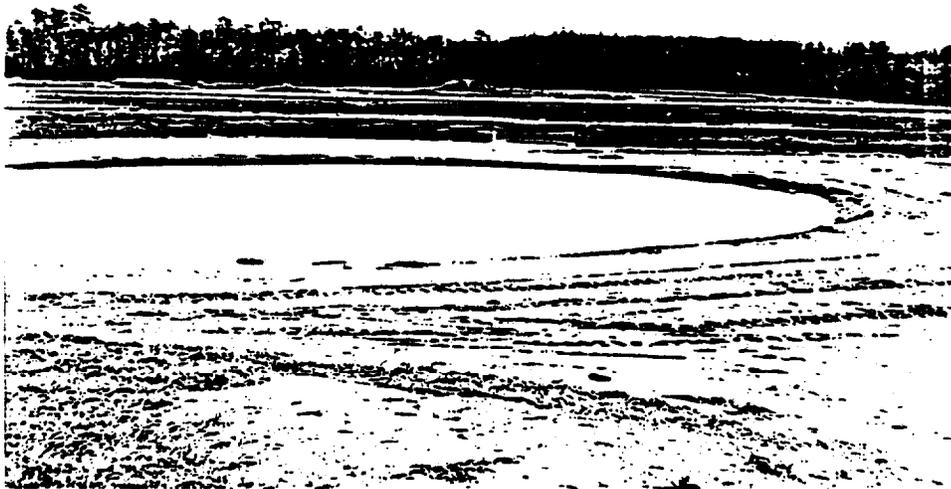
FIGURE 6-28
Site No. 54 – Crash Crew Fire Training Burn Pit

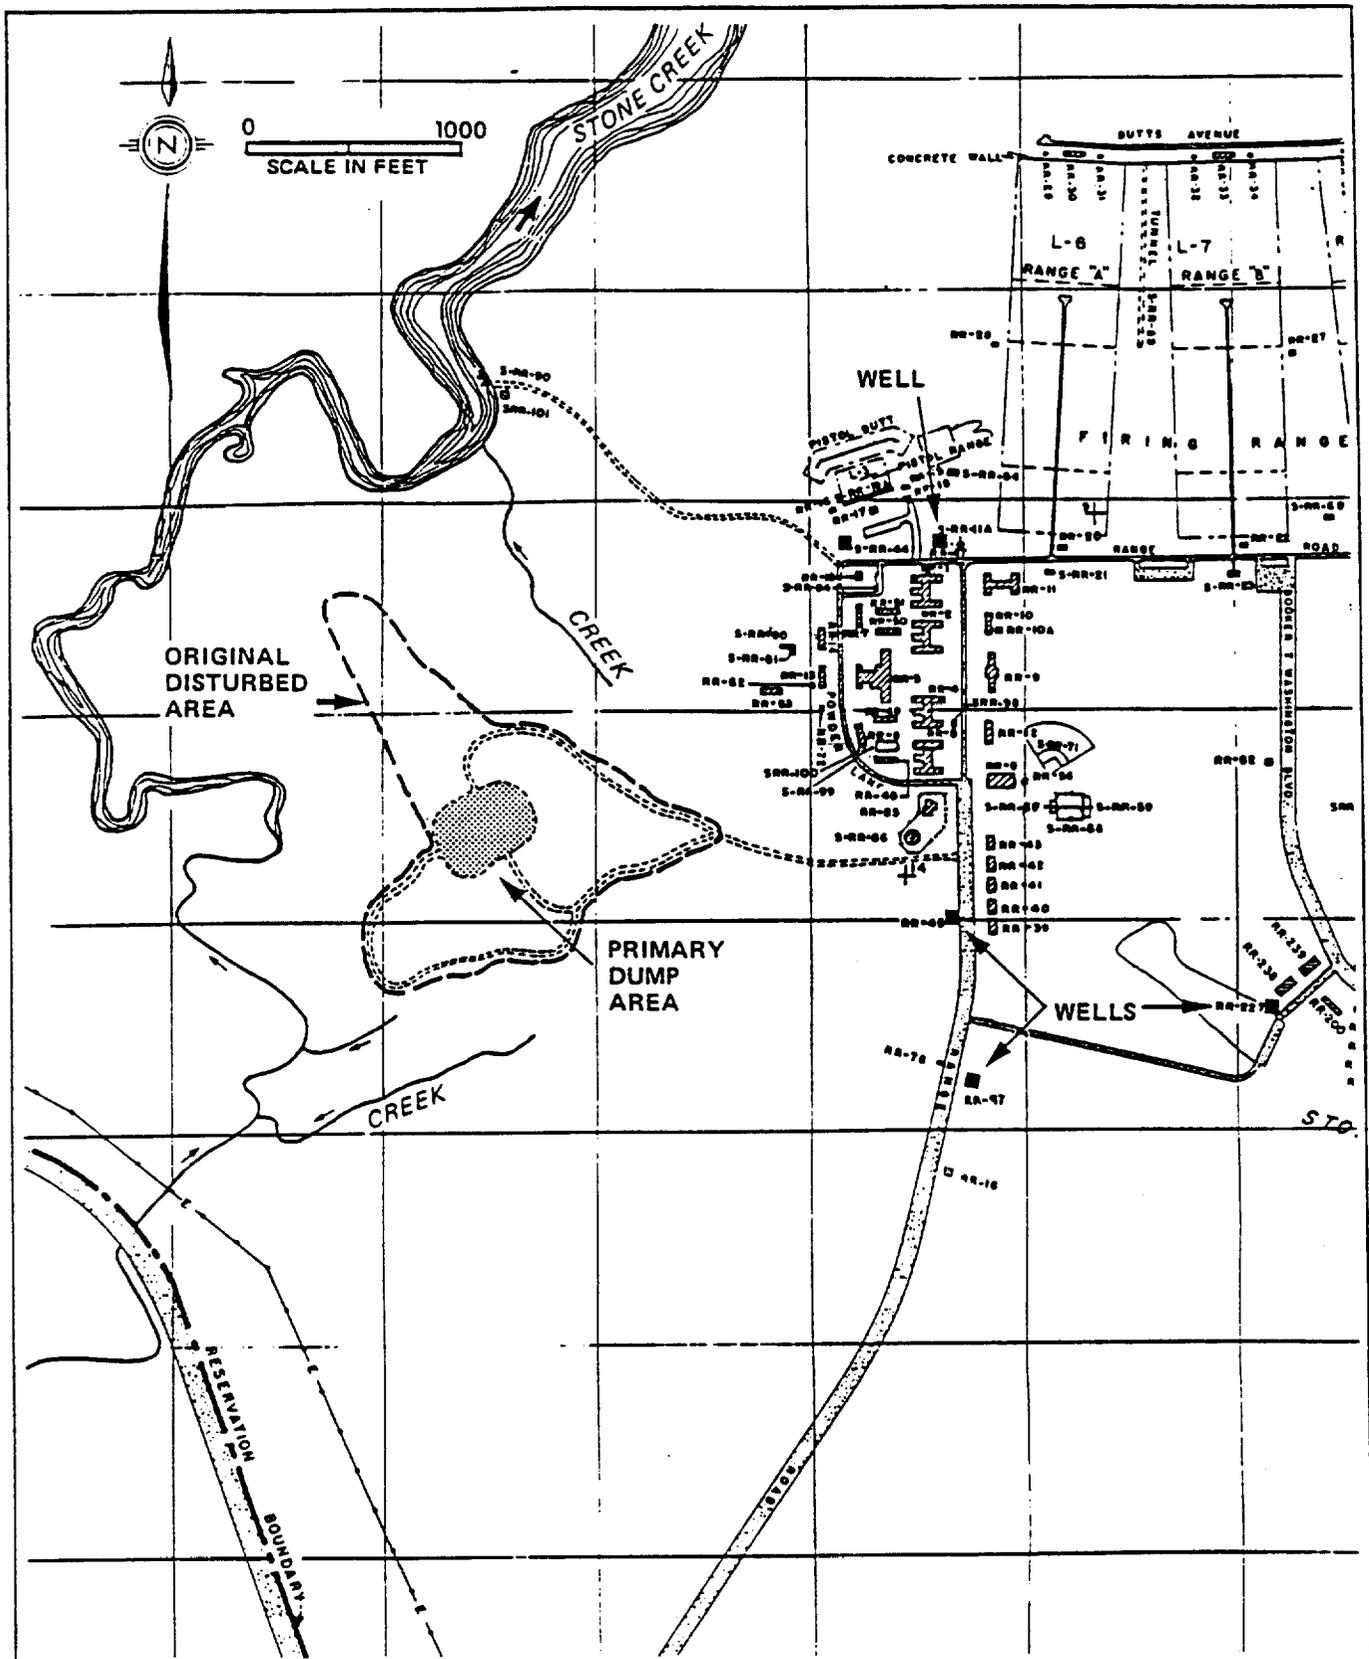
The report of solvent waste being disposed at the Rifle Range Dump has not been substantiated by follow-up interviews. Although the number of personnel qualifying with weapons at the rifle range apparently has decreased to 20,000 to 30,000 per year (range use has been higher during war years), weapon cleaning practices are probably unchanged for at least the last 20 years. Typically, weapon cleaning occurs at the "parent organization" and does not occur in the rifle range area except for the relatively small number of people working there. Dry cleaning solvent waste used for weapon cleaning does not exceed 20 to 30 gallons per year. Some discrepancy exists as to whether or not "bore cleaner" is presently used, but if it is, quantities used are expected to be similar to the amounts of dry cleaning solvents. No other unusual or specialized activity that uses solvents has been identified in this area.

FIGURE 6-29
Detail of Site No. 68, Rifle Range Dump
