INITIAL ASSESSMENT STUDY OF
MARINE CORPS BASE CAMP LEJEUNE
NORTH CAROLINA

NEESA 13-011

INITIAL ASSESSMENT STUDY
OF MARINE CORPS BASE CAMP LEJEUNE, NORTH CAROLINA
UIC-M67001

Prepared by:
WATER AND AIR RESEARCH, INC.
Gainesville, Florida

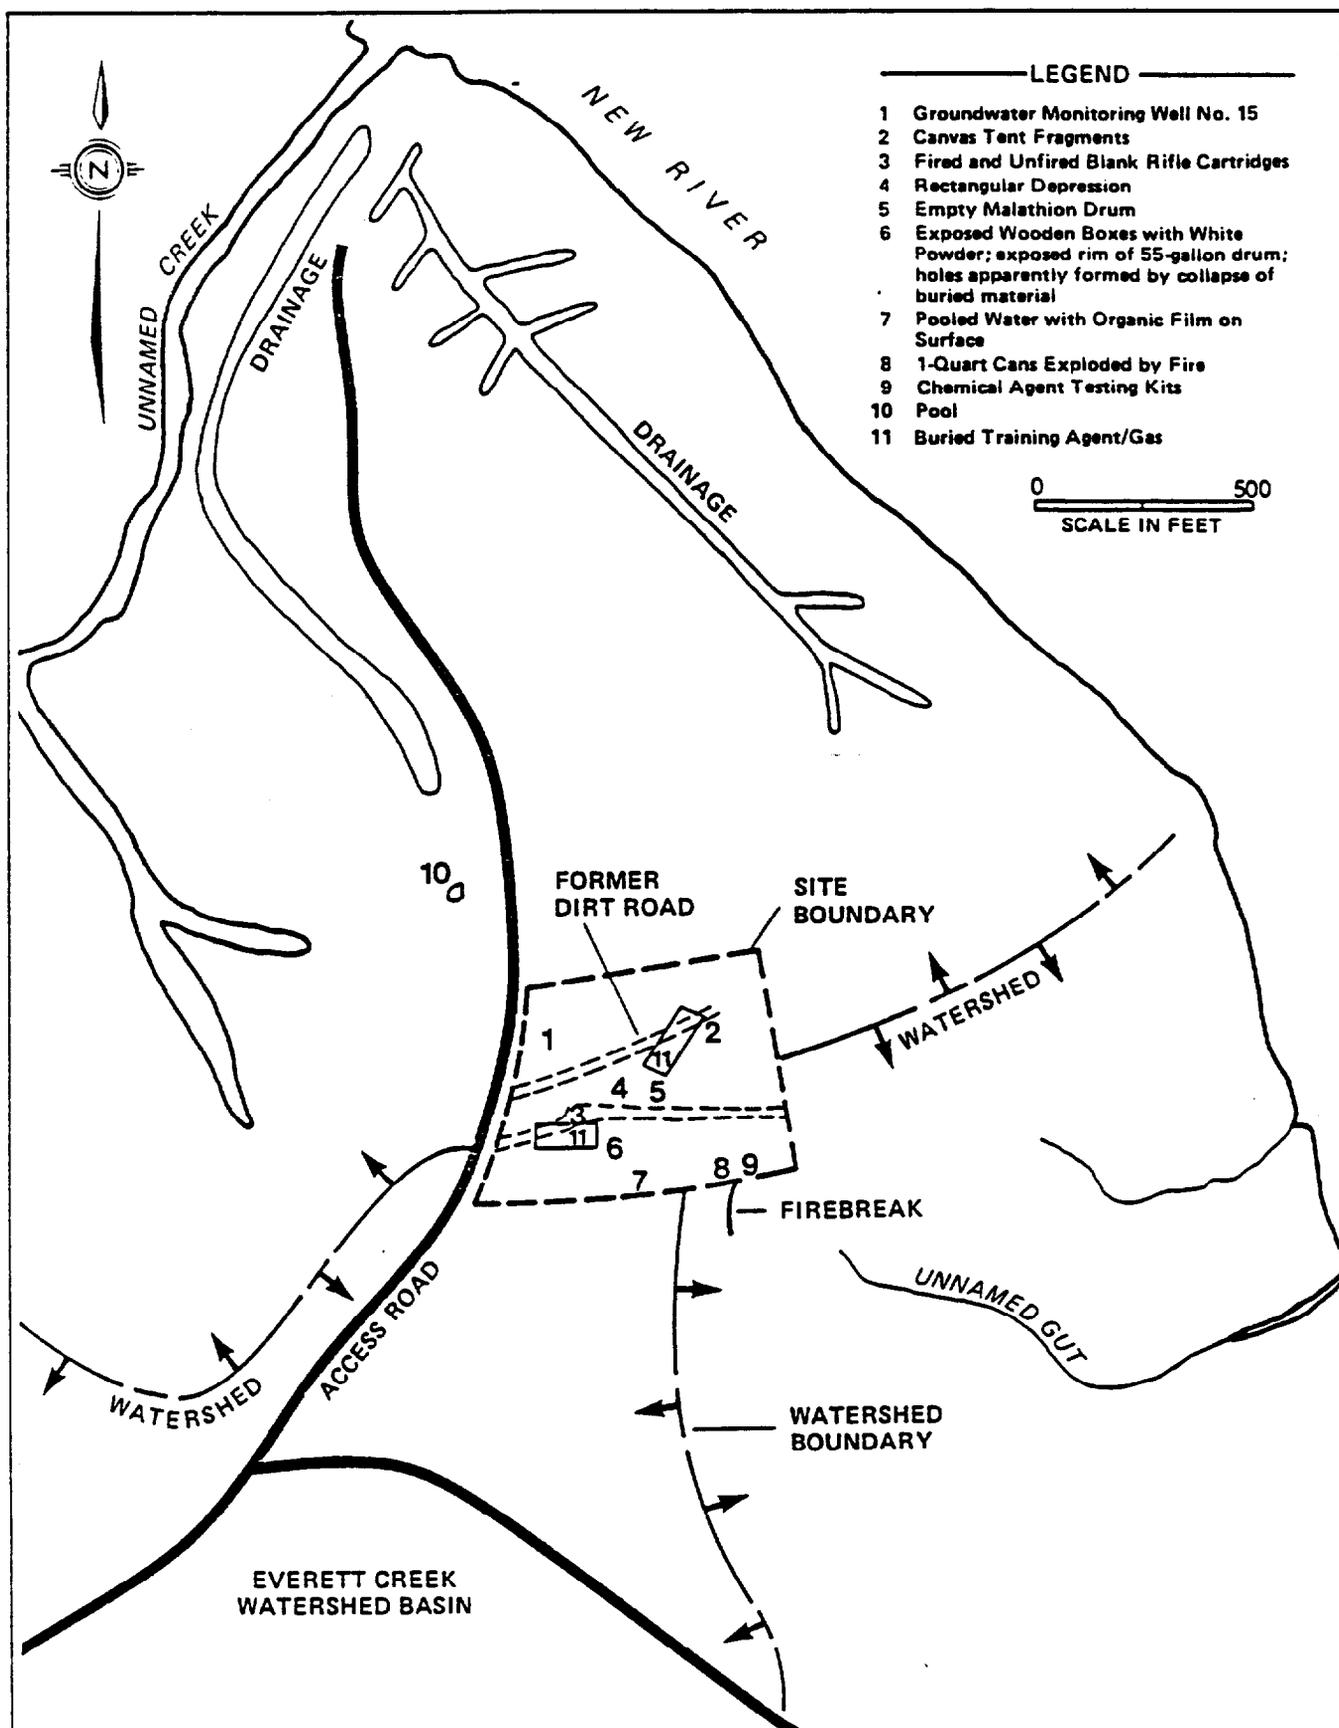
One disposal incident occurred in 1953 or 1954. About 50 drums of what is believed to be training agent were delivered on rubber padded trucks and were buried in two trenches (see Figure 6-32). The drums were described as being "not nearly as heavy as if filled with oil". These drums were placed in the pit one at a time and laid side by side. These two pits were up to 20 feet deep and the drums were stacked so

In 1970, another burial incident took place during which 5-gallon cans and 55-gallon drums of DDT, trichloroethylene (TCE), and calcium hypochlorite were placed together in a common pit. When earth was being placed over the containers, an explosion and fire occurred which caused a forest fire and blew drums from the pit into the forest about 40 yards from the pit. A fire truck and base safety personnel were present. Some of those present possessed gas masks.

FIGURE 6-32
Physical Features and Locator Map For Site No. 69

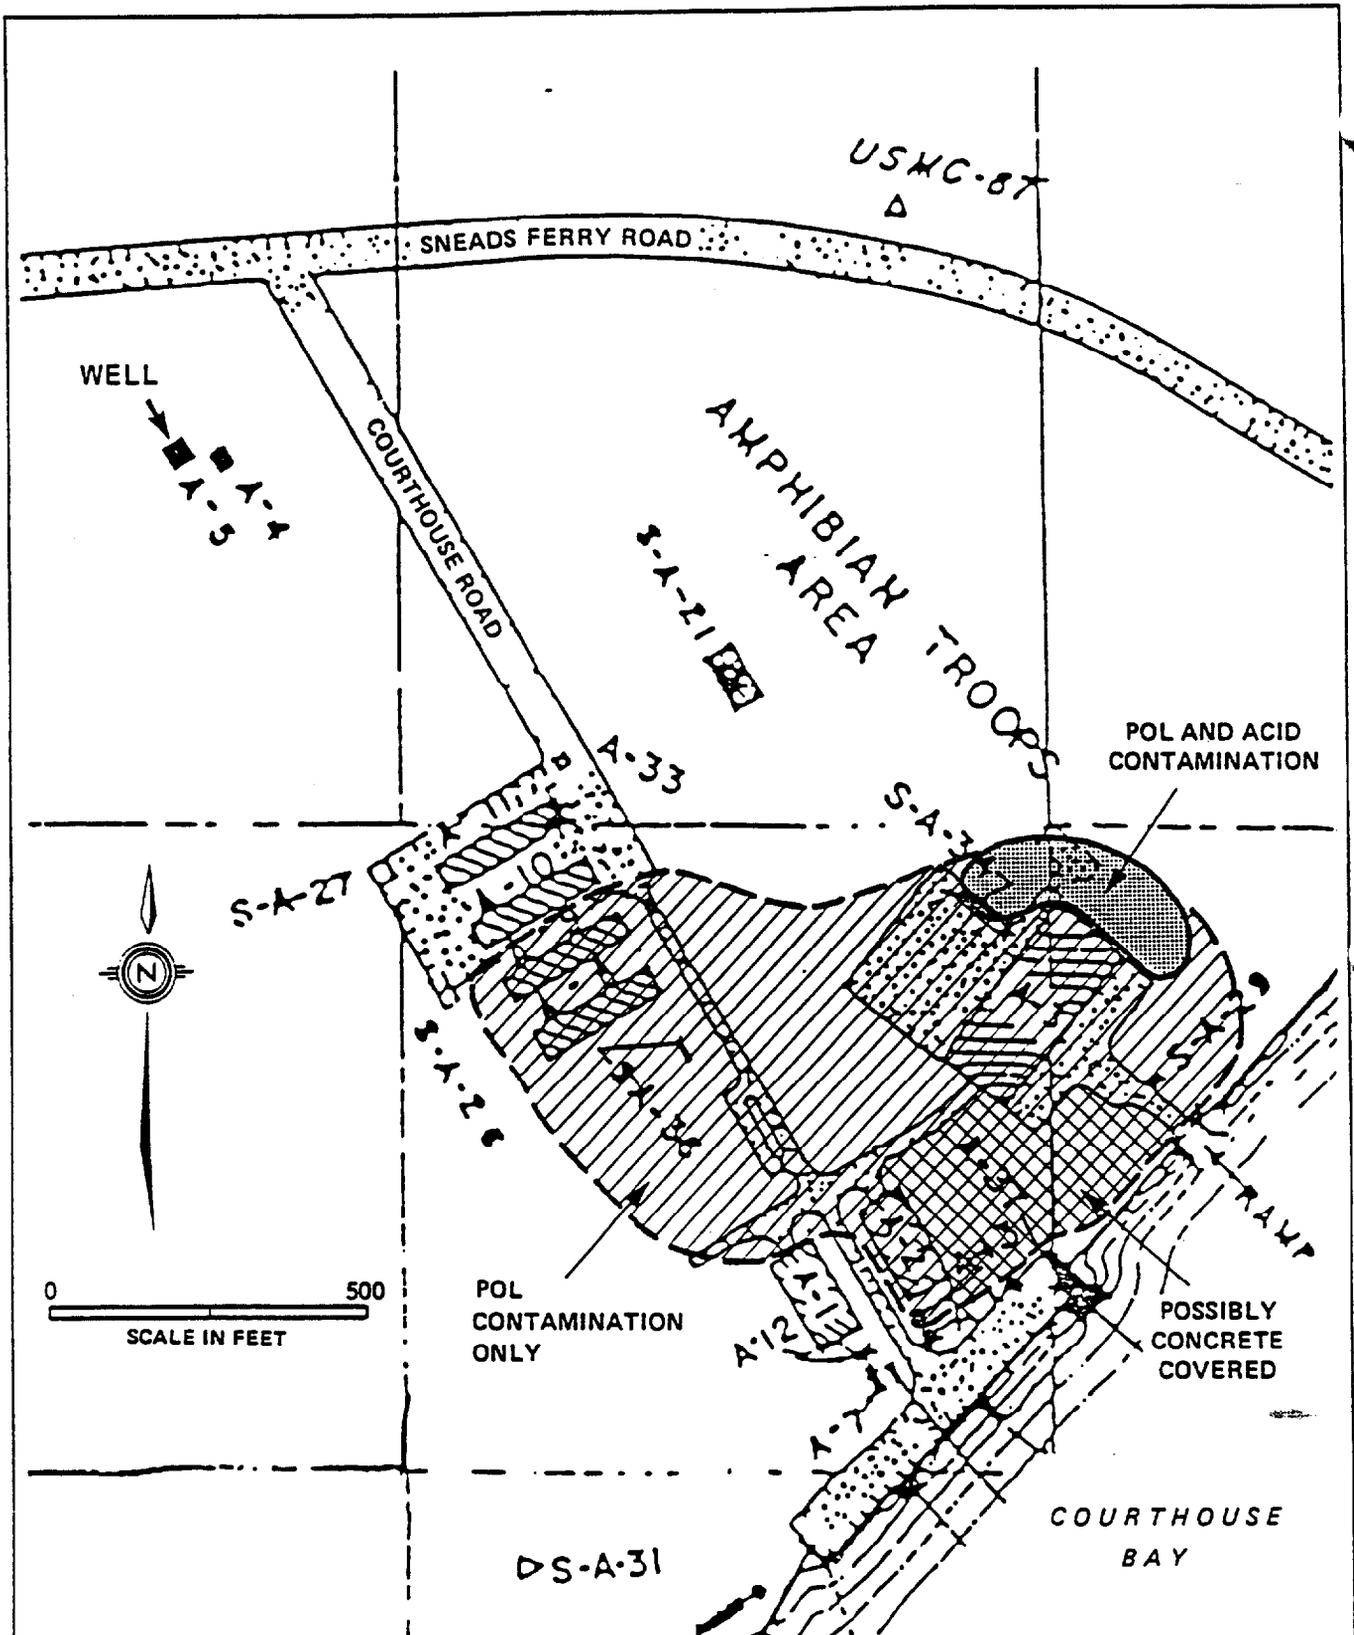
The acid disposal area is approximately 200 feet from Courthouse Bay. The disposal area for POL only is within just tens of feet from the shoreline.

FIGURE 6-34
Detail of Site No. 73, Courthouse Bay Liquid Disposal Area

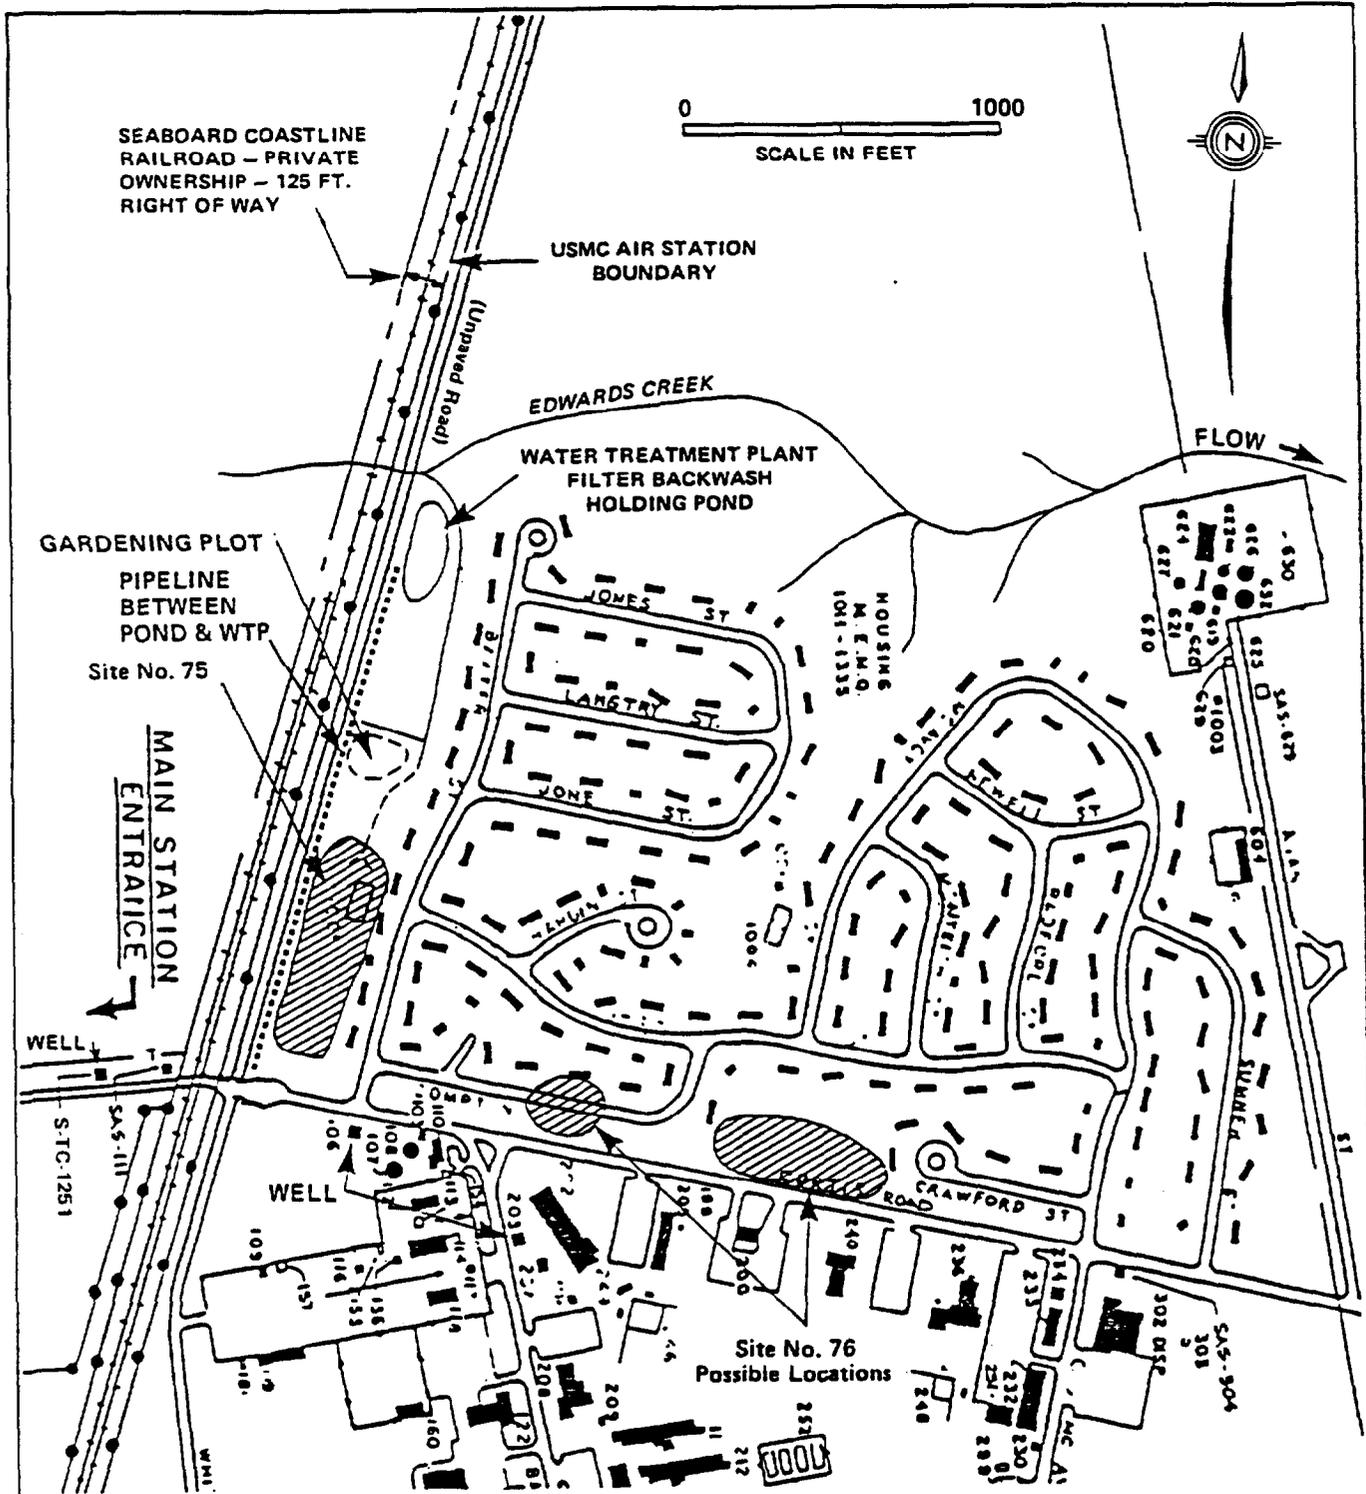
There are three potable wells within 1,000 feet. No basements or shallow wells are known to exist in the vicinity. Recycled filter backwash water is pumped through a buried pipe between the water treatment plant and a storage pond north of the site. This pipe runs north-south immediately west of the site. Relatively high permeability fill surrounding the pipe may provide an opportunity for groundwater movement from the site to and into the pond.

Aerial photographs for years 1949, 1954, 1956 and 1964 did not reveal a conclusive location for this site.

FIGURE 6-36
 Detail of Site No.s 75 and 76, MCAS Basketball Court Site
 and MCAS Curtis Road Site, Respectively

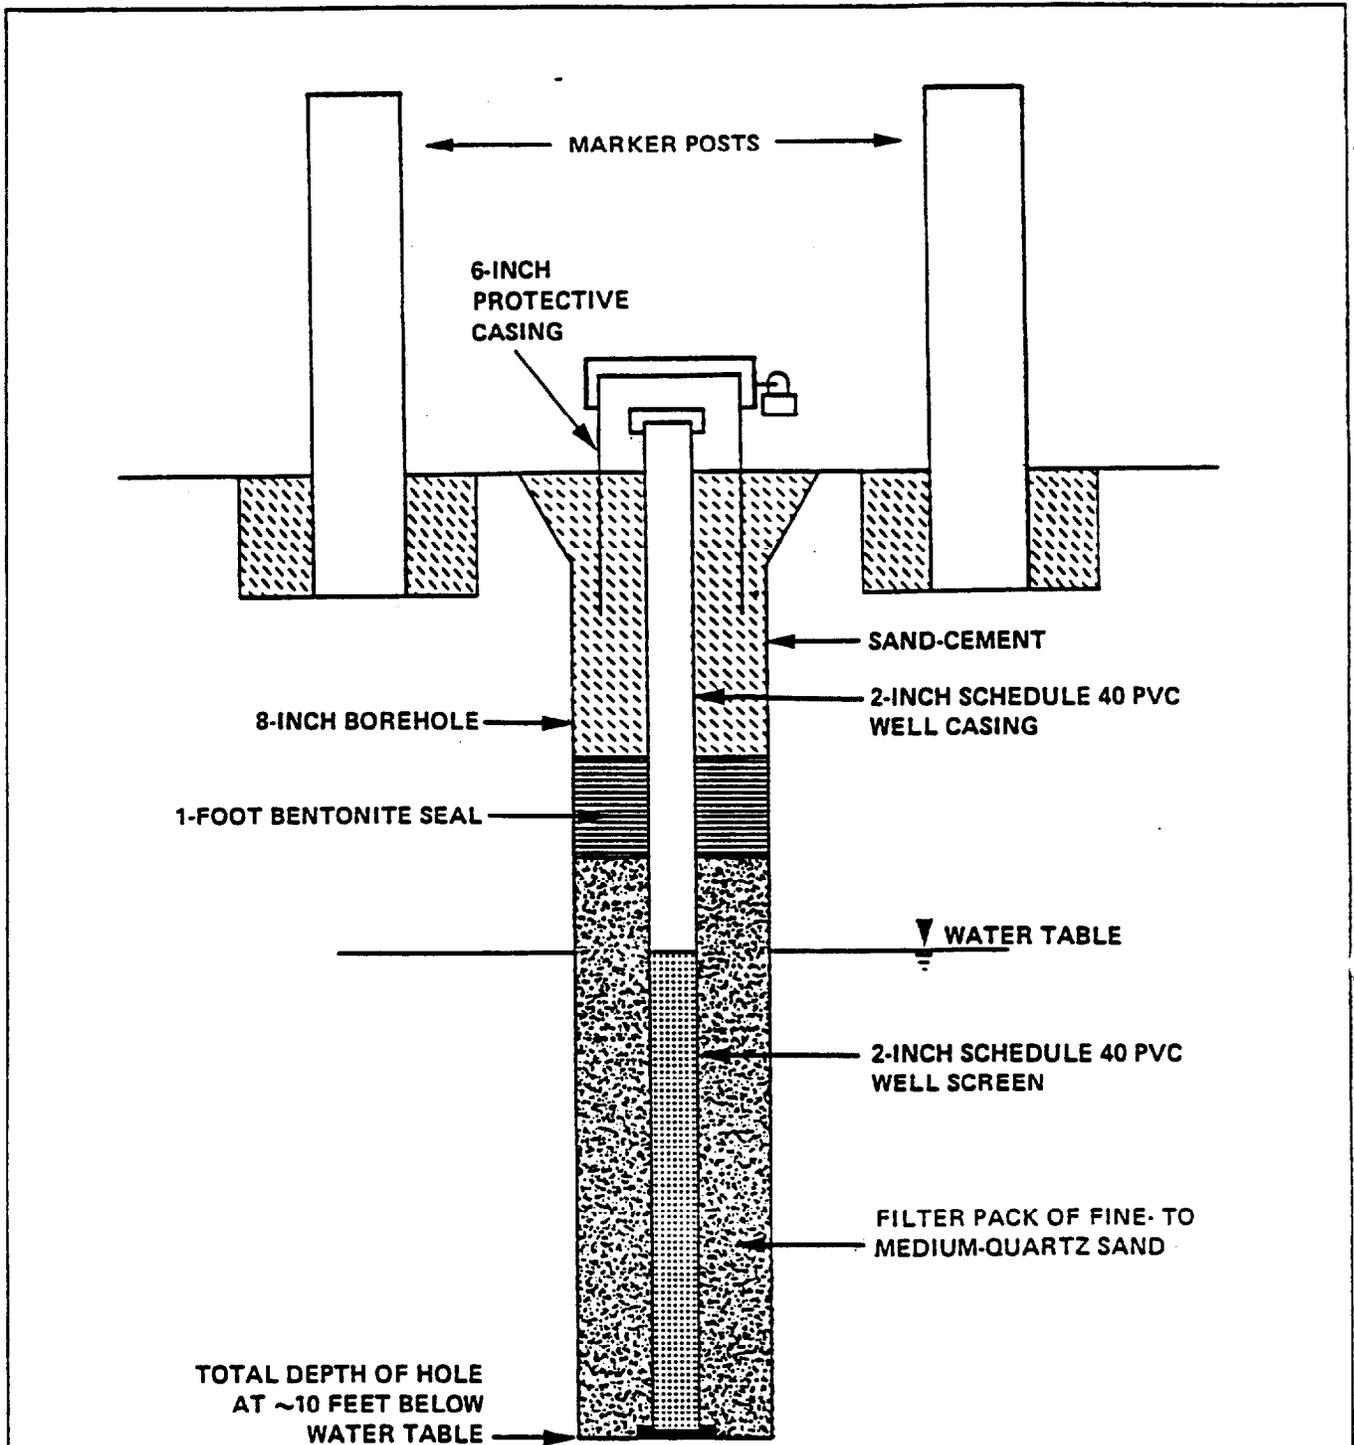
3. After the well casing and screen have been installed in the borehole, place a filter pack of fine- to medium-grained quartz sand in the annular space from the bottom of the hole to approximately 2 feet above the top of the screen.

FIGURE A-1. Recommended Monitoring-Well Construction

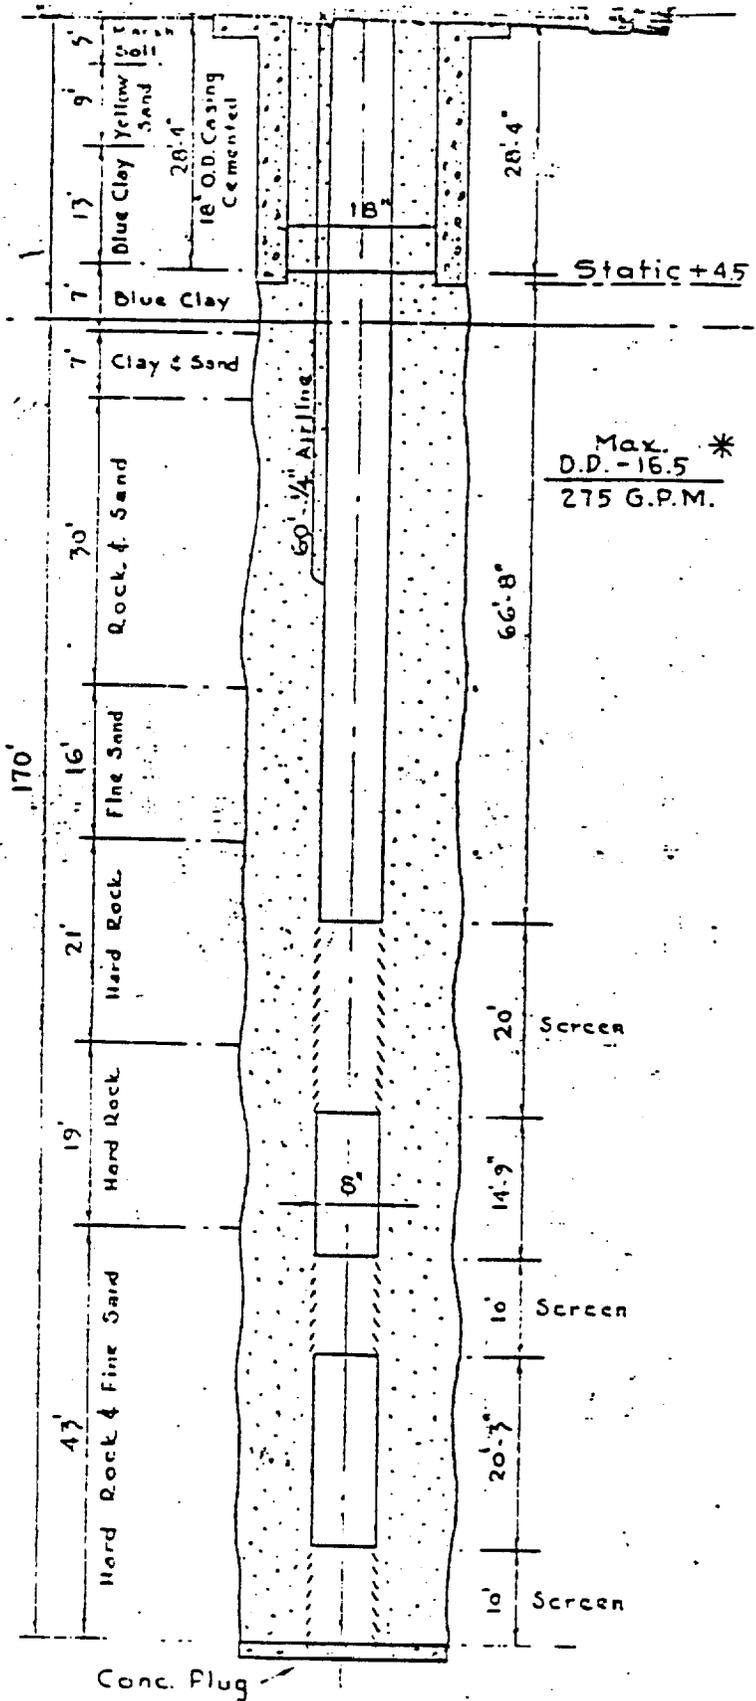
APPENDIX C
LOGS OF WELL NOS. HP-613 and HP-616

Armco Iron Screen Used In This Well
